Technical Report REMR-CS-53  
April 1997

# **Applications of Roller-Compacted Concrete in Rehabilitation and Replacement of Hydraulic Structures**

*by James E. McDonald, Nancy F. Curtis*

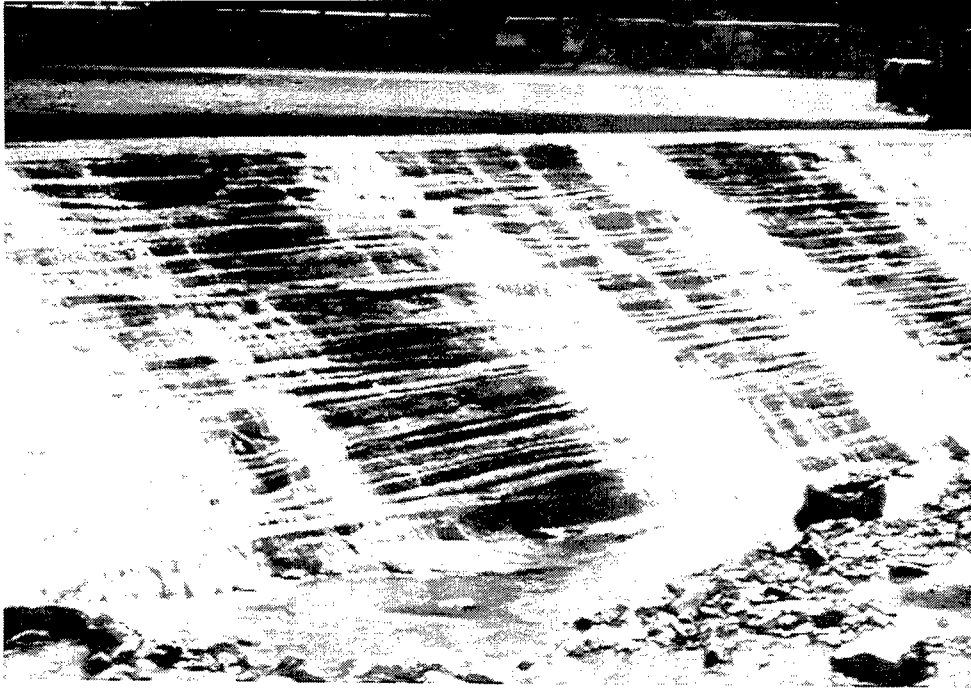
After more than 1,000 overtoppings of the rehabilitated structure, including a 3.7-m (12-ft-) depth of flow during a flood in early 1990, the RCC remains in good condition (Figure 2). Except for some erosion of poorly compacted RCC at the downstream toe, the RCC has not been damaged by water and weathering.

Figure 2. Downstream face of Ocoee Dam with RCC overtopping protection

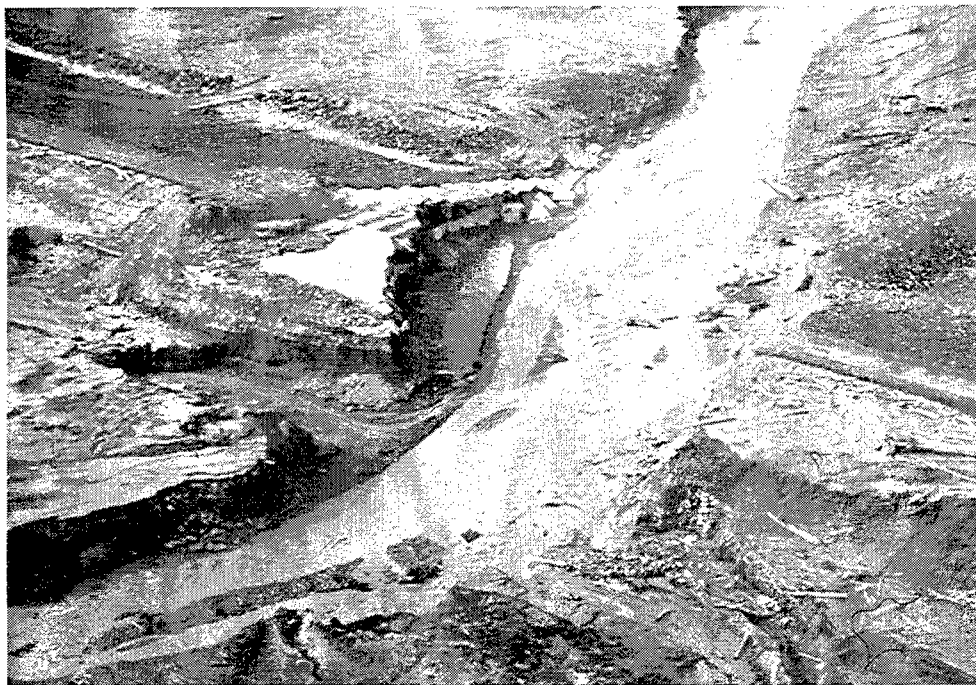
structure was 1 month old, the spillway had failed because of erosion caused by high flows and debris (Figure 3).

Figure 3. Failed gabion spillway, Toutle River

The USACE needed a quick and economical method for replacing the spillway before debris blocked the channel. Steel mesh-reinforced RCC was the option selected. The replacement spillway was 91.4 m (300 ft) wide with a 36.6-m- (120-ft-) long downstream apron. It had a horizontal crest and a downstream slope of 1:4 (Hansen 1989a).

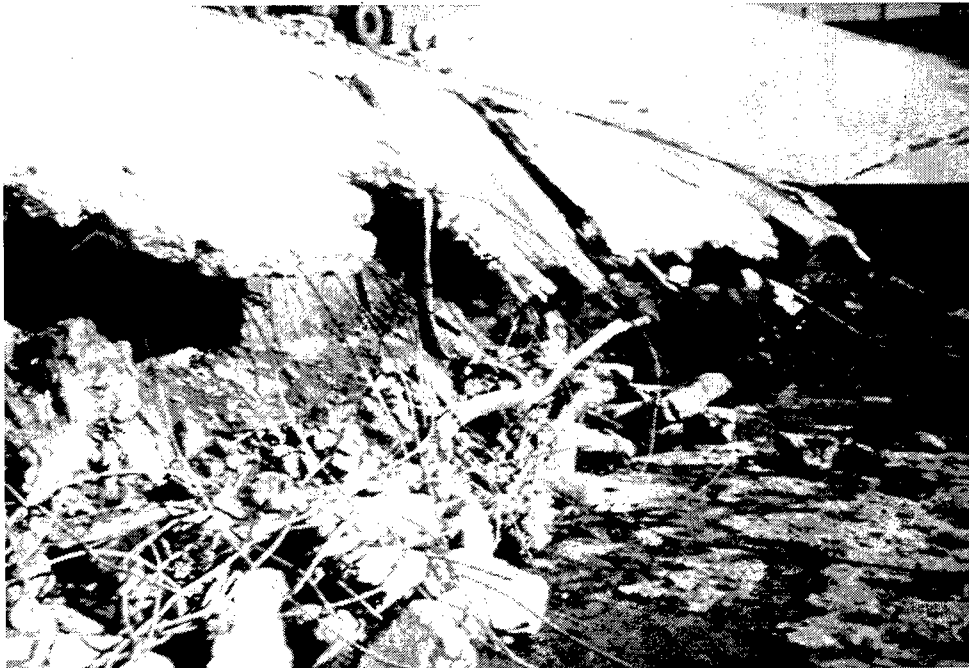
The dam was overtopped by 1.2 m (4 ft) in June 1981, when it sustained some damage. It was overtopped again in October 1982 by 1.4 m (4.5 ft); this time damage was more severe. Then on New Year's Eve 1984, the dam was overtopped by 3.0 m (10 ft). Damage included a loss of about 40 percent of the concrete shell over the service spillway and about one-half of the downstream embankment, severe concrete cracking in the emergency spillway, loss of filter material, and erosion in both abutments (Figure 8). The clay core was eroded to bedrock (Smith 1986).

Figure 8. Overtopping damage to service spillway, Kerrville Ponding Dam

Several alternatives, including repair of the existing structure, were evaluated, but design engineers and consultants determined the fastest and most economical solution was to construct a new RCC section on the downstream embankment (Figure 9).

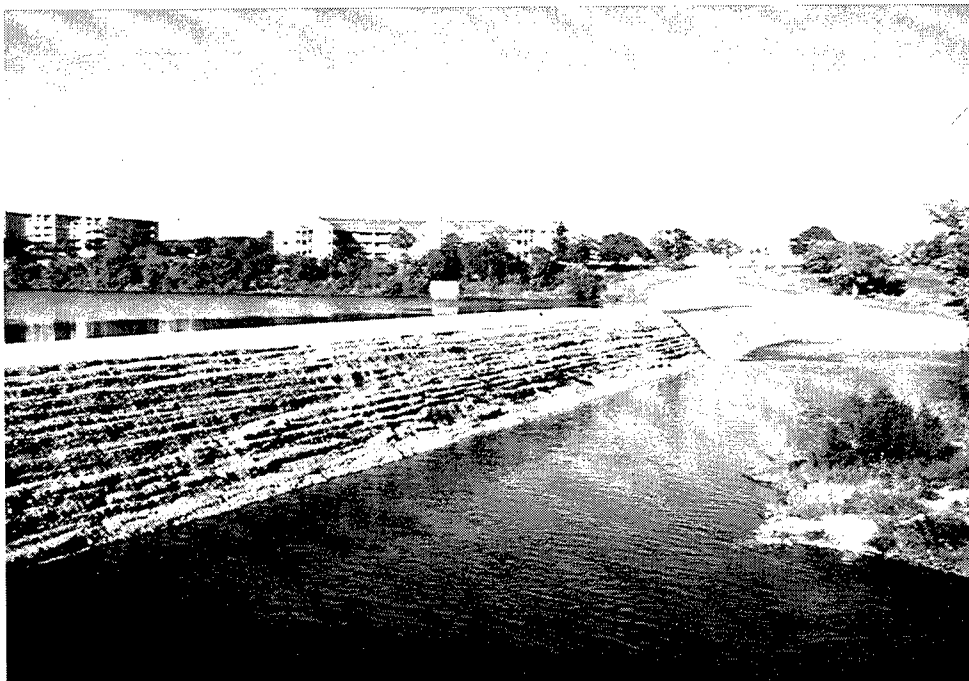
In October 1985, about a month following completion of RCC placement, a 279-mm (11-in.) rain caused a once-in-50-years flood. The new RCC gravity section was overtopped by 4.4 m (14.4 ft), and the emergency spillway by 4.1 m (13.4 ft). At its crest, the flood reached a flow of 3,540 cms (125,000 cfs) over the dam (*RCC Newsletter* 1986). Water flowed over the entire dam for about 5 days and over the service spillway for 3 weeks. An inspection of the dam following the flood revealed significant erosion in the uncompleted earthen abutments; however, damage to the RCC was limited to some minor surface spalling (Figure 11).

In 1987, the area was hit with a once-in-100-years flood. Overtopping reached 4.9 m (16.2 ft) with a maximum flow of 4,590 cms (162,000 cfs). Once again, the only damage to the RCC was minor spalling (*RCC Newsletter* 1988).

Figure 11. Condition of the RCC following overtopping, Kerrville Ponding Dam

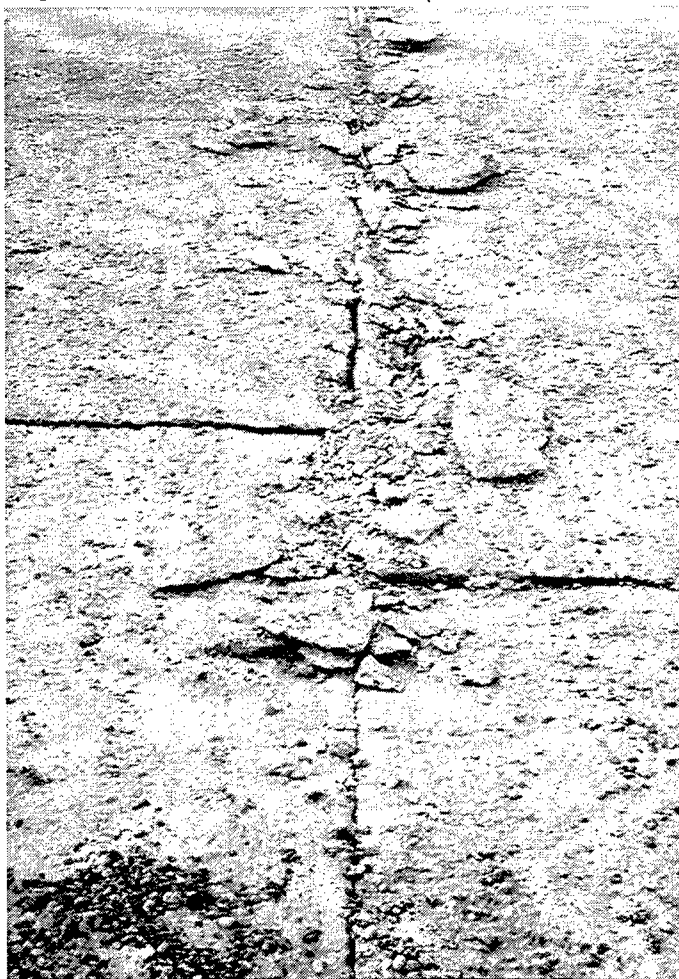
In general, depth of spalling was a maximum at a crack or joint and decreased to a featheredge within 0.3 to 0.6 m (1 to 2 ft) perpendicular to the crack or joint (Figure 16).

Figure 16. RCC spalling along a joint, Addicks Dam

Typically, spalling of this type is caused by excessive stress concentration resulting from debris lodged in the crack or joint or an improper joint. Spalls of this type usually start as delaminations.

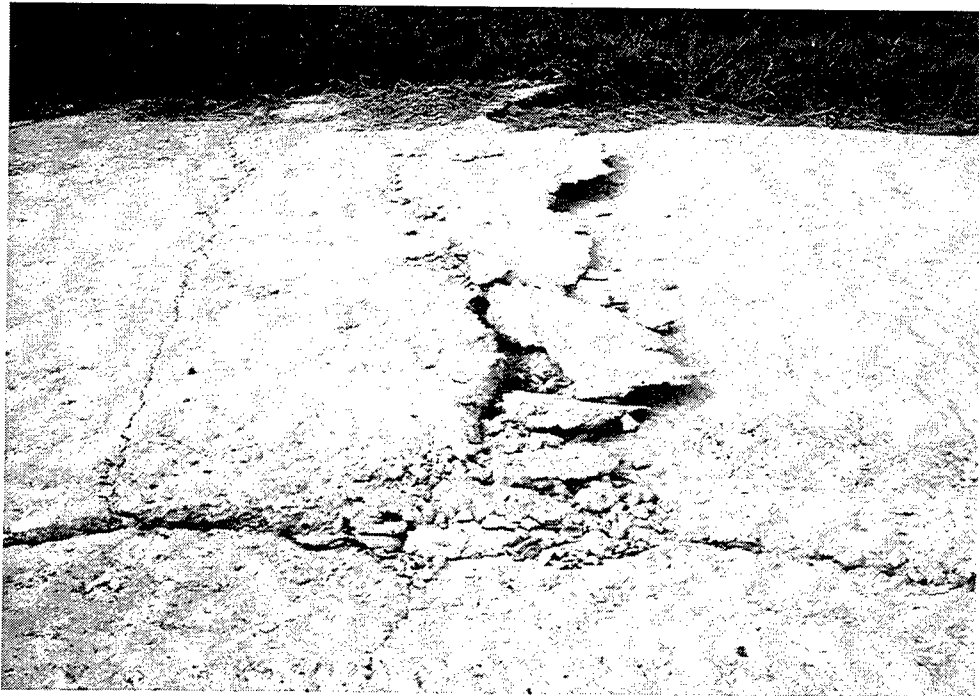
**Figure 17. Buckling blowups in RCC at Addicks Dam**

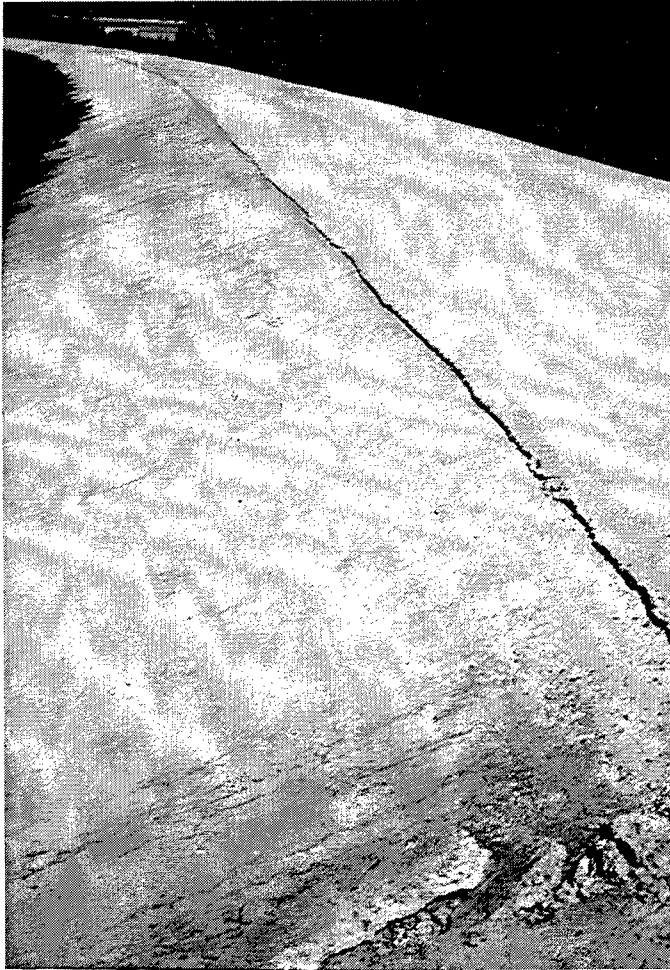
Longitudinal separations between the crest and facing lanes (Figure 18) occurred at both dams. The wider separations, averaging about 25 mm (1 in.),

Figure 18. Typical separation of crest and slope at Addicks and Barker Dams

Backer rods were installed in most lane separations (Figure 23) and larger cracks, and then the openings were sealed with crack and joint sealer (Figure 24). Backer rods were installed in approximately 640 lin m (2,100 lin ft) of these repairs. Cracks with surface widths smaller than 9.5 mm (3/8 in.) were routed to allow placement of the sealant (Figure 25).

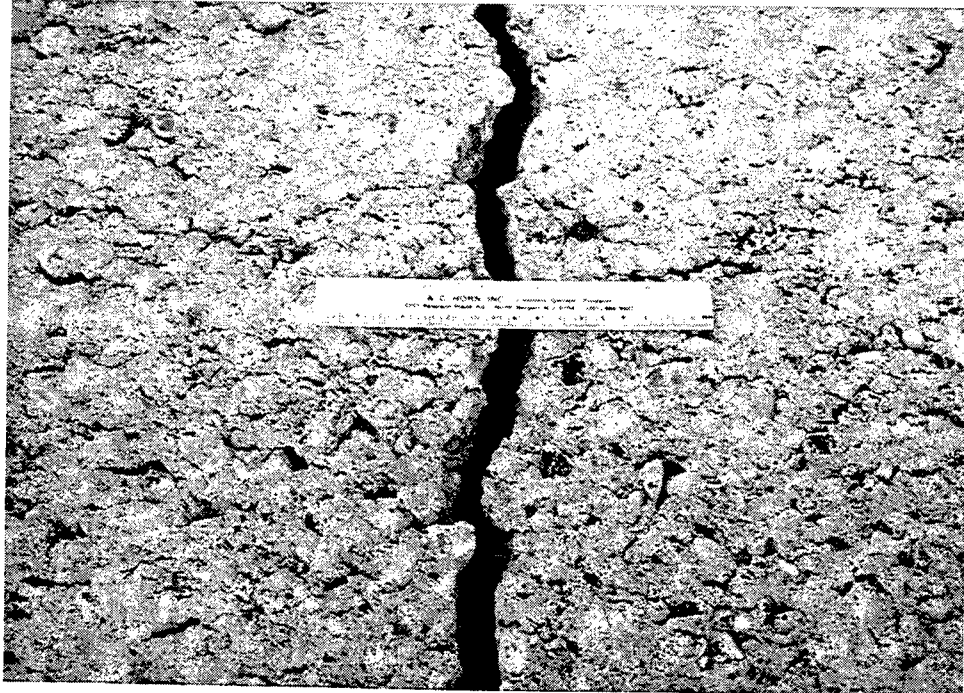
Figure 19. Longitudinal crack in the RCC armorplating at Addicks Dam

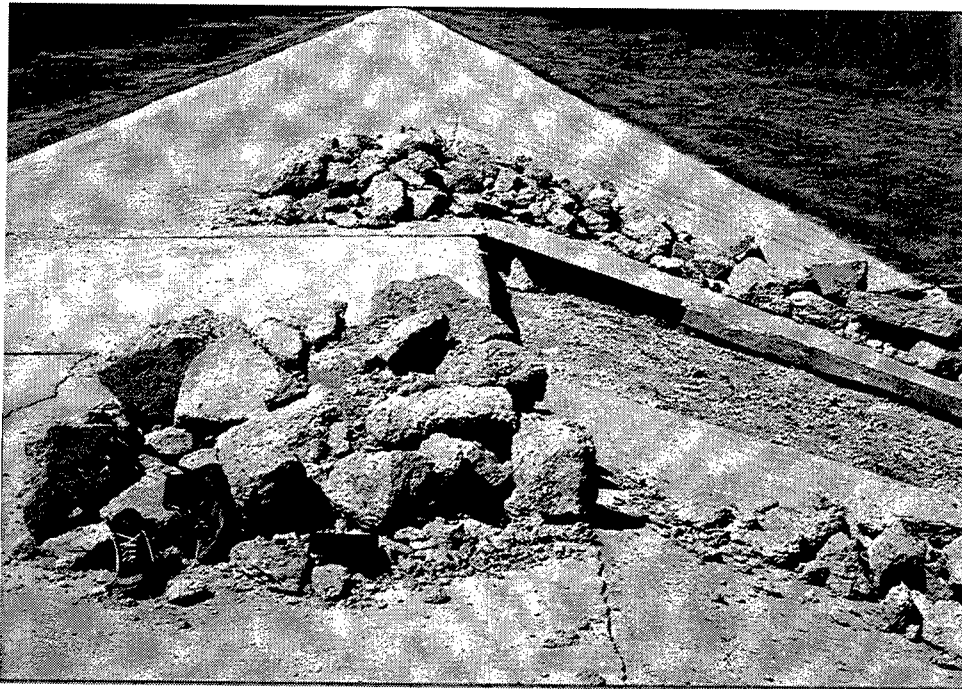
Figure 20. Removal of spalled RCC and replacement with new concrete, Barker Dam

76 mm (3 in.). Each cubic yard contained a minimum of five bags of portland cement and 5 percent entrained air. Repair areas were identified by sounding cracks and construction joints to locate delamination or spalling. Spall repair involved removing and replacing damaged concrete (Figure 20). Repair

boundaries were extended beyond the spalled areas. The sides of the repair area were vertically saw cut a depth of 51 mm (2 in.). Damaged concrete was removed down to sound, unweathered concrete, and the repair surfaces were cleaned with brooms and compressed air. Any areas that were contaminated with oil or grease were sandblasted. Epoxy-resin adhesive was used to bond the replacement concrete to the existing RCC (Figure 21).
