# Technical Manual: Outlet Works Energy Dissipators

Best Practices for Design, Construction, Problem Identification  
and Evaluation, Inspection, Maintenance, Renovation, and Repair

FEMA P-679/ June 2010

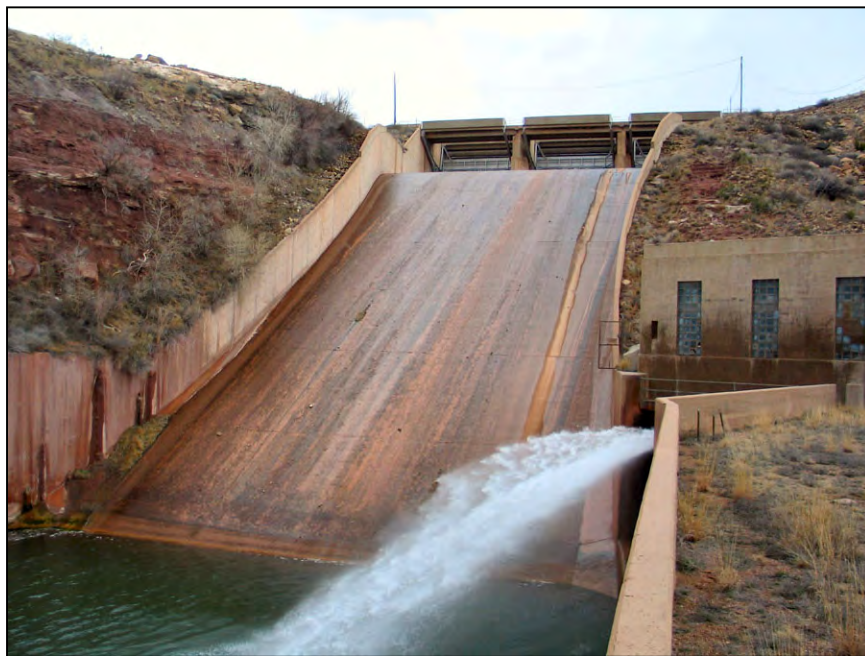
Figure 3.—An outlet works discharging into a spillway stilling basin.

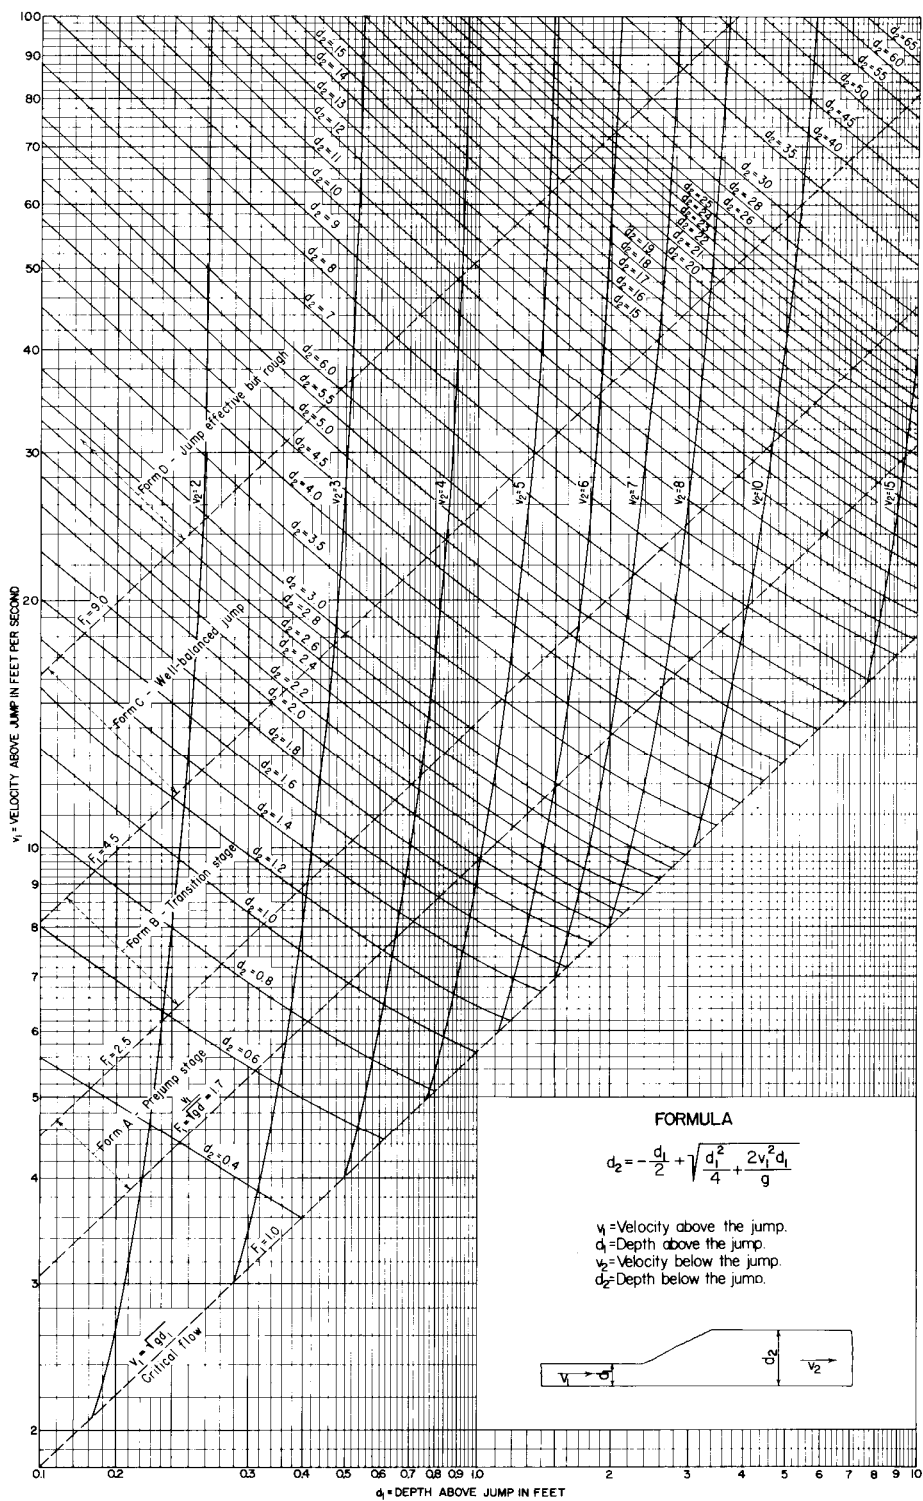
Figure 18.—Relationship between variables in a hydraulic jump (Reclamation, 1987, p. 389). See Reclamation (1987) for information concerning the variables as denoted in this figure.

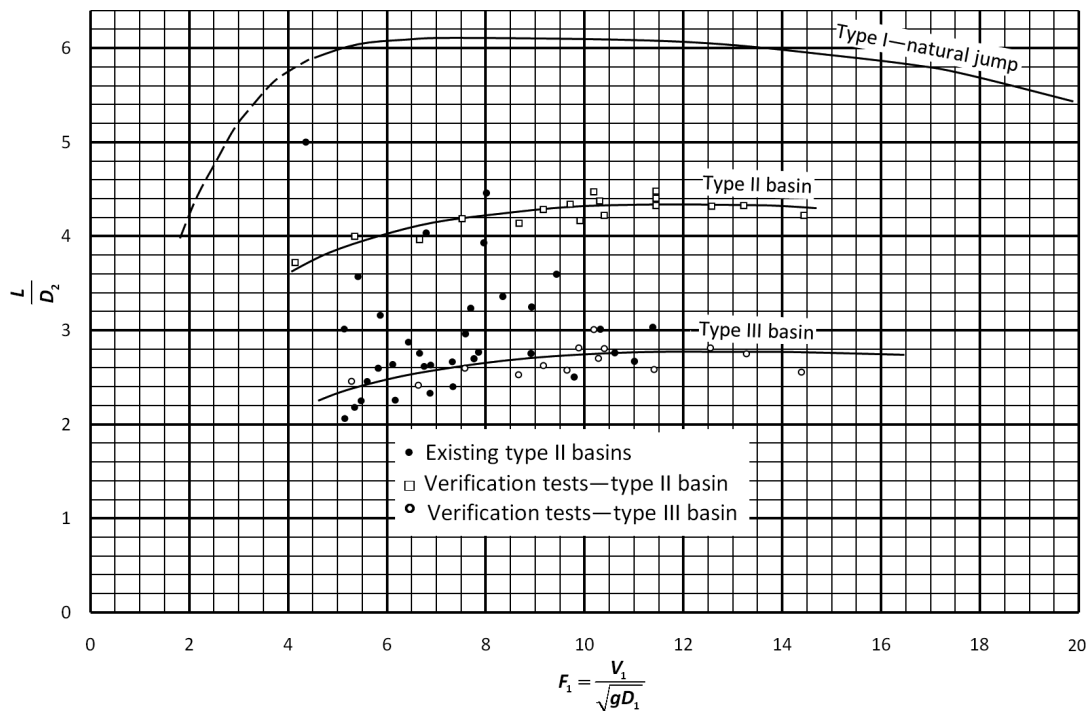
Figure 20.—Length of hydraulic jump for type I, II, and III basins (Reclamation, 1984, p. 27). See Reclamation (1984) for information related to the variables as denoted in this figure.

A type III basin is shorter than a type II basin and is typically used for canal structures, small outlet works, and small spillways. The reduction in length is mainly achieved by baffle blocks. Figure 33 shows the recommended basin lengths for a type III basin based on the Froude number of the incoming flow and the conjugate depth ( $d_2$ ). The recommended type III basin length is also shown on figure 20.

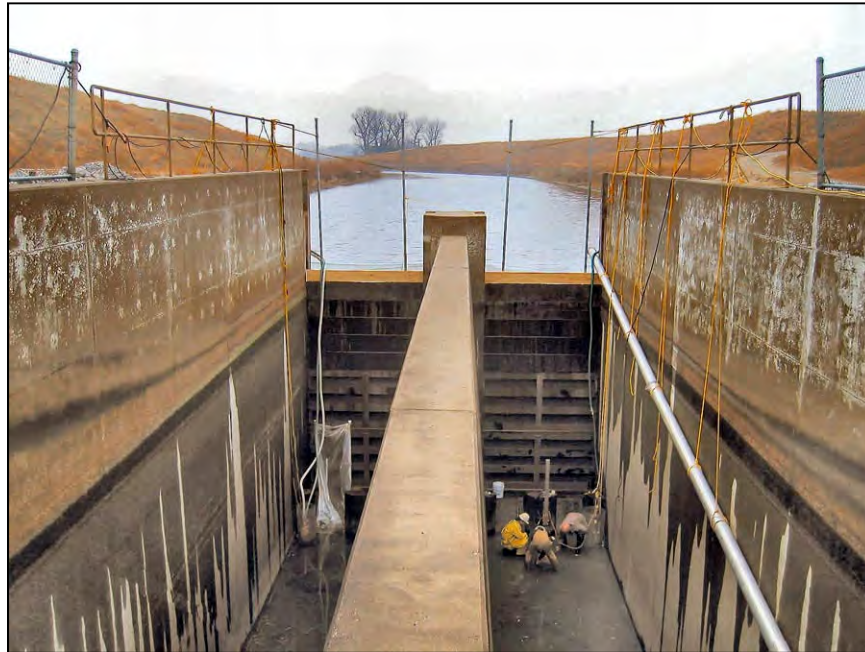
Figure 27.—Stoplogs have been installed in slots to allow for repairs to be made to the unwatered stilling basin.

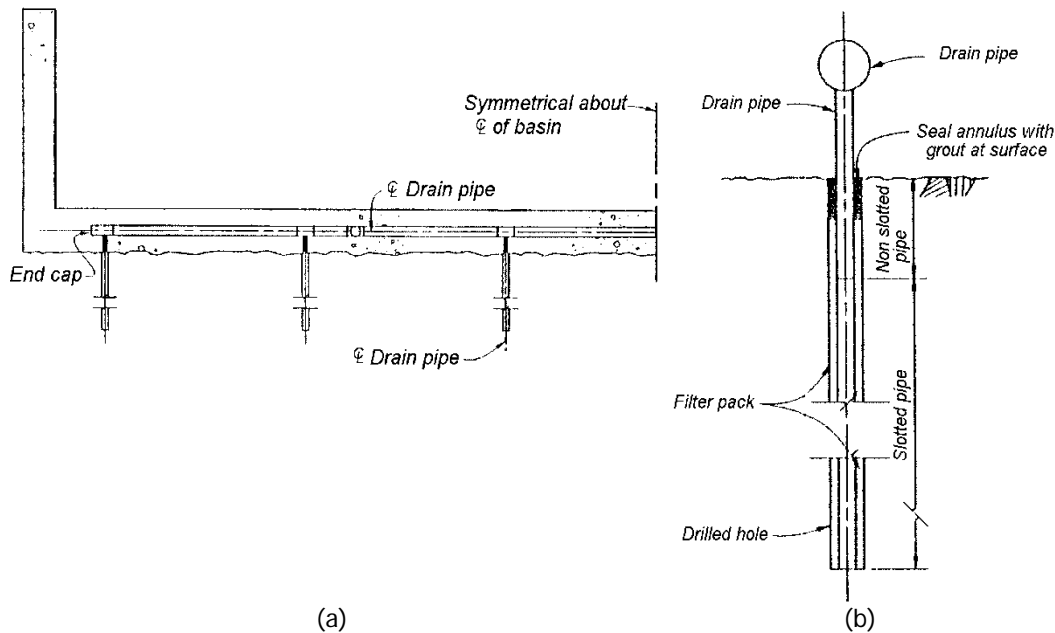
Figure 29.—Alternative underdrain system—(a) lateral (horizontal) collector drain with drilled/formed (vertical) weep hole drains. Note lateral collector drain is embedded in concrete to minimize disturbance to foundation. Cleanouts and covers for vertical drilled/formed drains are not shown, but are required for maintenance and inspection. (b) Typical detail of vertical drilled drain hole.

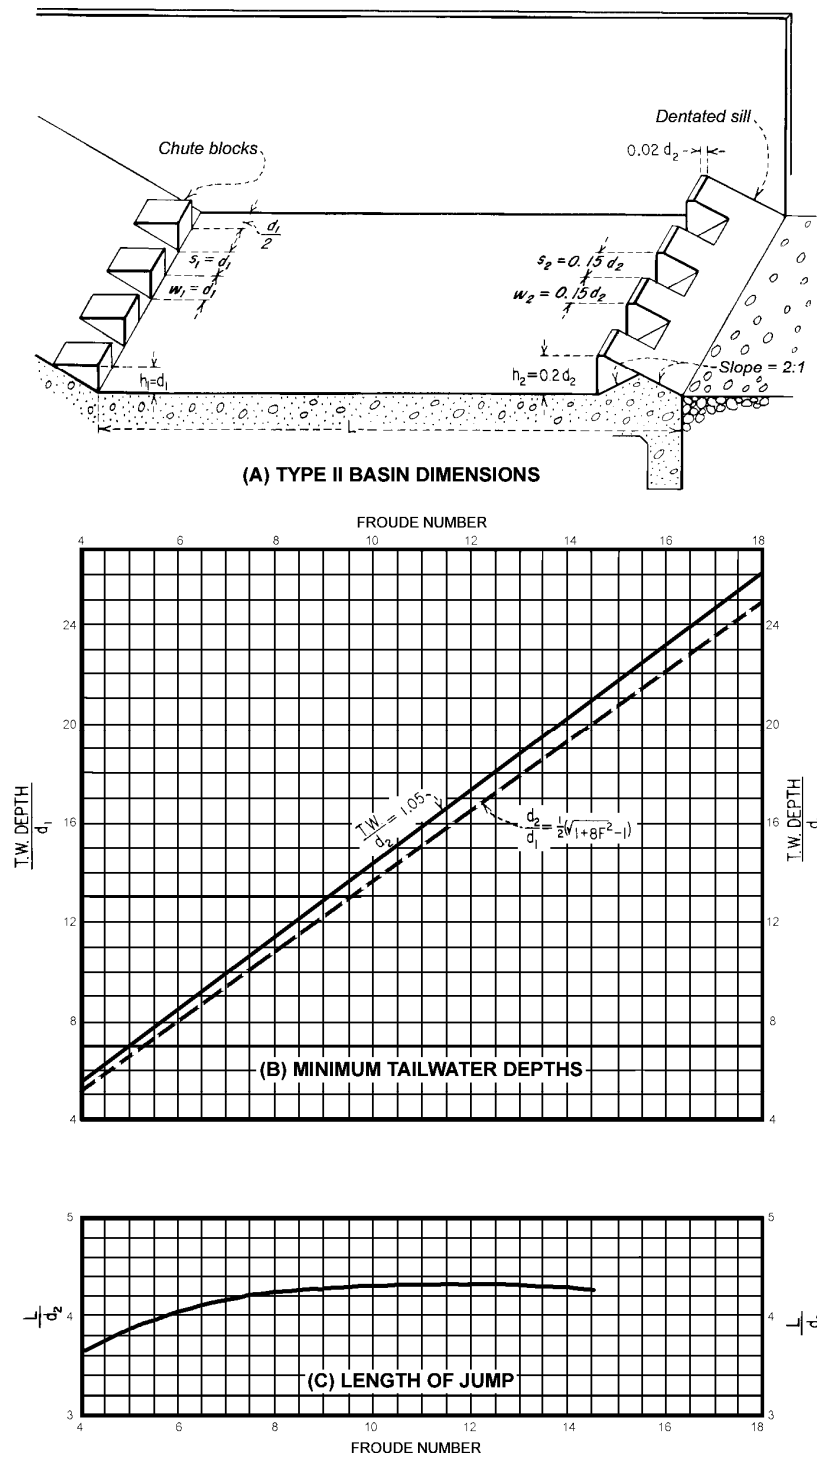
Figure 32.—Type II basin characteristics for Froude numbers greater than 4.5 and incoming velocities greater than 60 ft/s (Reclamation, 1987, p. 395). See Reclamation (1987) for information related to variables as denoted in this figure.

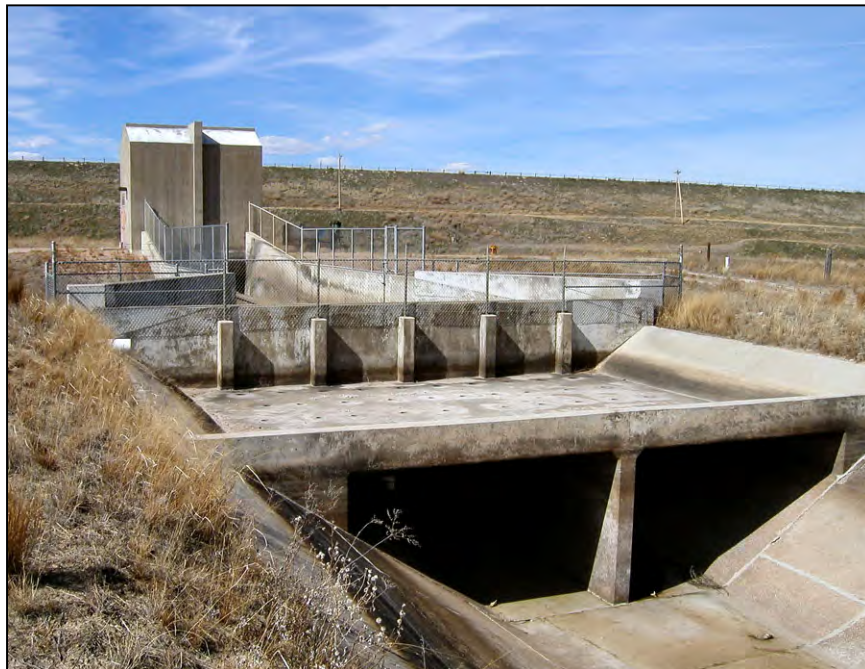
**Figure 34.**—This wave suppressor (also known as an underpass-type) was constructed after completion of the stilling basin to prevent unanticipated waves exiting the basin from overtopping the downstream canal lining. Overtopping could result in either undermining of the soil supporting the canal lining or introduction of uplift pressures beneath the canal lining. Note the formed openings through the deck of the wave suppressor.

The type IV basin is typically used for outlet works, canal structures, and diversion dams. Two separate type IV basins have been developed and have proved relatively effective for dissipating the bulk of the energy of the flow. However, the wave action propagated by the oscillating flow cannot be entirely dampened. Auxiliary wave dampeners or wave suppressors must sometimes be used to provide a smooth flow surface downstream. Figure 34 shows an example of a wave suppressor at the

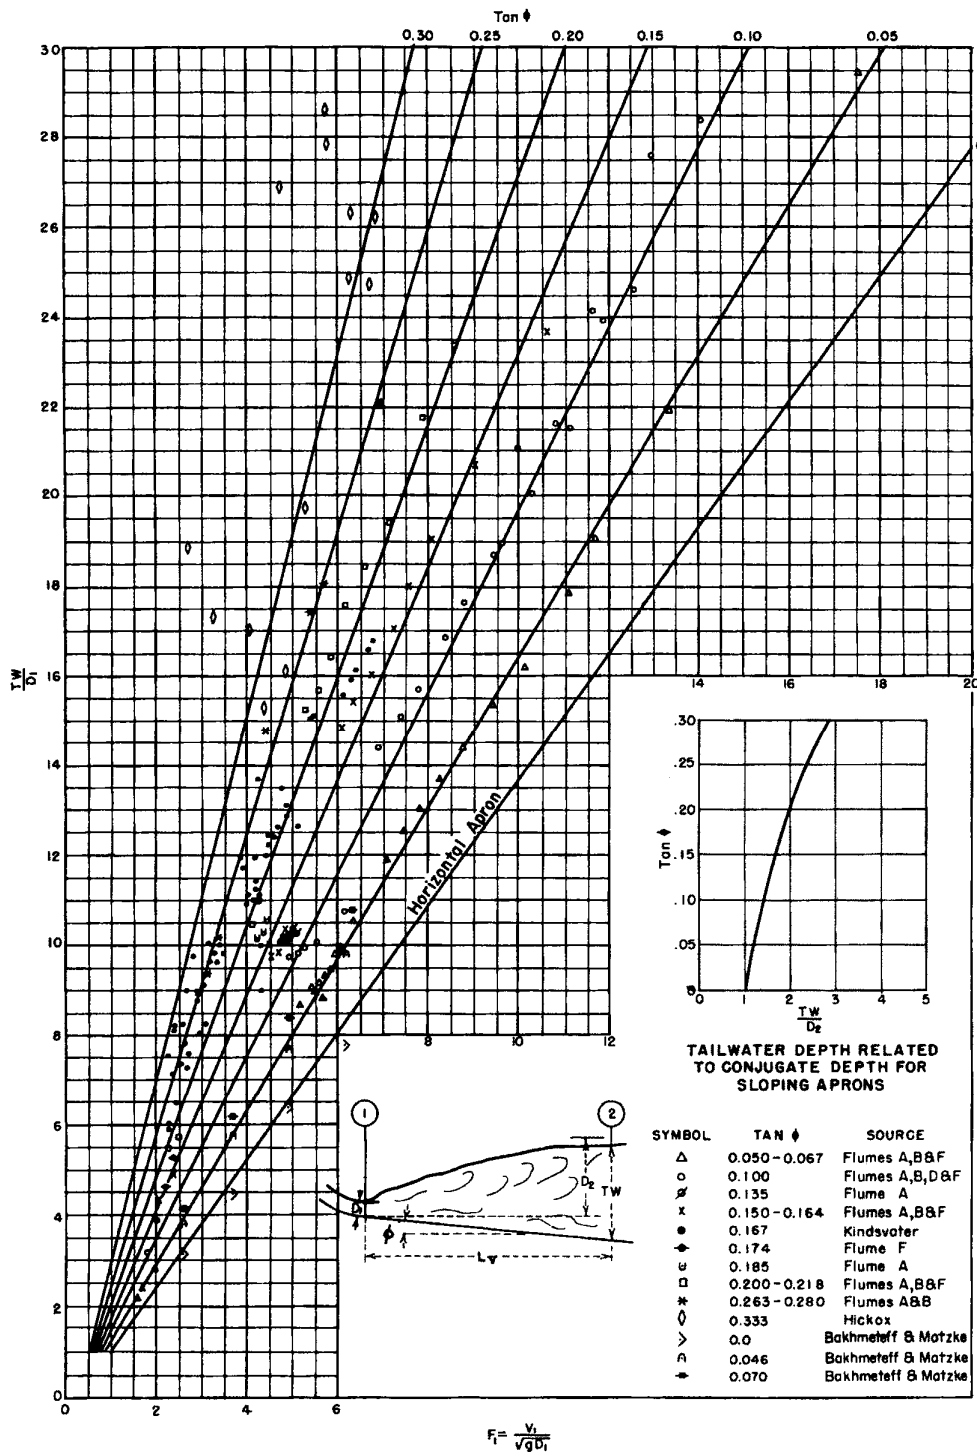
Figure 38.—Ratio of tailwater to initial depth for jump on slope (type V basin, case D) (Reclamation, 1984, p. 63). See Reclamation (1984) for information related to variables as denoted in this figure.

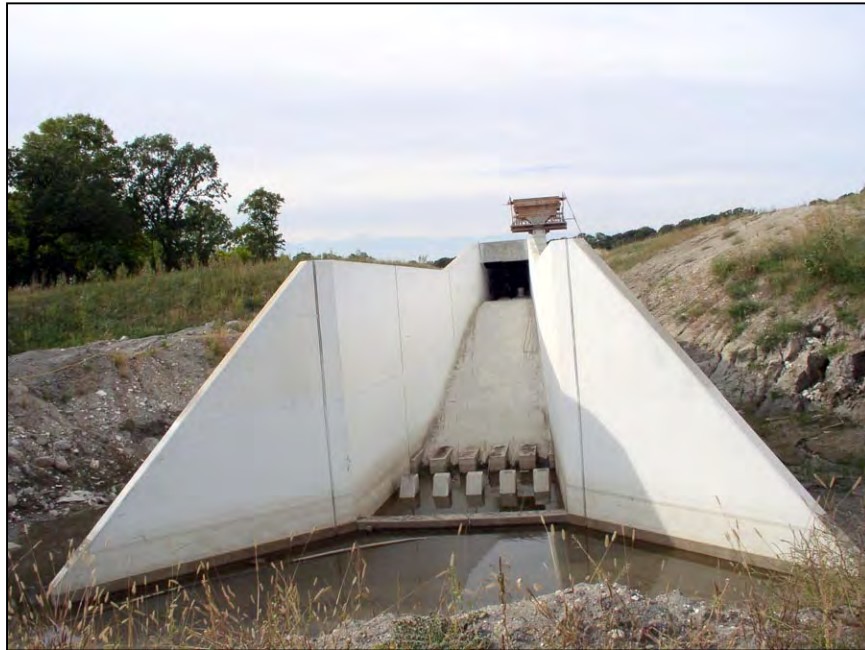
Figure 46.—SAF stilling basin.

The SAF stilling basin uses chute blocks at the entrance of the basin to increase the inflow depth and break up the high velocity flow into a number of small streams.

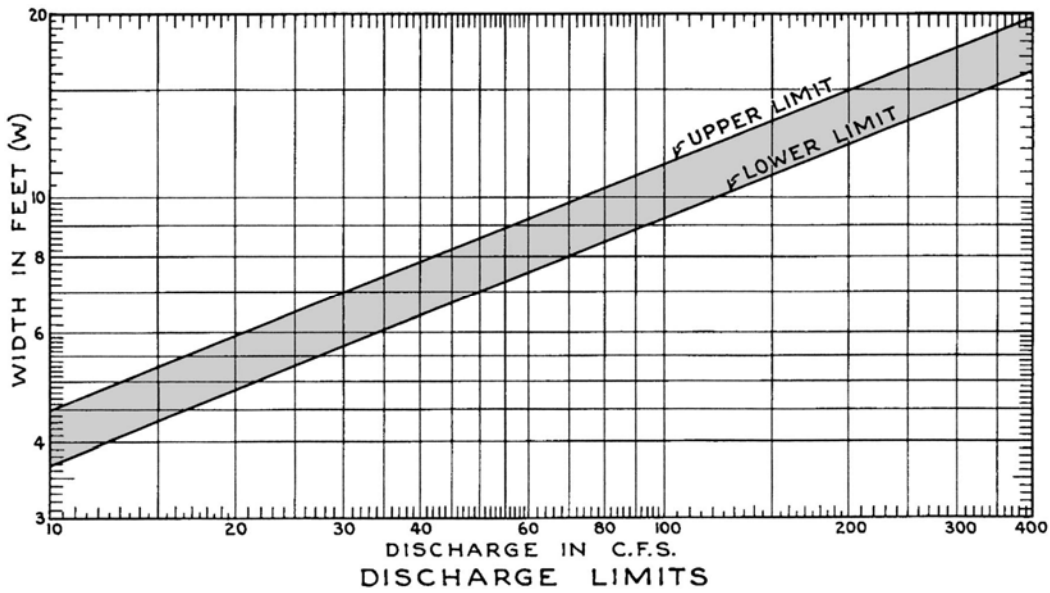
Figure 52.—Reclamation design aid for type VI impact basins (Reclamation, 1984, p. 83).

The graph in [figure 52](#) has two parallel lines, which show, for a given basin width ( $W$ ), the range of discharges over which best operation is obtained. These lines are

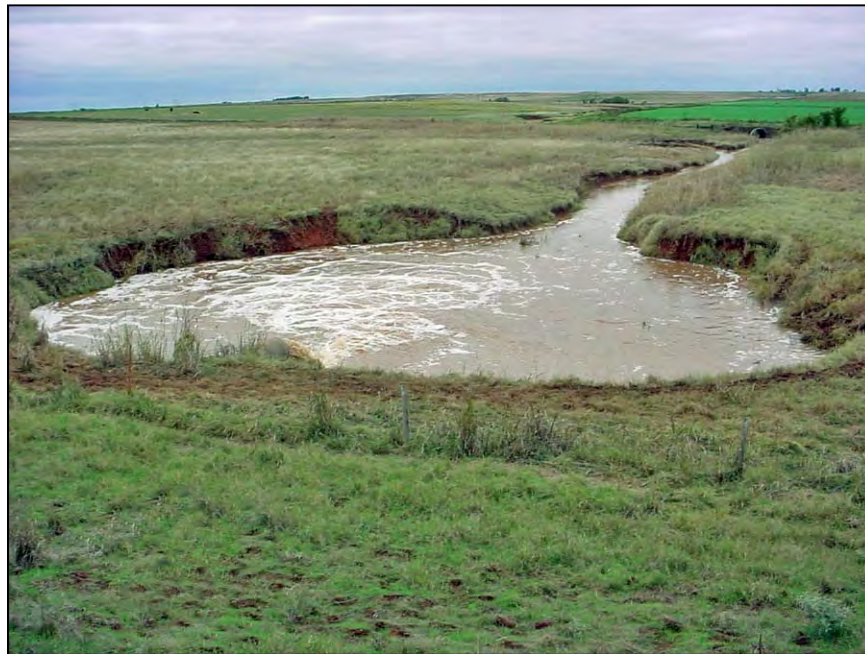
Figure 58.—Unlined plunge basin (view is looking downstream). This basin has been allowed to scour over time.

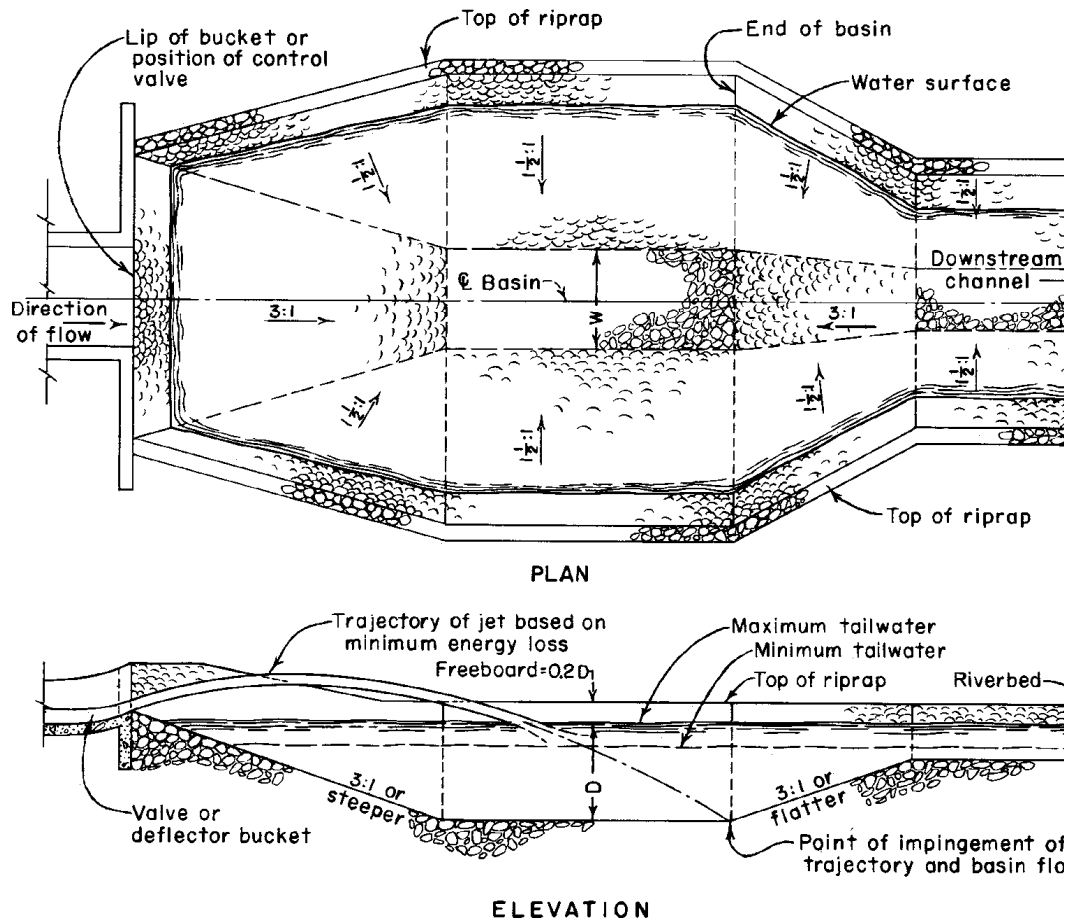
Figure 62.—Typical lined plunge basin design (Reclamation, 1987, p. 403). See Reclamation (1987) for information related to the variables as denoted in this figure.

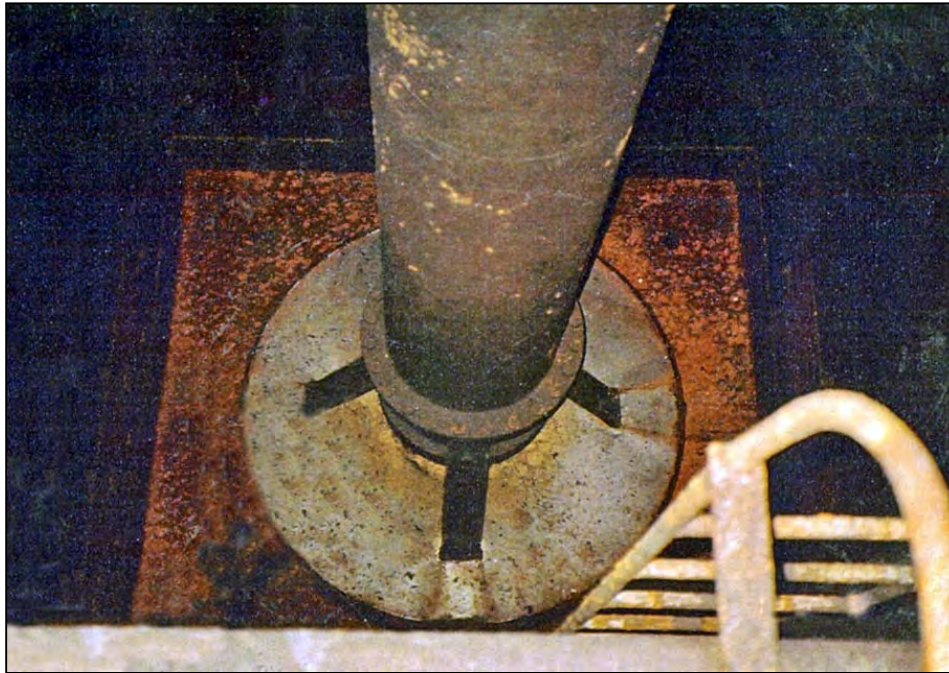
**Figure 64.**—This stilling well was installed in 1966 and consists of a 10-foot wide well, 16-foot depth, and a 24-inch diameter sleeve valve. Design discharge is 78 ft<sup>3</sup>/s at a static head of 88 feet.

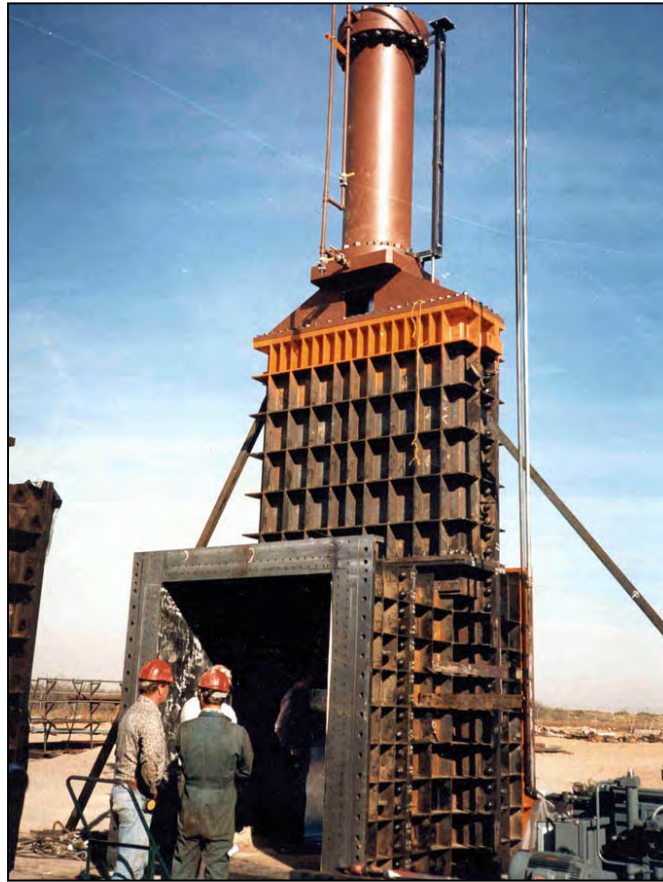
Figure 101.—One half of a tandem bonneted gate system.

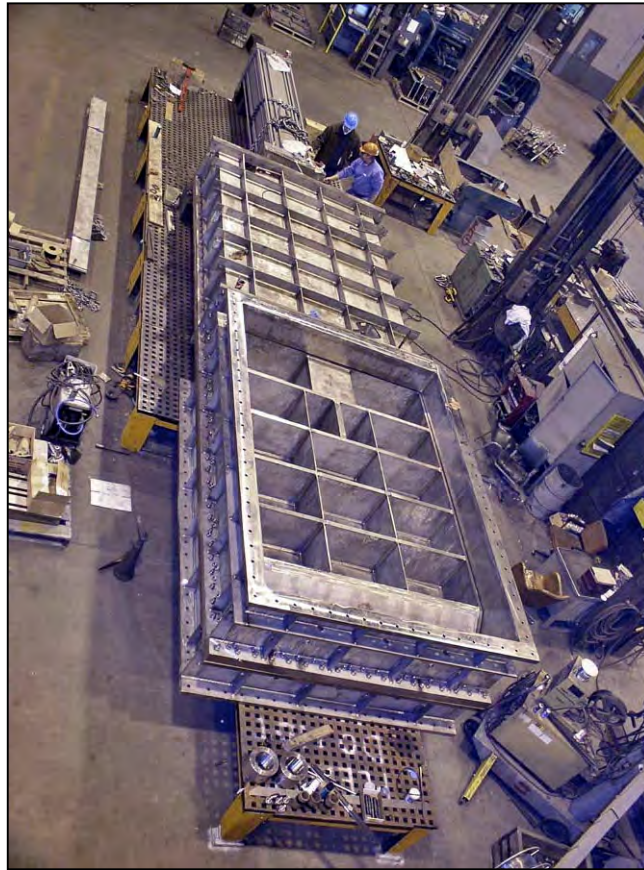
Figure 102.—A fabricated (stainless steel) bonneted gate being produced for 200 feet of head. Photo courtesy of Rodney Hunt Corporation.

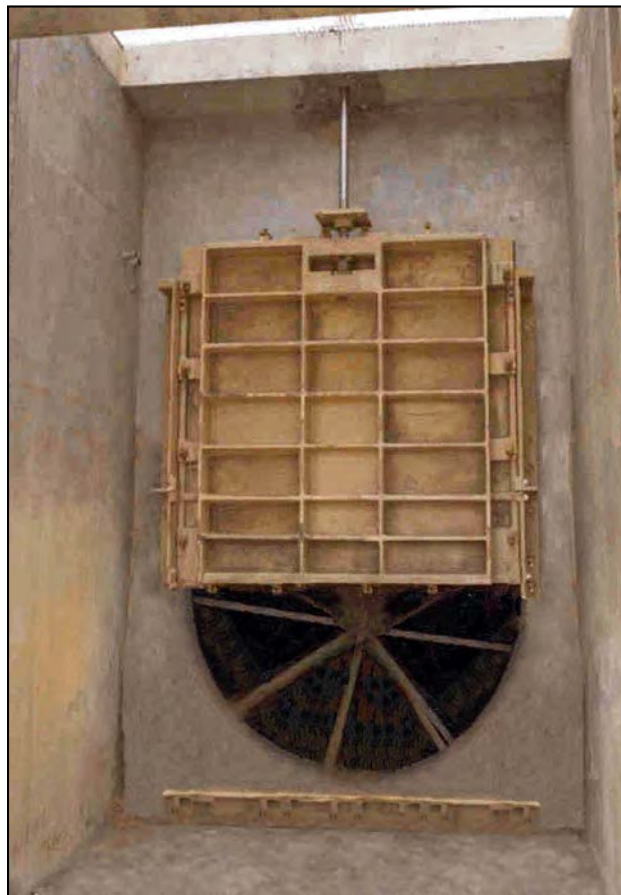
Figure 104.—Unbonneted slide gate.

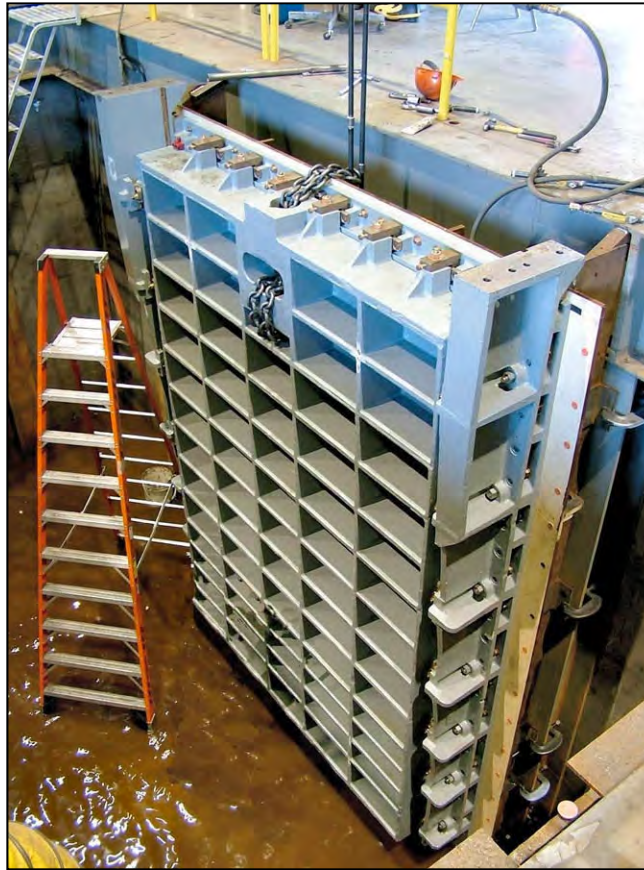
Figure 105.—Shop testing of cast-iron slide gate. Photo courtesy of Rodney Hunt Corporation.

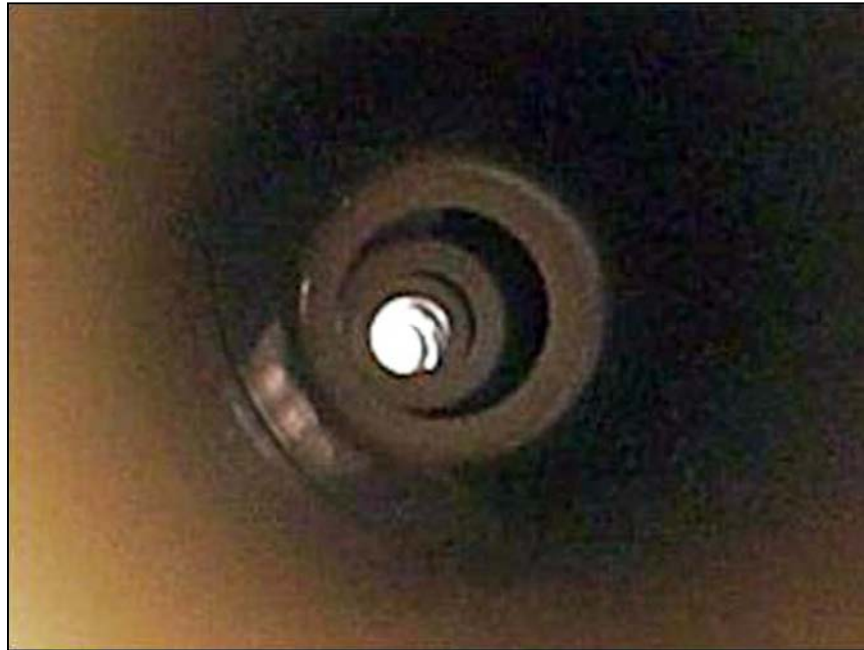
Figure 116.—Looking upstream at inline orifices within a 36-inch outside diameter pipe.

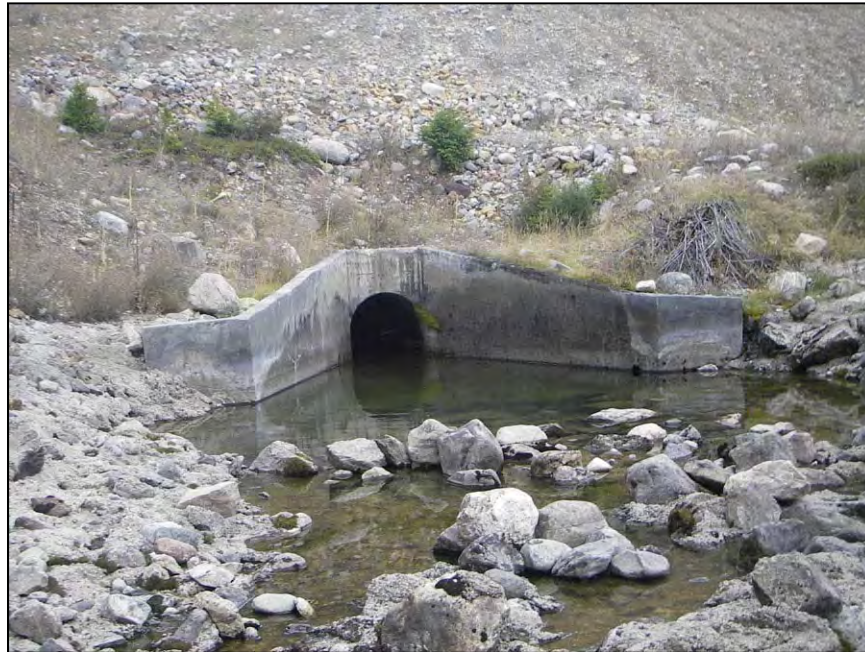
**Figure 126.**—The grouted riprap has performed well although some of the larger rocks in the foreground are displaced immediately downstream of the concrete apron.

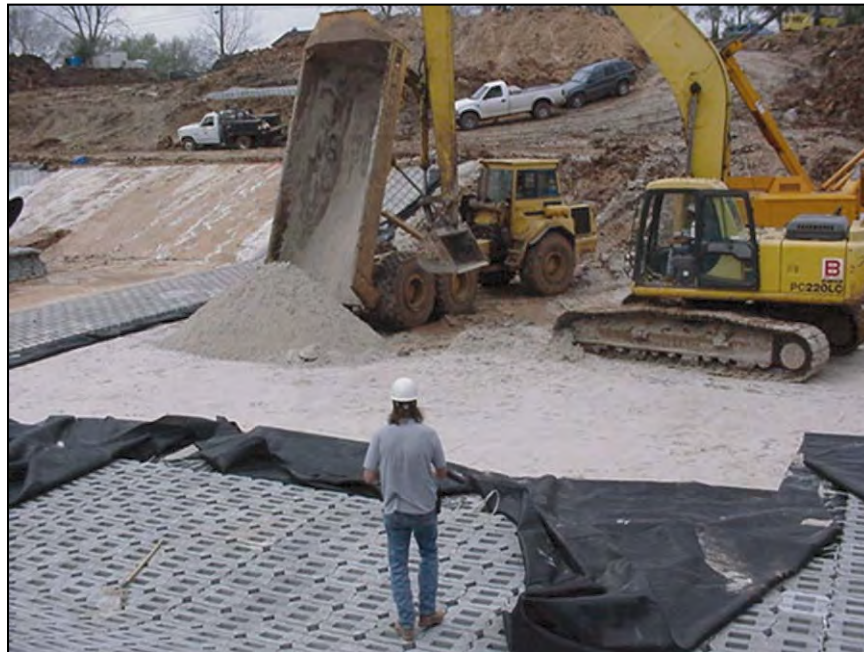
Figure 133.—An ACB system using a combination granular and geotextile filter.

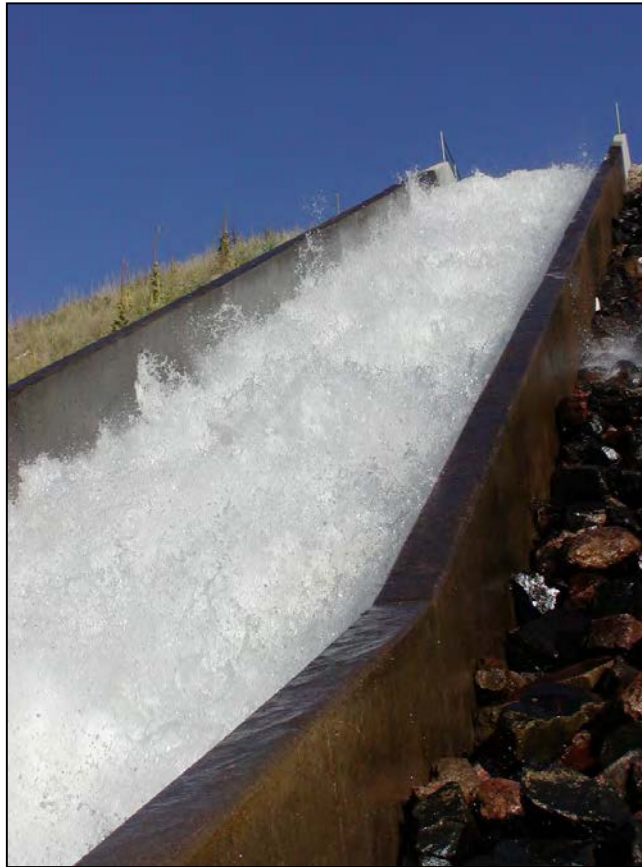
Figure 140.—Baffled drop aerating the flow so that it becomes saturated.

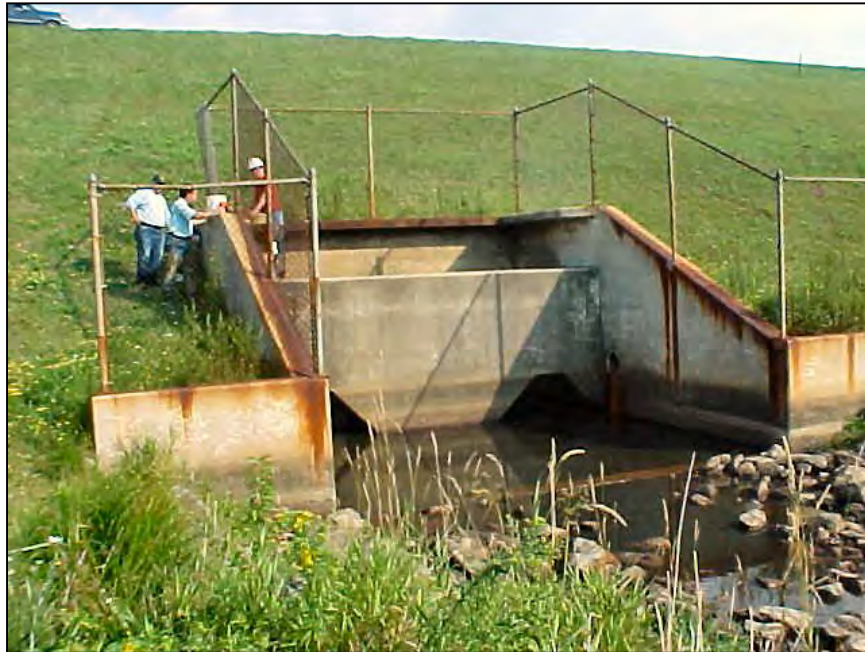
Figure 144.—A periodic inspection being performed at an impact basin.

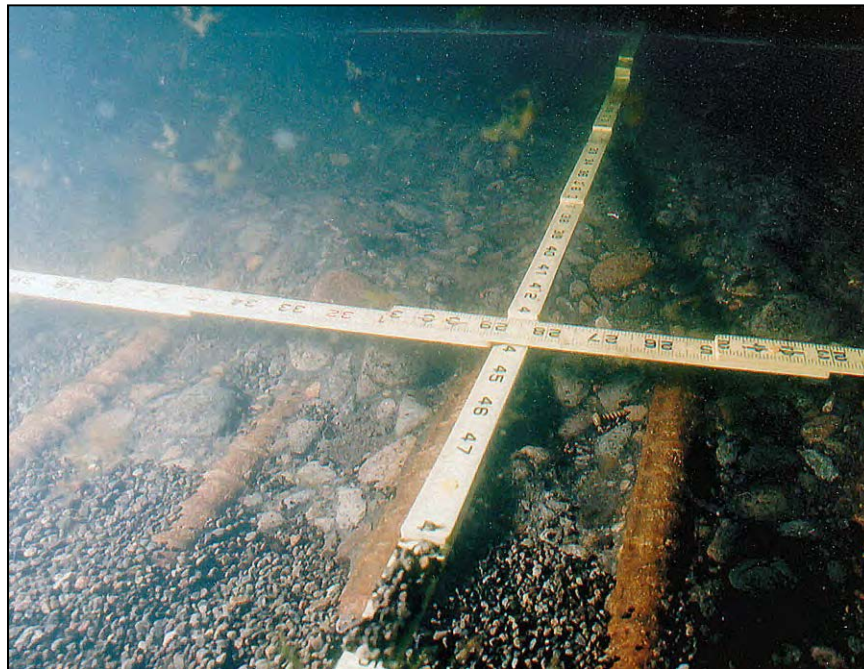
Figure 146.—A dive team inspection revealed significant concrete damage and exposed reinforcement on this stilling basin floor caused by abrasion erosion.

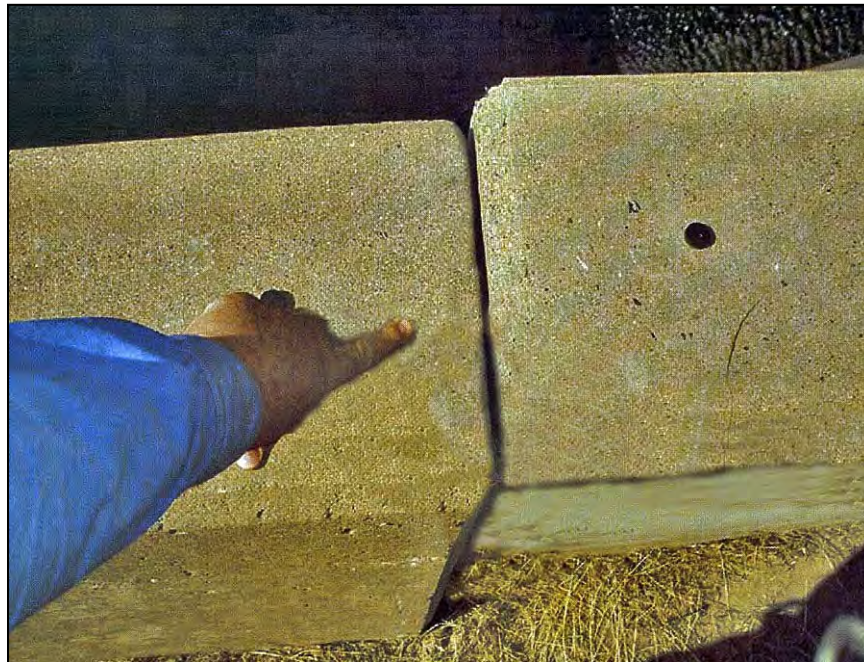
Figure 152.—This vertical wall joint has experienced a 2-inch offset.

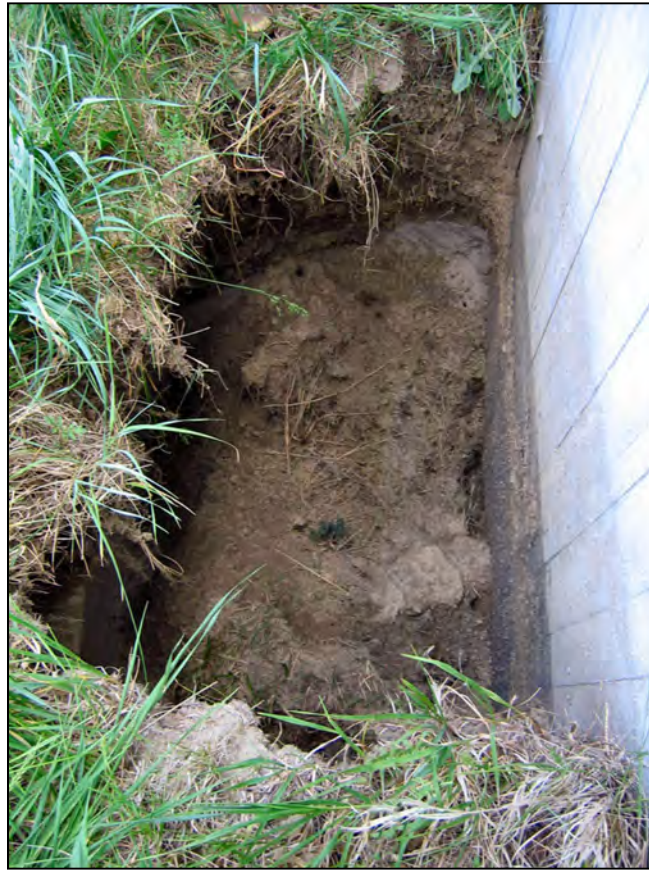
**Figure 154.**—A sinkhole developed next to this basin wall indicating internal erosion of foundation materials was occurring.

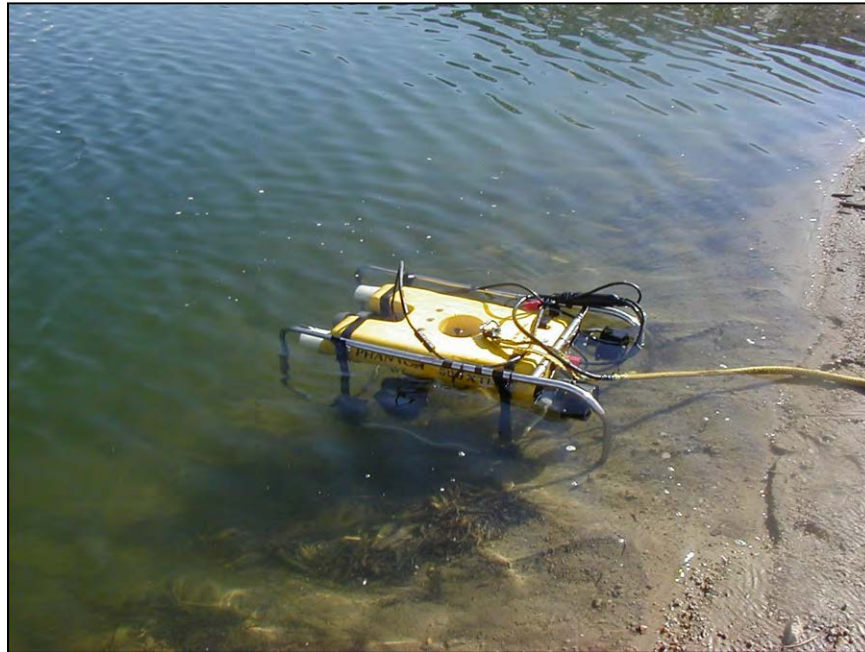
**Figure 159.**—An observation-class ROV entering the water to begin an inspection.

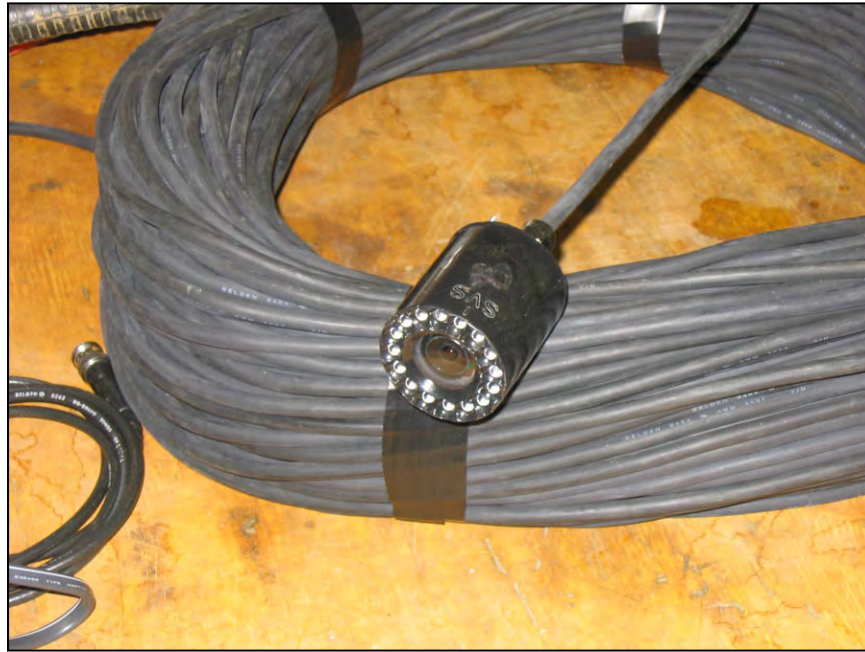
**Figure 161.**—Small video camera that can be attached to PVC or metal poles and manually pushed into underdrain pipes.

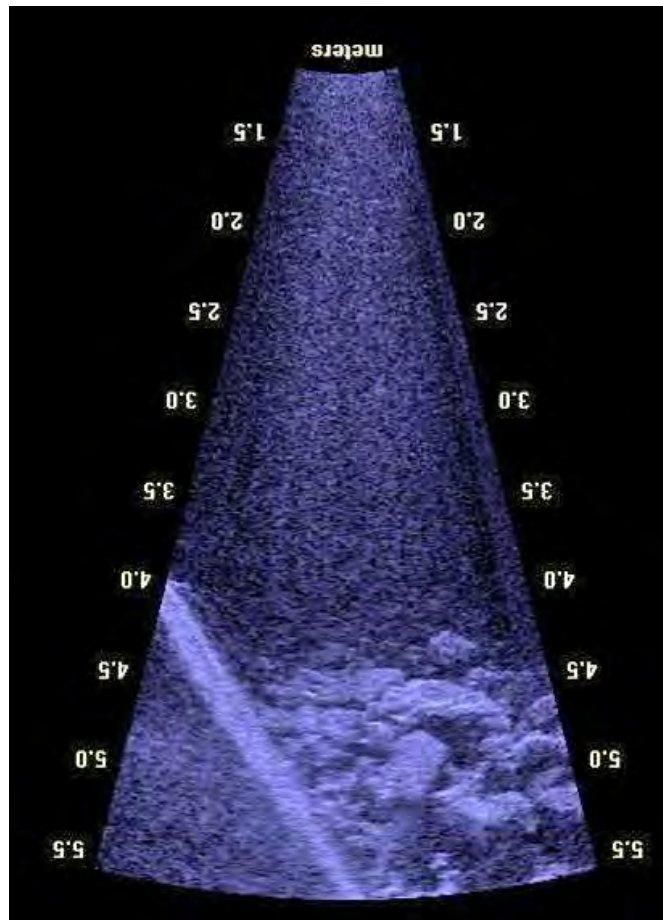
Figure 164.—Inspection of stilling basin for abrasion erosion using an acoustical camera. Rock can be seen lying on the stilling basin floor.

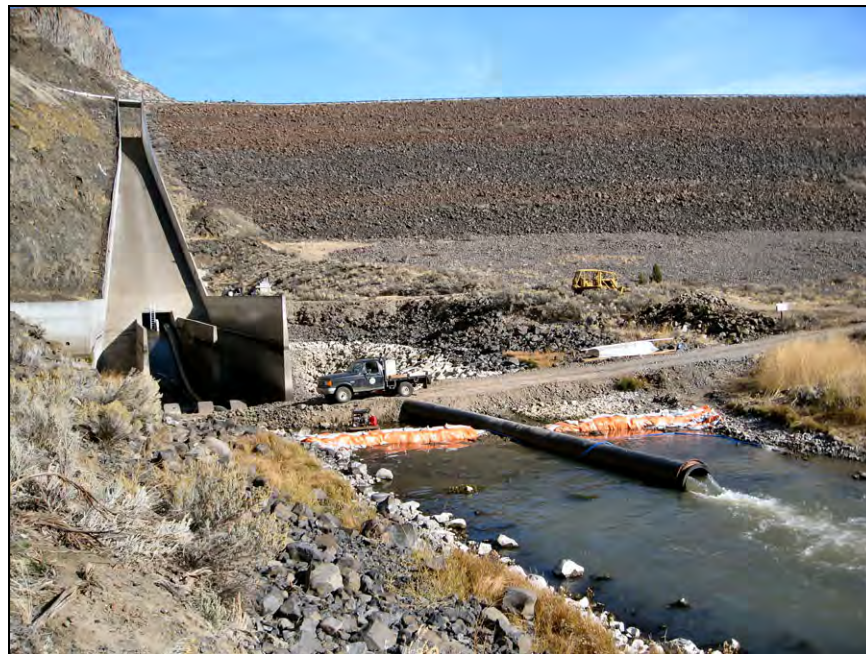
Figure 166.—Cofferdam constructed to keep the basin area dry for repairs.

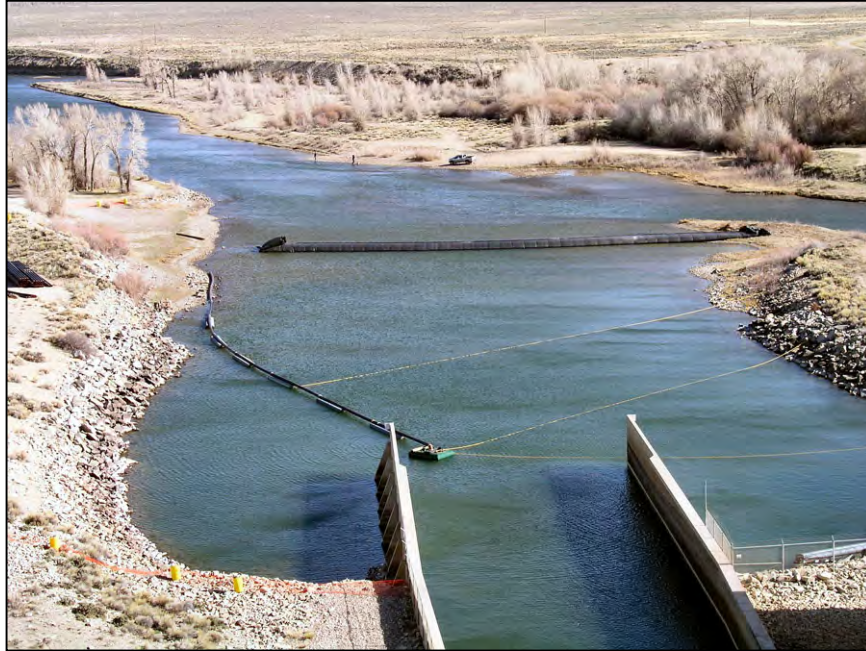
**Figure 167.**—A polyethylene baffled bladder dam is being placed downstream from a stilling basin. The dam is 250 feet long by 19 feet wide by 8 feet high. The dam weighs 2,600 pounds (dry). Two 3-inch pumps (8 hp) and two 3-inch pumps (4.5 hp) were used to fill the dam with 150,000 gallons of water. The dam took about four hours to deploy (watering up and rolling out the dam). Upon removal, the dam took 2 hours of dewatering and 2½ hours to roll up and remove. Removal of the dam required the rental and use of two track-hoes for rolling up the dam on a log.

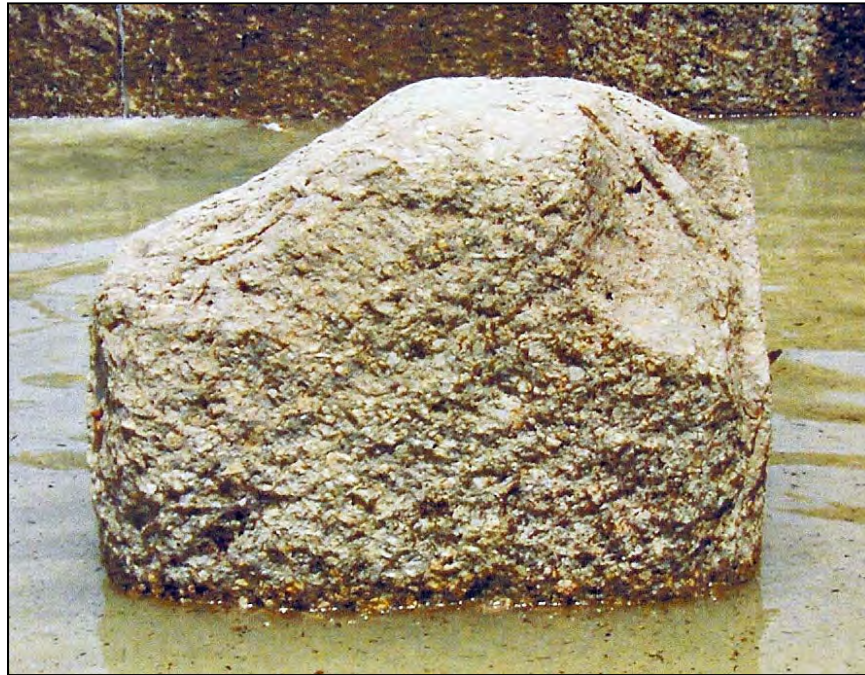
**Figure 169.**—This baffle block has experienced impact damage resulting from an object in the flow.

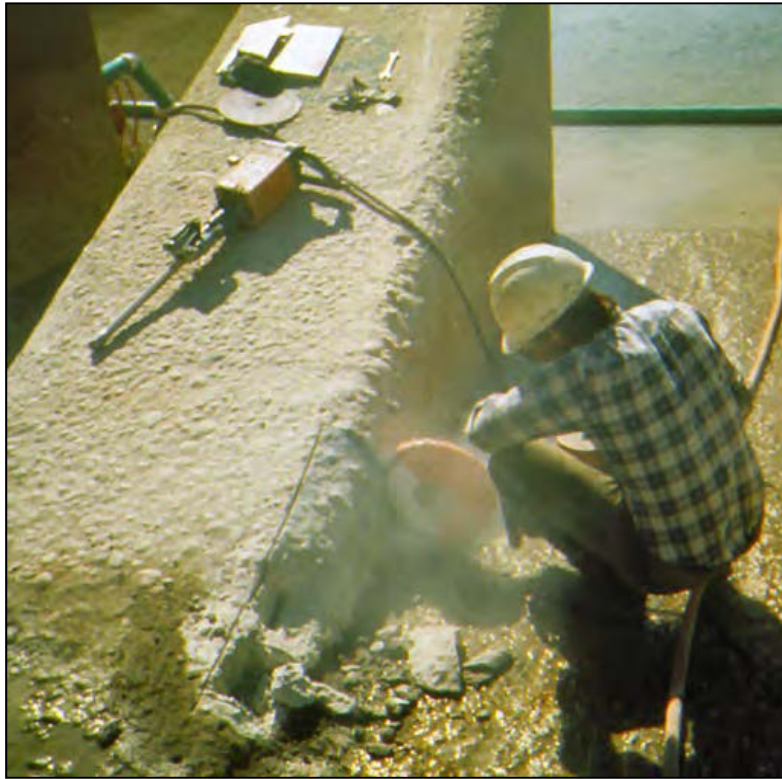
Figure 171.—Sawcutting the perimeter of spalled concrete prior to removal of concrete.
