# Technical Manual: Outlet Works Energy Dissipators

Best Practices for Design, Construction, Problem Identification  
and Evaluation, Inspection, Maintenance, Renovation, and Repair

FEMA P-679/ June 2010

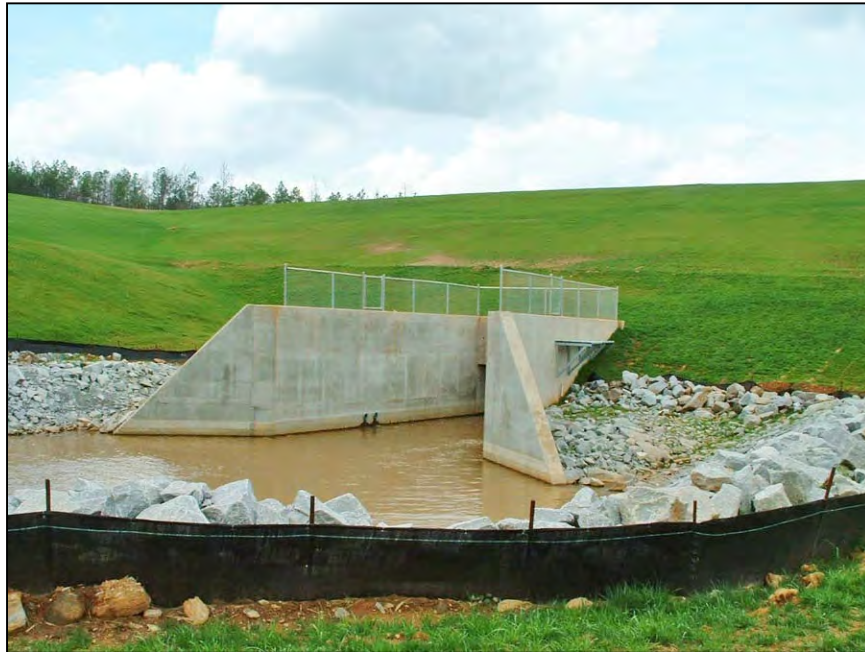
Figure 175.—Fencing installed along the tops of the stilling basin walls.

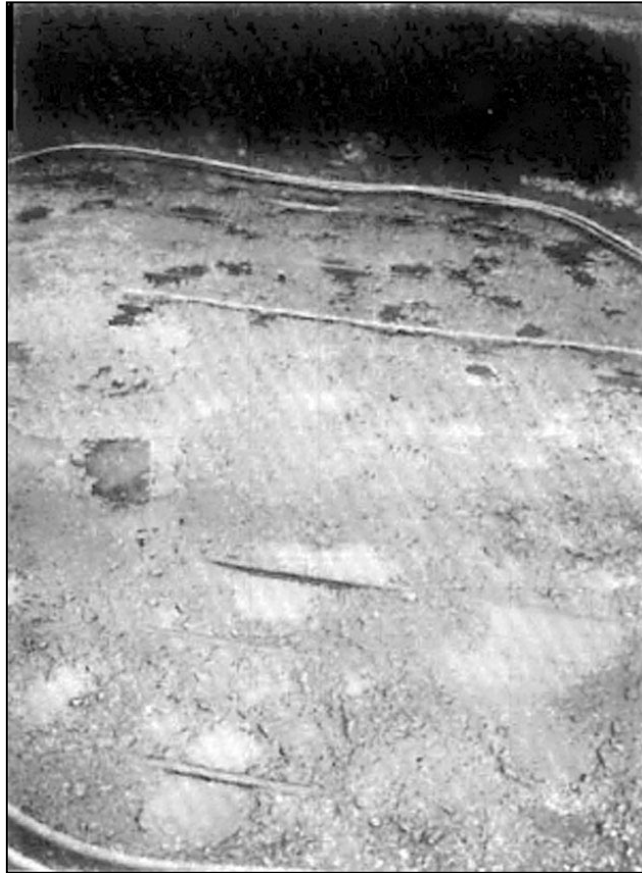
Figure A-8.—Exposed reinforcement in the stilling basin downstream of the baffles.

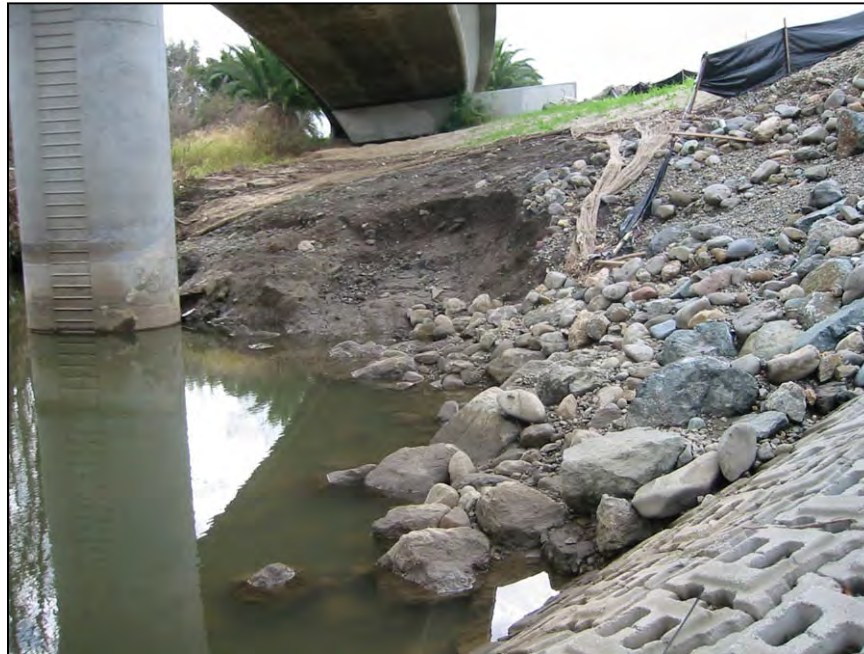
Figure A-31.—Uplifted CCM mats near the bridge pier.

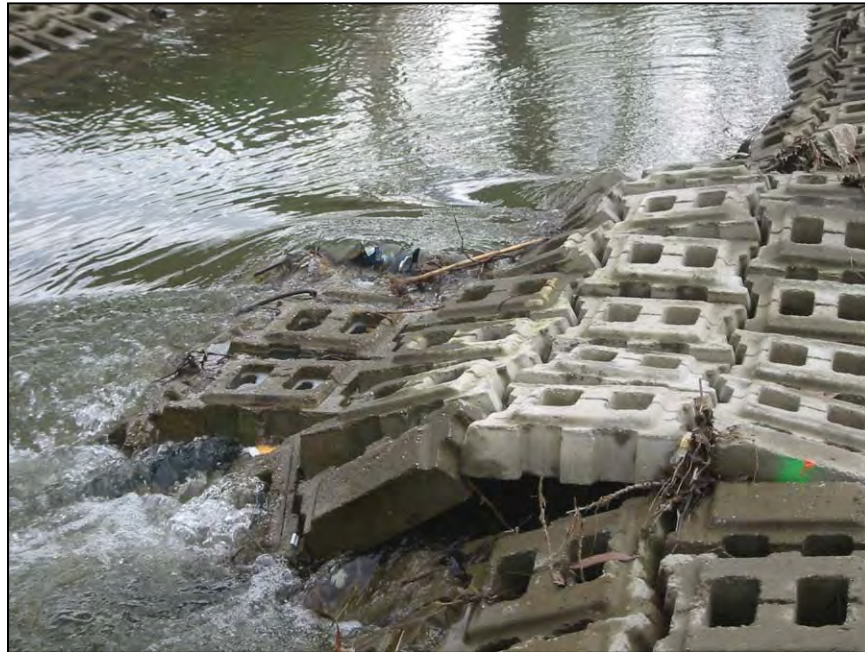
Figure A-32.—Uplifted blocks with loss of granular filter material.

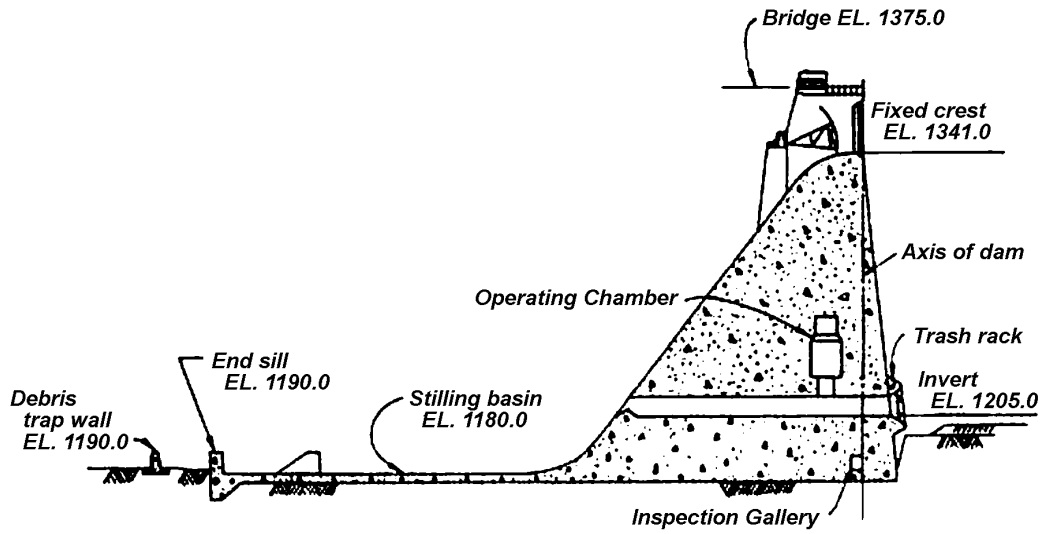
Figure A-41.—Stilling basin profile with debris trap.

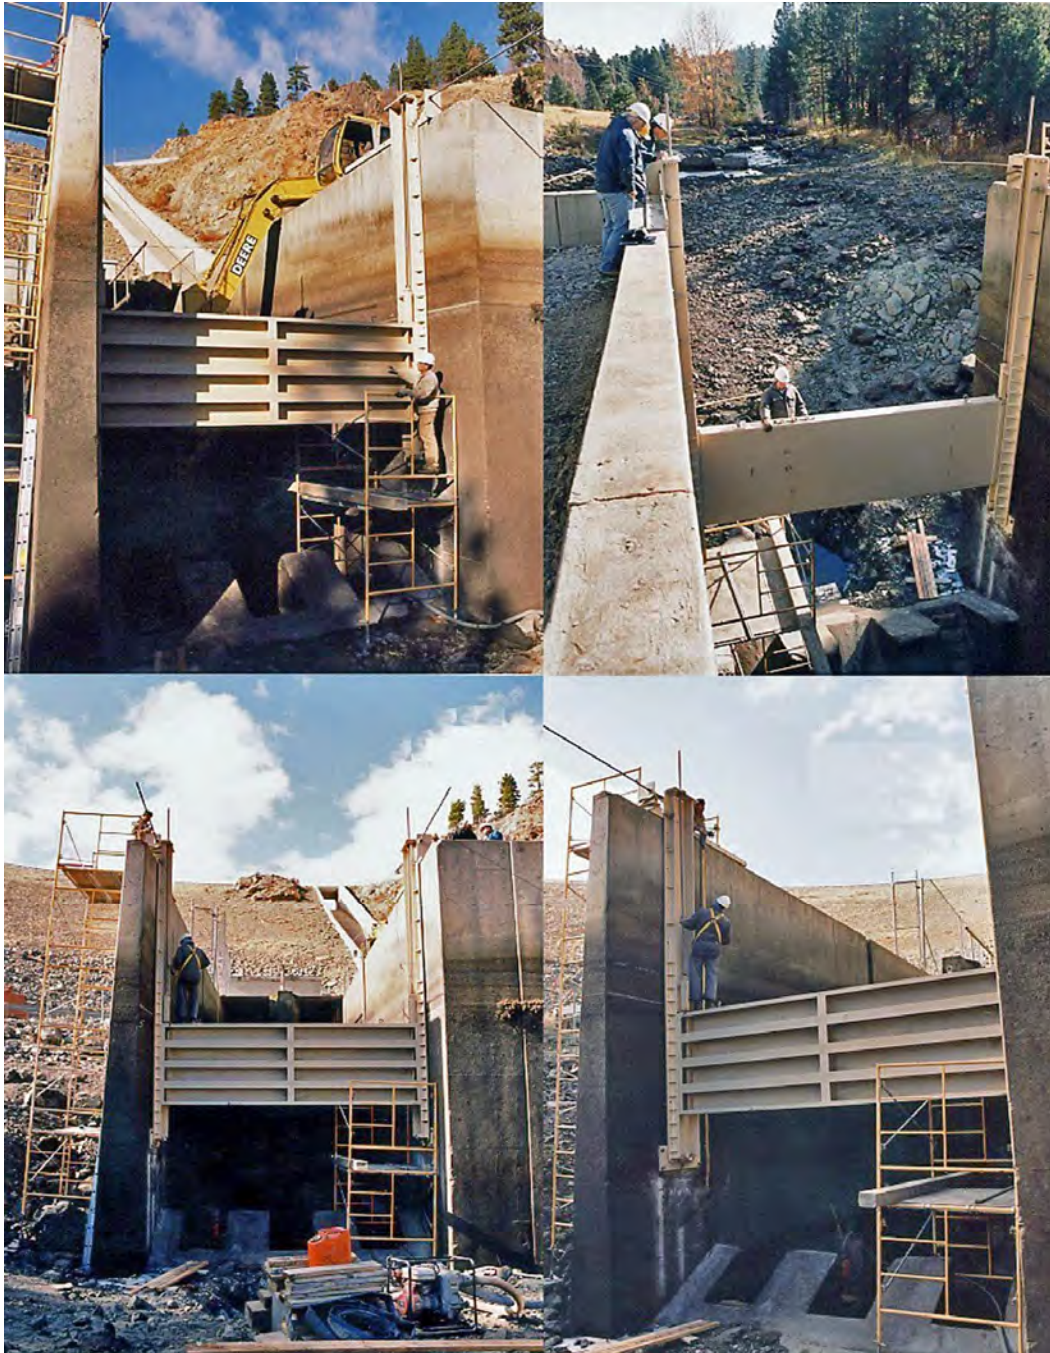
Figure A-51.—Prototype flow deflector installation at Mason Dam in October 2002.

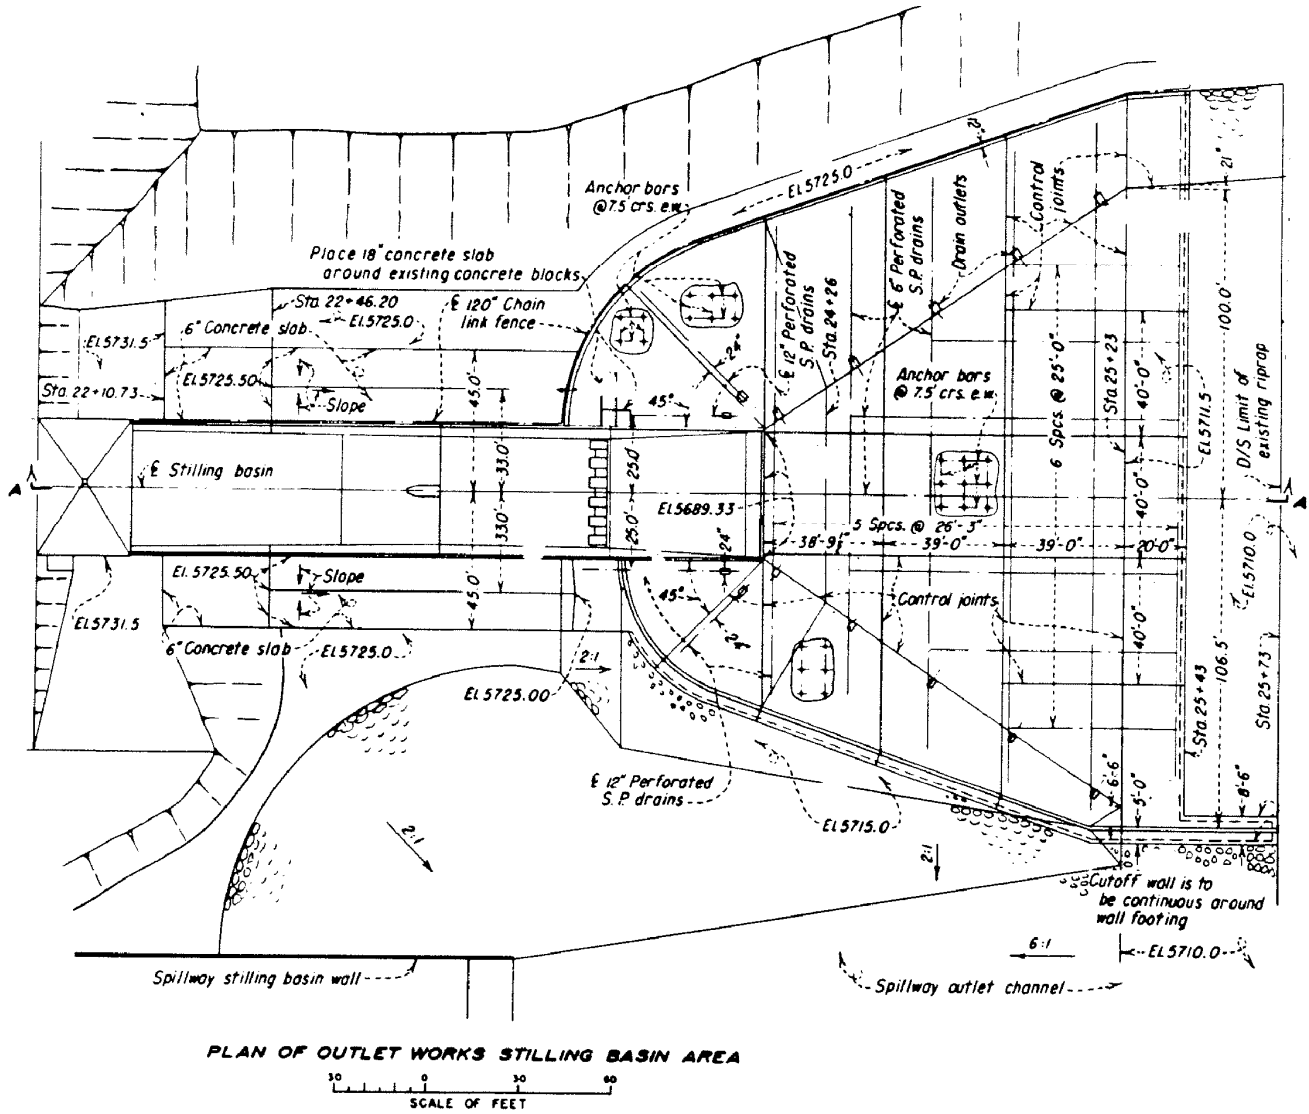
Figure A-54.—Plan and profile of the hollow-jet stilling basin at Navajo Dam.

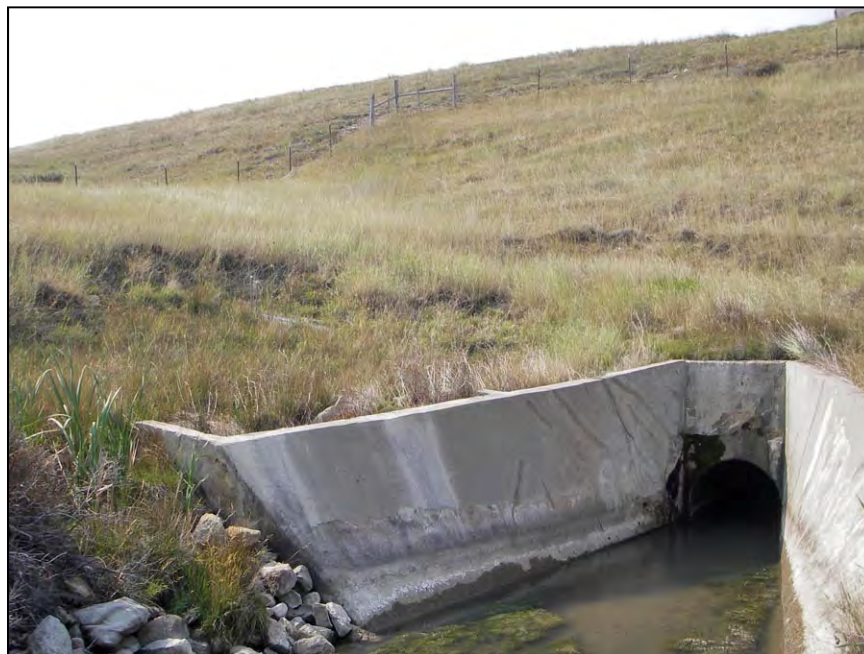
Figure A-56.—Original trapezoidal energy dissipator.

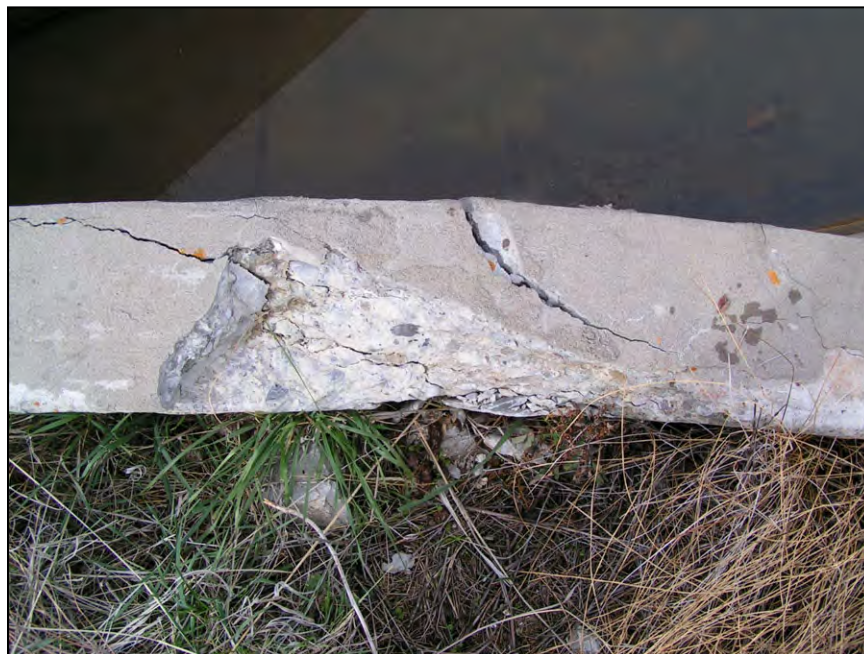
Figure A-57.—Deflection in left wall of dissipator.

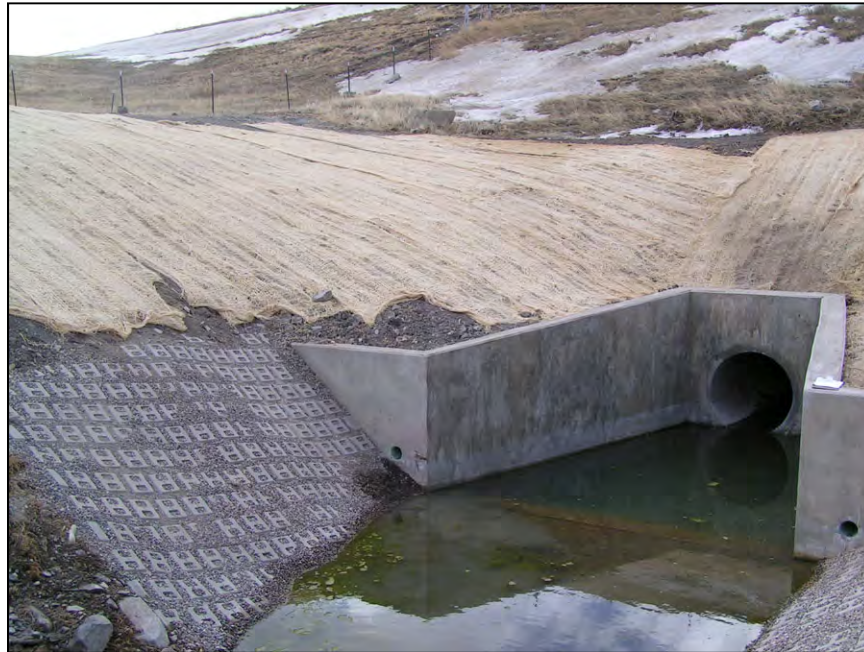
Figure A-58.—Replacement structure.

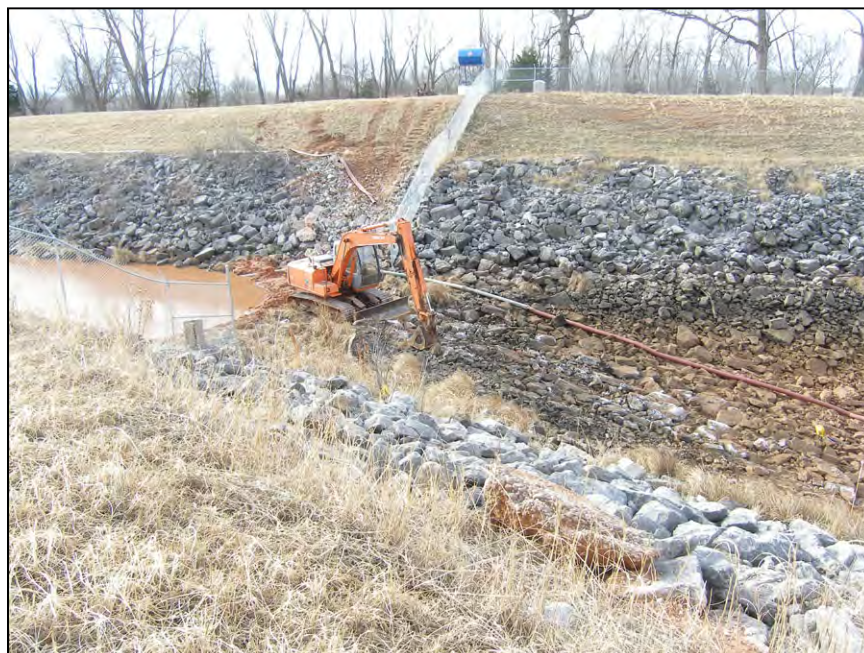
Figure A-60.—The contractor created a small earthen dike in the downstream river channel to facilitate unwatering of the stilling basin.

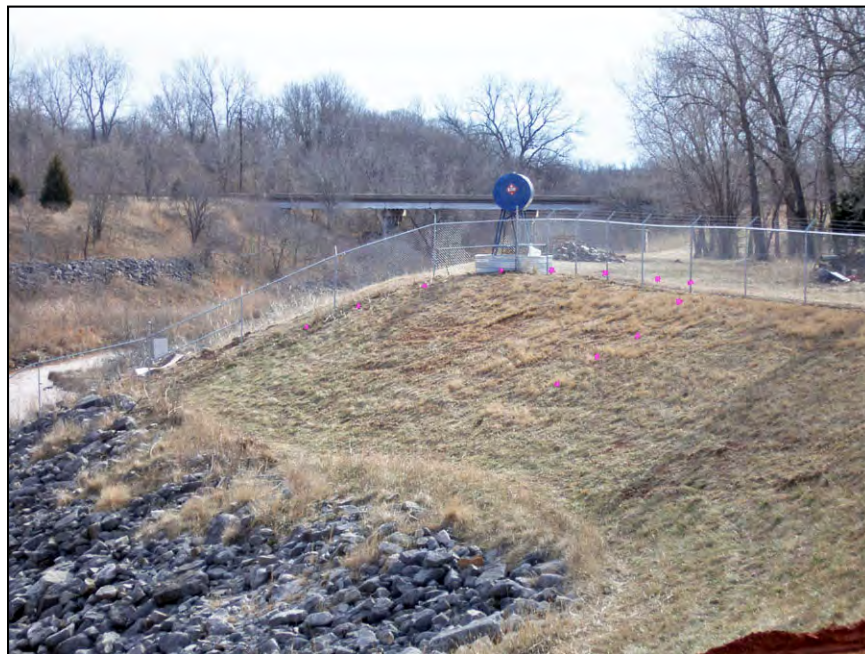
Figure A-63.—Shortly after unwatering, an excavated slope downstream and to the right of the stilling basin was observed to be experiencing cracking and developing a slump. There are pink flags marking the edge of the slump area.

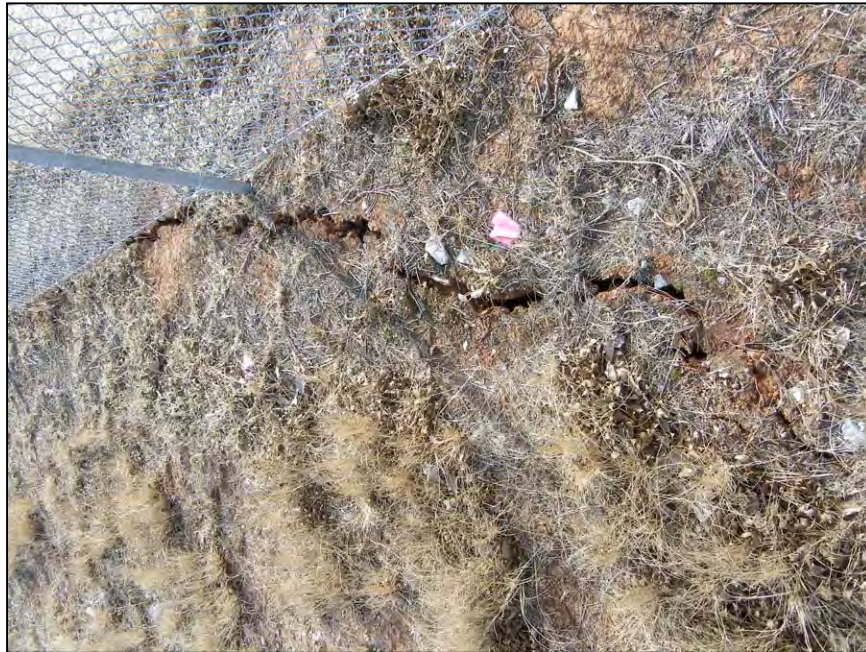
Figure A-64.—Cracking developing on slope near fence line.

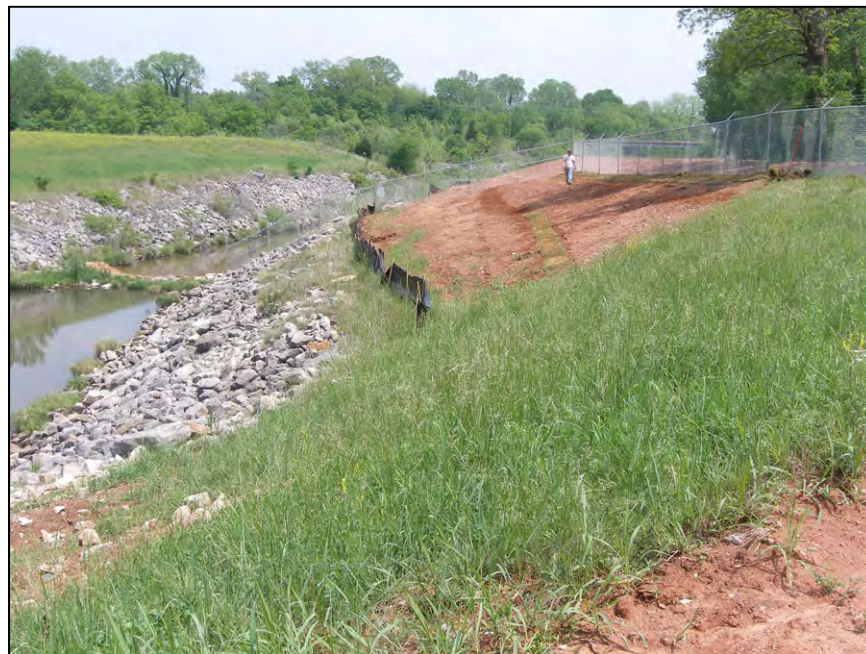
Figure A-65.—Slump area after cutting back slope. Sod is being placed to prevent erosion.

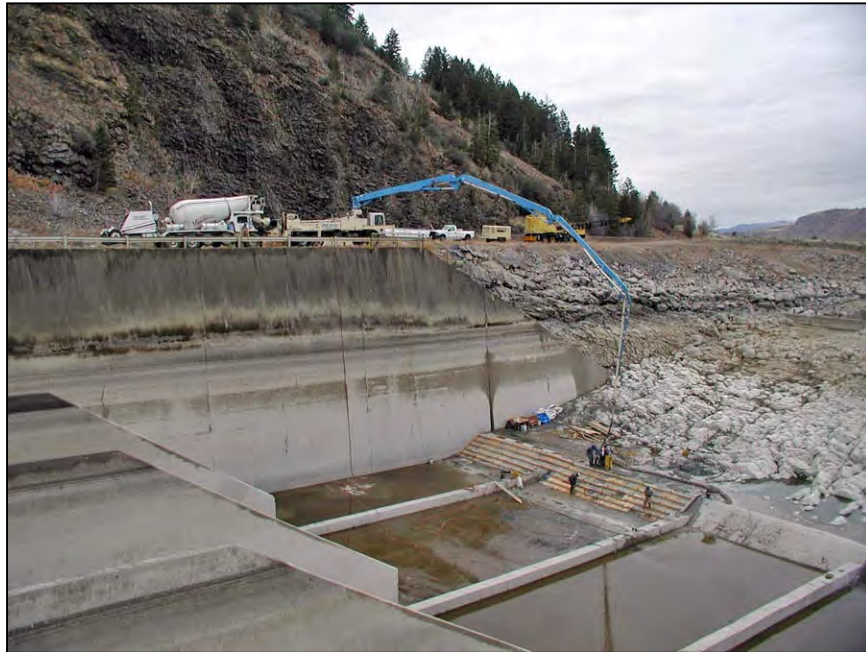
Figure A-71.—Concrete being pumped to forms for repairs to dentate sill.

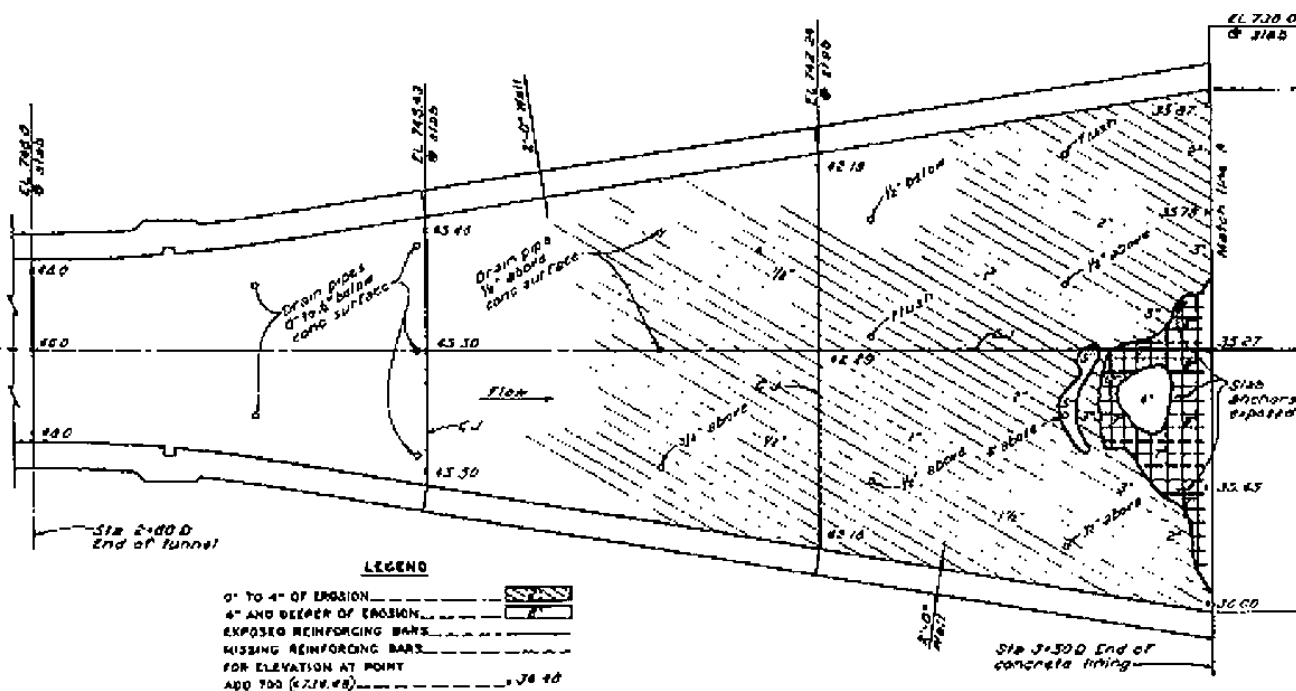
Figure A-79.—Abrasion erosion of in the transition section.

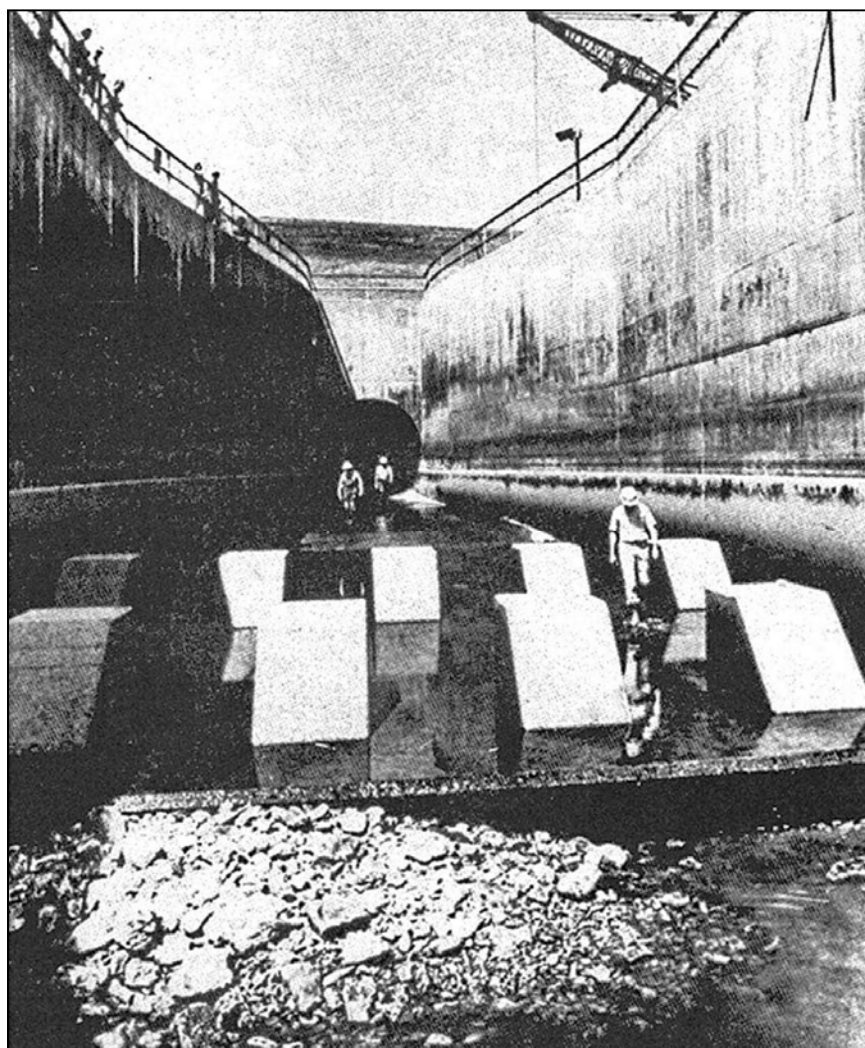
Figure A-82.—Unwatered stilling basin.

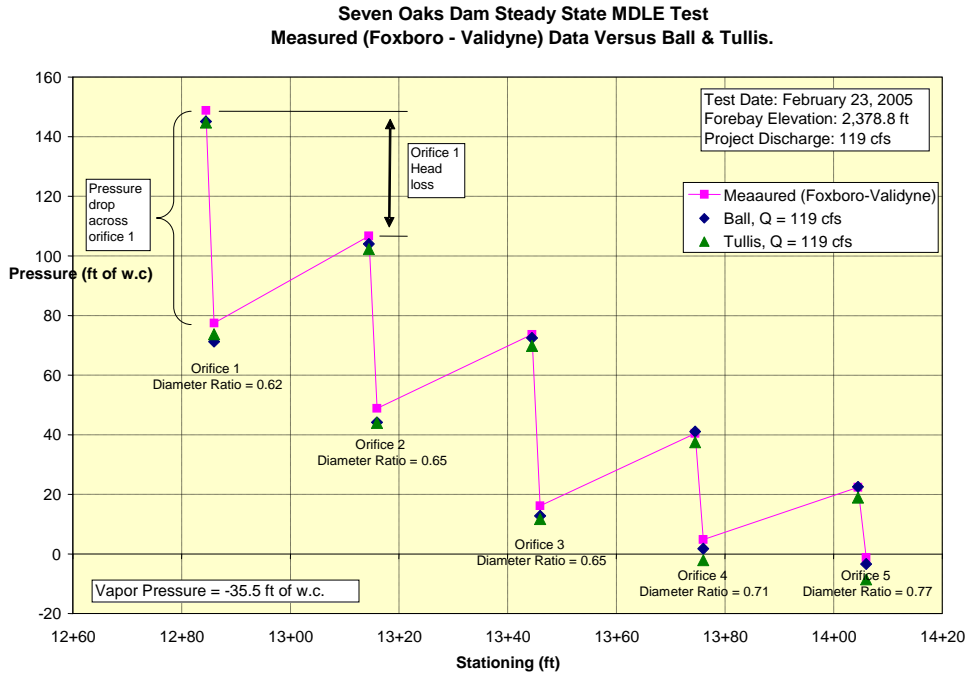
Figure A-94.—Comparative pressure gradeline data from measurements versus calculations based on coefficients from Ball and Simmons (1963) and Tullis (1989).

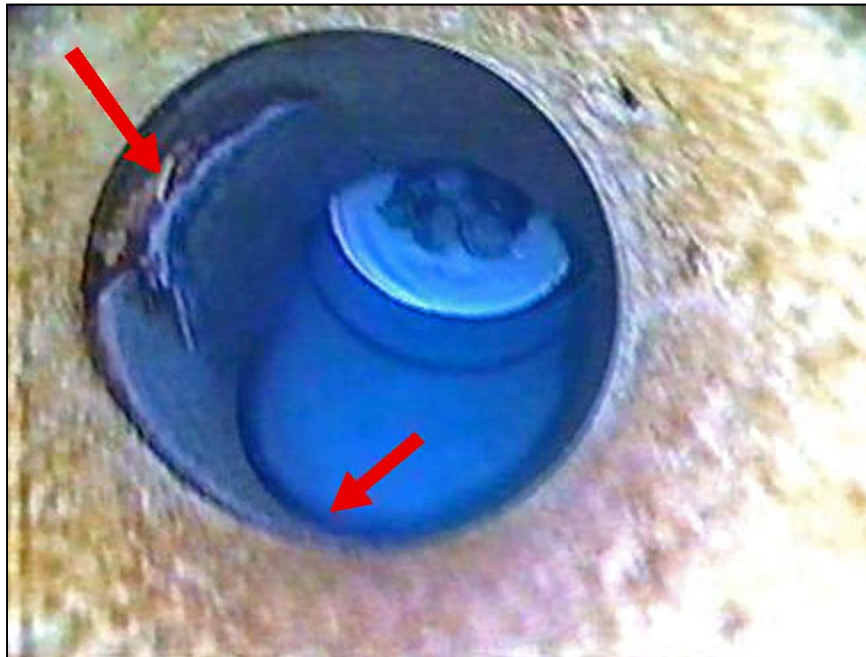
Figure A-111.—Visible rupture (upper arrow) in the side of the pipe wall of Underdrain No. 2 at the second bend. Lower arrow indicates visible entrance of upstream drain beneath the chute.

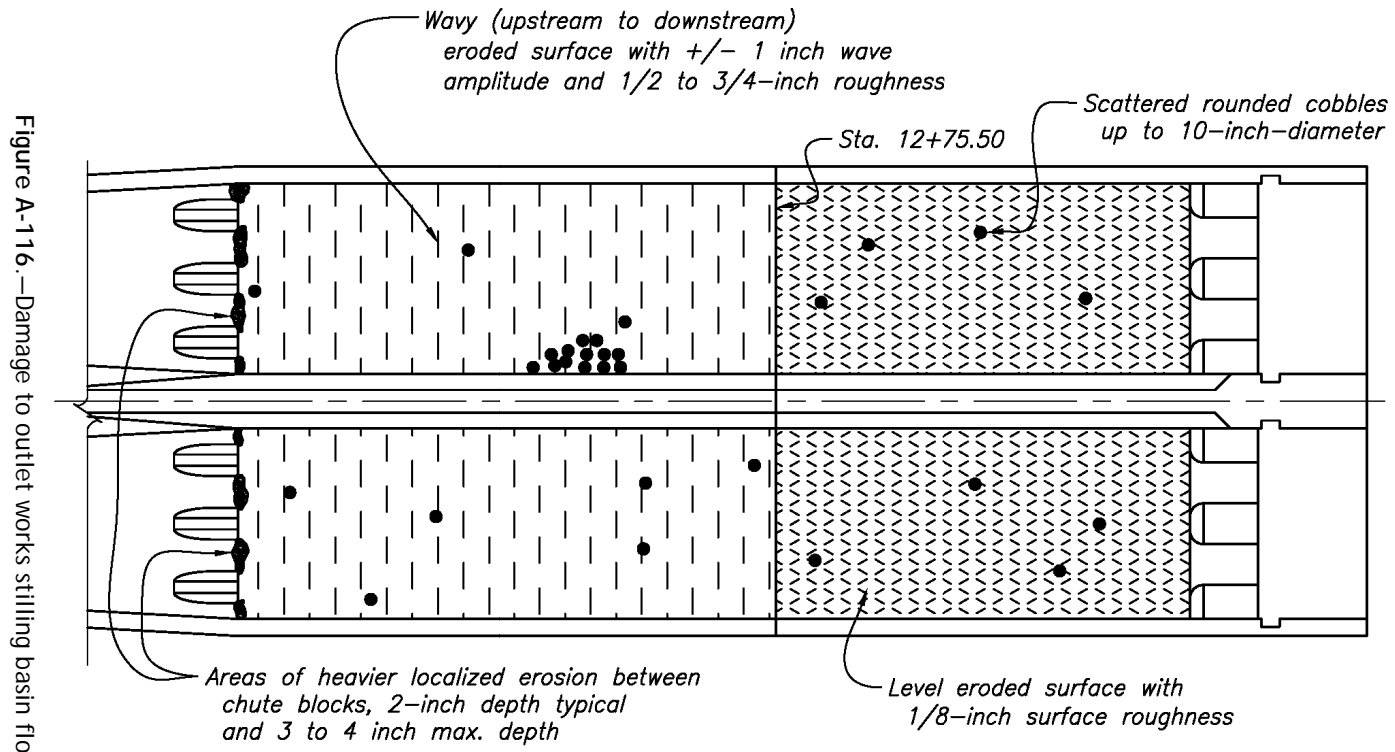
Figure A-116.—Damage to outlet works stilling basin floor.

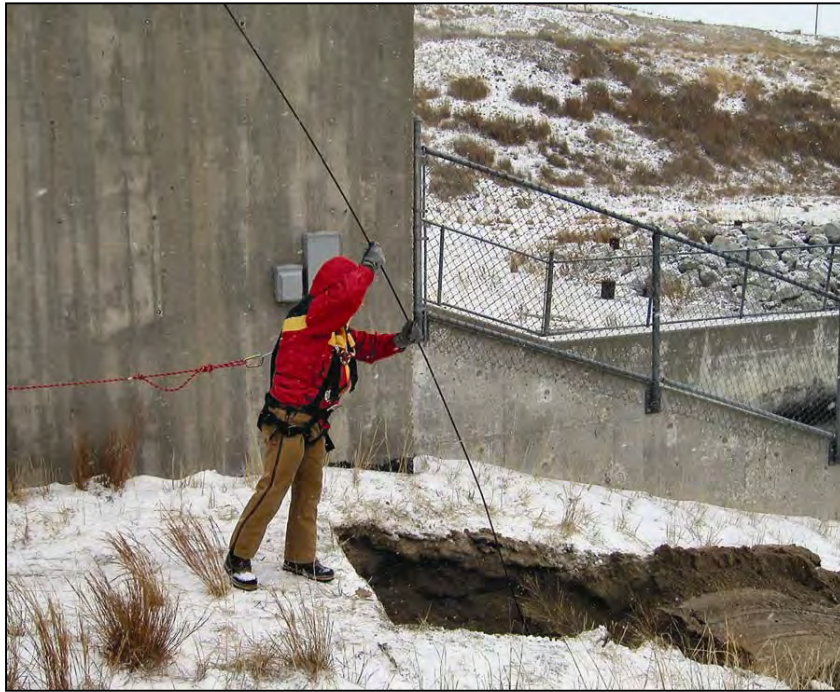
Figure A-125.—The depression is being probed to determine its depth.

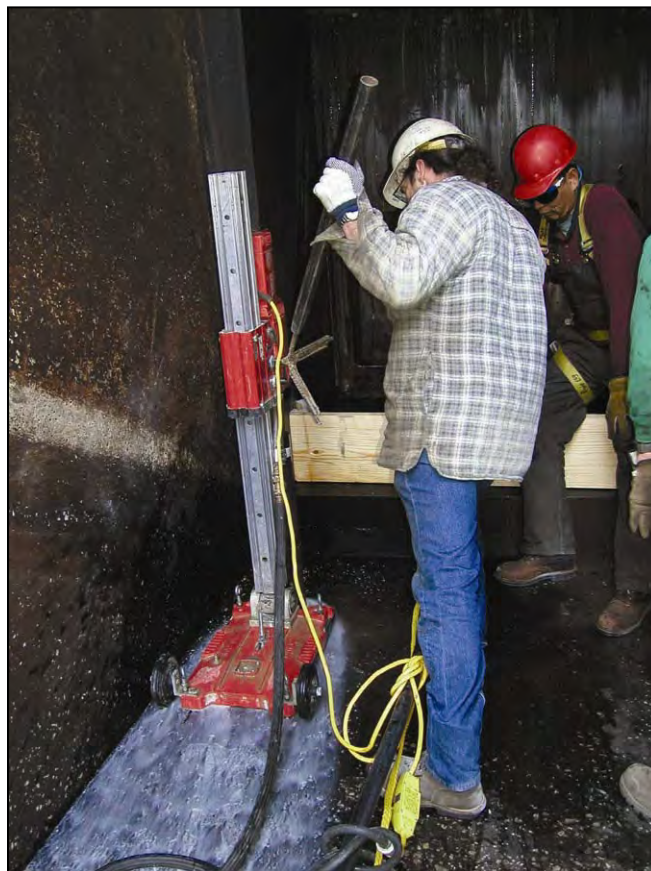
Figure A-126.—Drill crew drilling a hole in right bay of stilling basin.

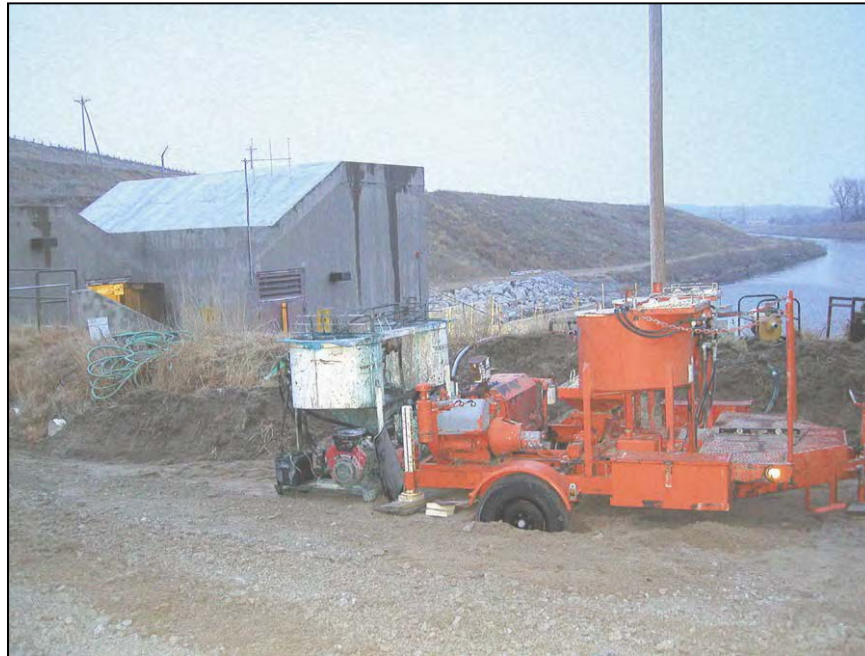
Figure A-127.—Grout pumps located at access road by gate house. White pump was used for grouting and the orange pump was on site as backup pump.

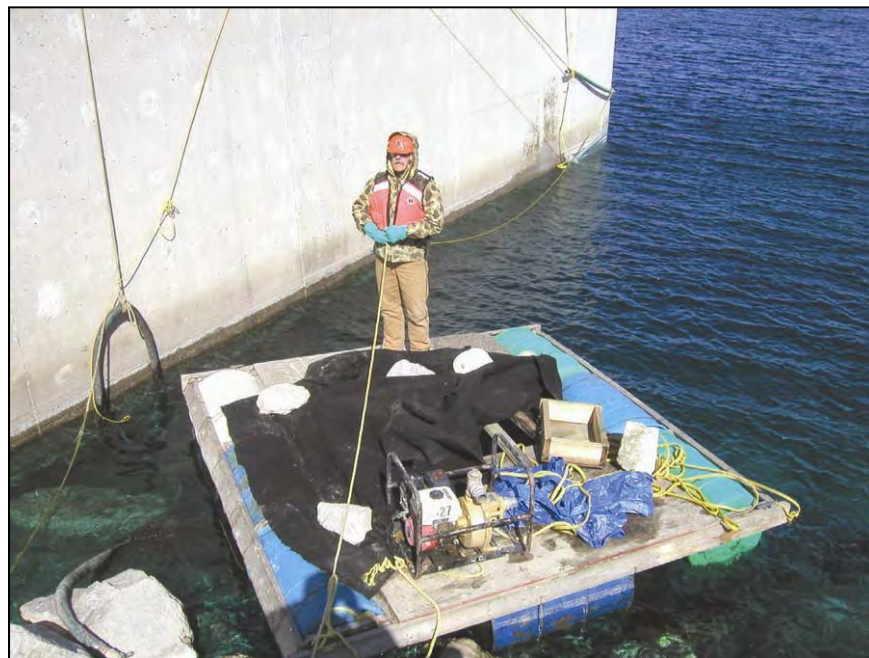
Figure A-129.—Barge used to monitor for grout blowout through foundation.
