Technical Report REMR-CS-53  
April 1997

# **Applications of Roller-Compacted Concrete in Rehabilitation and Replacement of Hydraulic Structures**

*by James E. McDonald, Nancy F. Curtis*

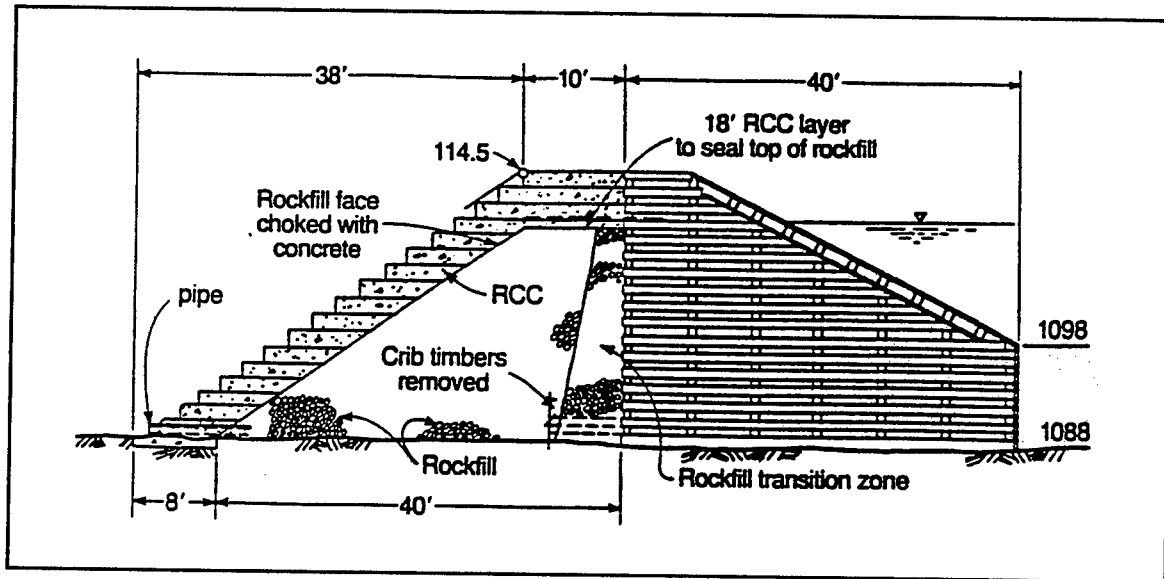
Figure 1. Cross section showing rehabilitation plan for Ocoee Dam. (Multiply feet by 0.3048 to obtain metres)

been choked with concrete to produce a 1.54H:1.0V downstream slope (Figure 1).

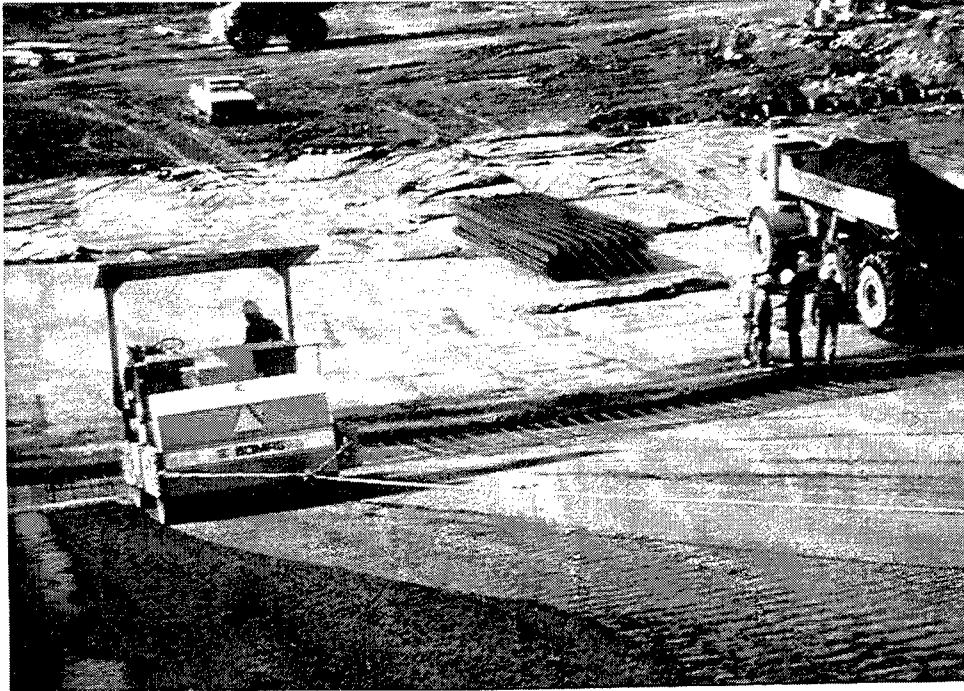
Figure 4. RCC compaction on the downstream slope, Toutle River Dam

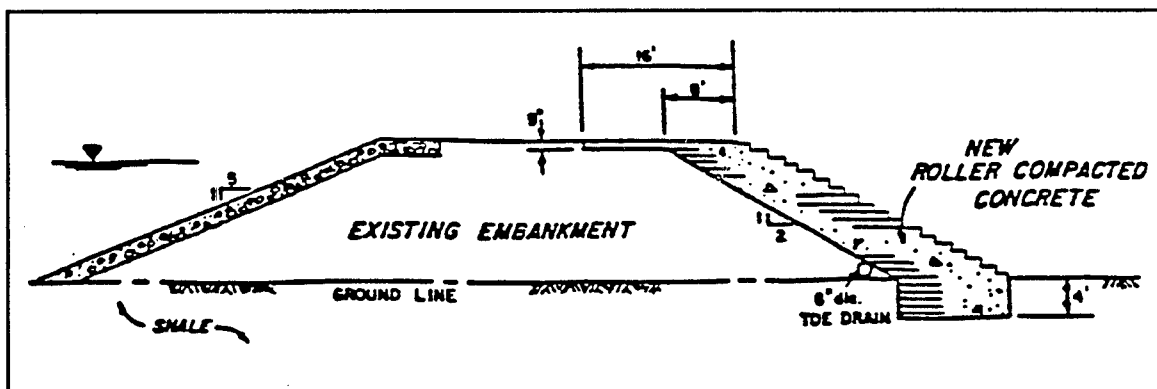
Brownwood Country Club Dam is a 5.8-m- (19-ft-) high earthfill dam that forms a reservoir in the middle of the golf course at the country club in Brownwood, TX. It has an impoundment of 215,860 cu m (175 acre-ft) (Reeves 1985). Originally built around 1938, the dam was constructed with a 19.8-m- (65-ft-) wide reinforced concrete slab spillway with a capacity of approximately 74 cms (2,600 cfs). A study conducted in the early 1980s determined that in the event of a probable maximum flood (PMF), the spillway would need a capacity of 328 cms (11,600 cfs) (Hansen 1993).

The state dam safety department placed the dam in the high-hazard category because of the inadequacy of the spillway and the increased development downstream of the dam (*RCC Newsletter* 1986). The country club was instructed to draw down the level of the reservoir; however, lowering the water level detracted from the appearance of the golf course. Country club officials chose to widen the spillway so it could pass the PMF (Hansen 1993).

Figure 5. Cross section of modified spillway, Brownwood Country Club Dam (courtesy of Reeves 1985, ASCE). (Multiply inches by 25.4 to obtain millimetres and feet by 0.3048 to obtain metres)

Options considered for increasing the spillway included excavating the right abutment, constructing a reinforced concrete spillway next to the existing spillway, or constructing the spillway with RCC. An RCC spillway was chosen (Figure 5) because it would have the lowest total cost and would require the least construction time (Morsman, Lawler, and Seimears 1985). This was the initial application of RCC to rehabilitate an existing embankment dam.

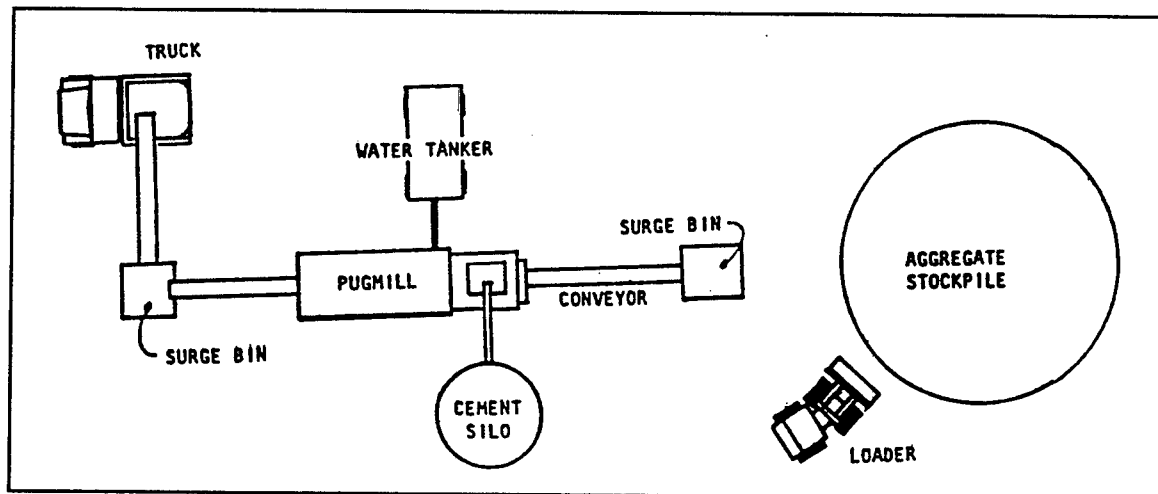
Figure 6. Layout of RCC batch plant at Brownwood Country Club Dam (courtesy of Morsman, Lawler, and Seimears 1985, ASCE)

A batch plant was set up at the site to mix the RCC (Figure 6). Dump trucks were used to transport the mixture to the fill area. RCC was first placed in a 1.2-m- (4-ft-) deep trench excavated into the shale foundation at the toe of the dam to prevent undercutting during overtopping. A modified spreader mounted on a track-type tractor was used to spread the RCC in 254-mm (10-in.) lifts. In hard-to-reach areas, a small track-type tractor was used. All RCC surfaces on which subsequent lifts would be placed were kept continuously damp until the next lift was placed. Succeeding lifts were placed within an 8-hr time limit to eliminate cold joints. A self-propelled vibratory roller was used to compact all of the RCC. The final RCC surface was kept moist for 14 days while the RCC cured (Morsman, Lawler, and Seimears 1985).

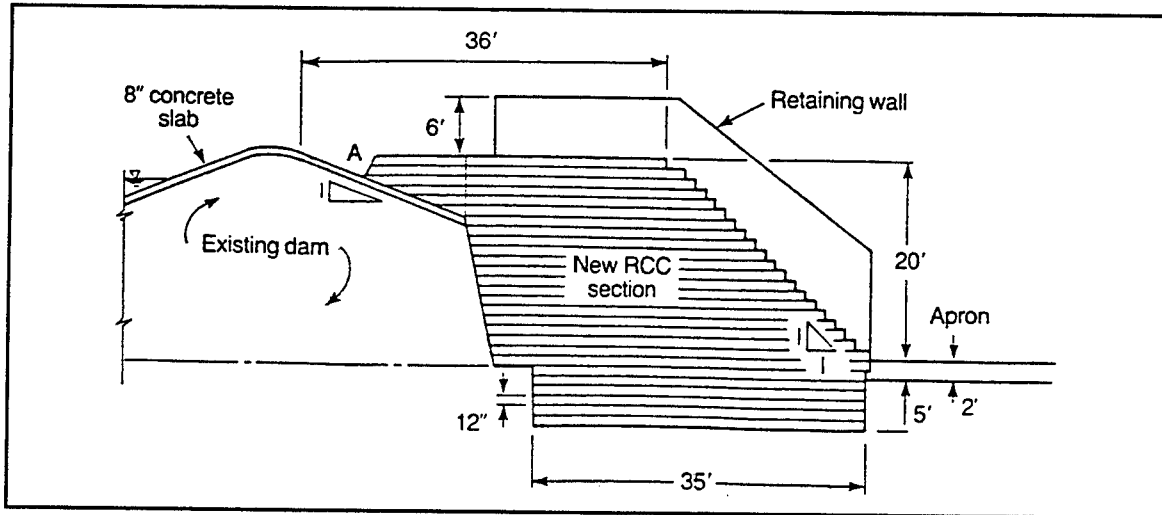
The dam was overtopped by 1.2 m (4 ft) in June 1981, when it sustained some damage. It was overtopped again in October 1982 by 1.4 m (4.5 ft); this time damage was more severe. Then on New Year's Eve 1984, the dam was overtopped by 3.0 m (10 ft). Damage included a loss of about 40 percent of the concrete shell over the service spillway and about one-half of the downstream embankment, severe concrete cracking in the emergency spillway, loss of filter material, and erosion in both abutments (Figure 8). The clay core was eroded to bedrock (Smith 1986).

Figure 9. Plan for RCC gravity buttress, Kerrville Pounding Dam (courtesy of Hansen and France 1986). (Multiply inches by 25.4 to obtain millimetres and feet by 0.3048 to obtain metres)

Several alternatives, including repair of the existing structure, were evaluated, but design engineers and consultants determined the fastest and most economical solution was to construct a new RCC section on the downstream embankment (Figure 9).

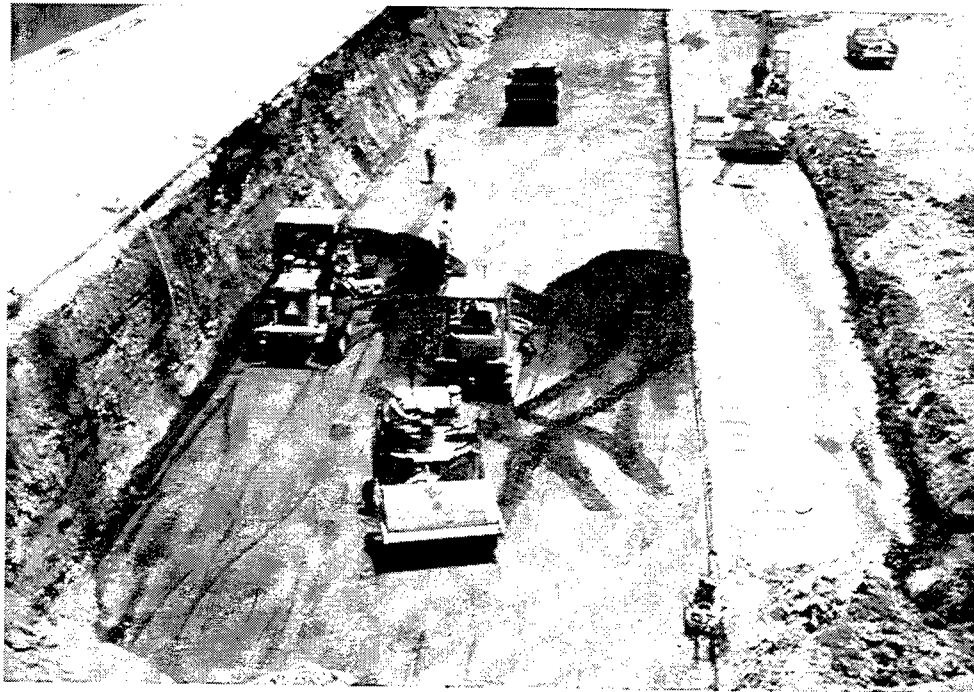
Figure 10. RCC placing and compaction, Kerrville Pounding Dam

In preparation for the RCC, the downstream portion of the embankment was removed; the undamaged upstream portion served as a cofferdam during construction of the RCC section (Figure 10). The RCC was placed in 0.3-m- (1-ft-) thick lifts, beginning on the foundation rock against the near-vertical face of the embankment. A sand-cement mortar was brushed on each lift as a bonding agent. RCC placement began in June 1985 and was completed 3 months later. Approximately 16,820 cu m (22,000 cu yd) of RCC was used in the project (Hansen and France 1986). Cost of the repairs, including engineering, construction, and stabilizing the remaining portions of the original dam, was between \$3 and \$3.5 million (Smith 1986).

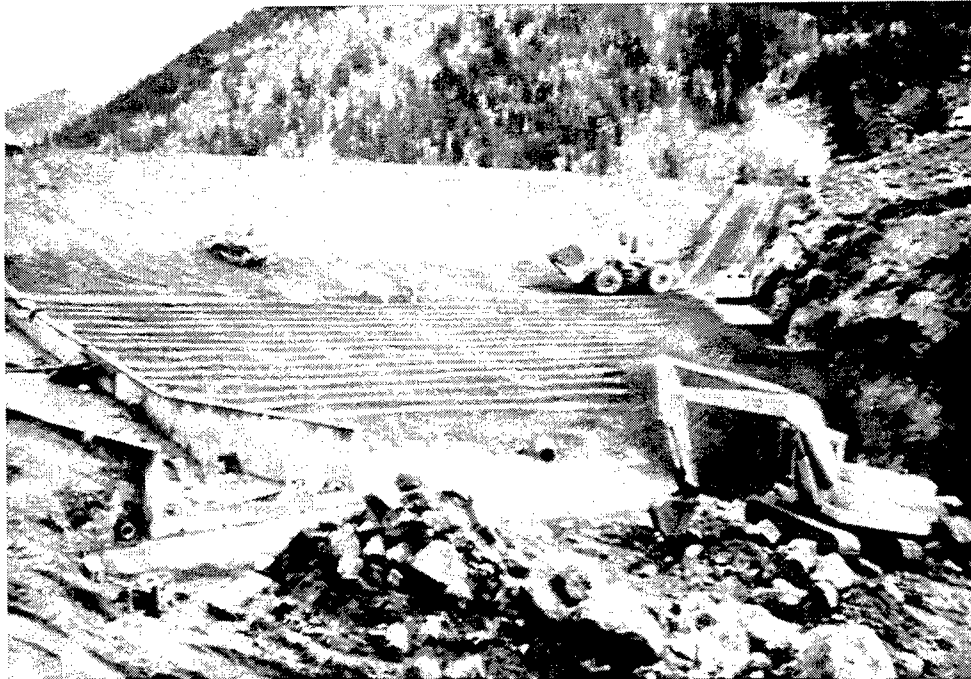
Figure 12. RCC placement, Spring Creek Dam

RCC was placed to a depth of 0.9 m (3 ft) in the overflow section on the downstream face of the dam. It was placed in 2.4-m- (8-ft-) wide by 0.3-m- (1-ft-) thick horizontal layers to form a stairstep profile, which would help dissipate energy during overtopping (Figure 12). The horizontal layers were turned at the abutment to create a groin that would contain the design flood (Figure 13). The crest slab was anchored on the upstream side by a 1.5-m- (5-ft-) deep by 1.8-m- (6-ft-) wide RCC cutoff key.

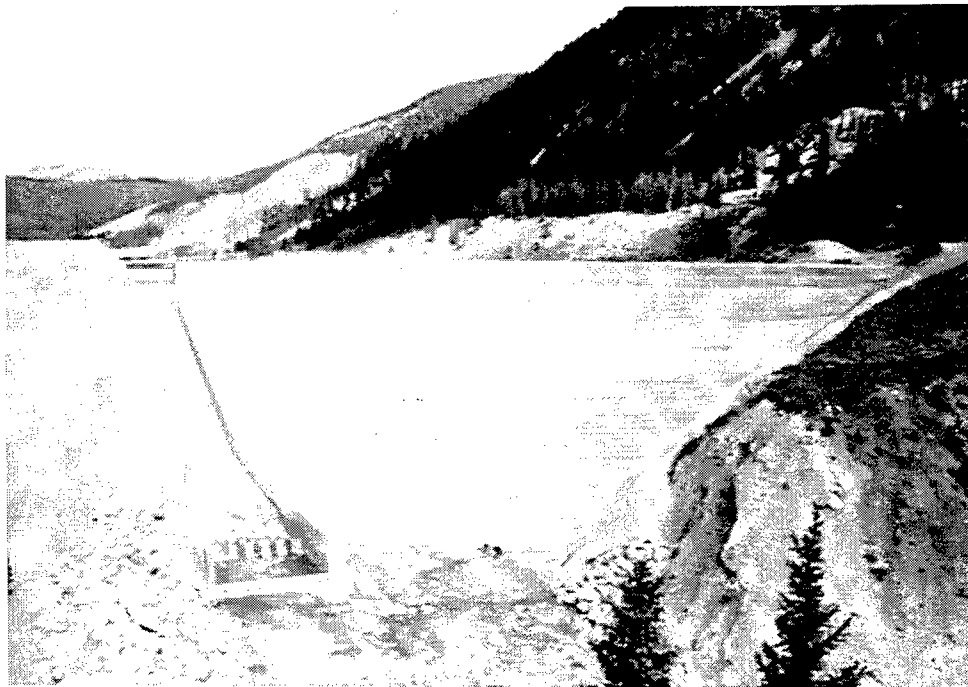
Figure 13. Completed emergency spillway, Spring Creek Dam

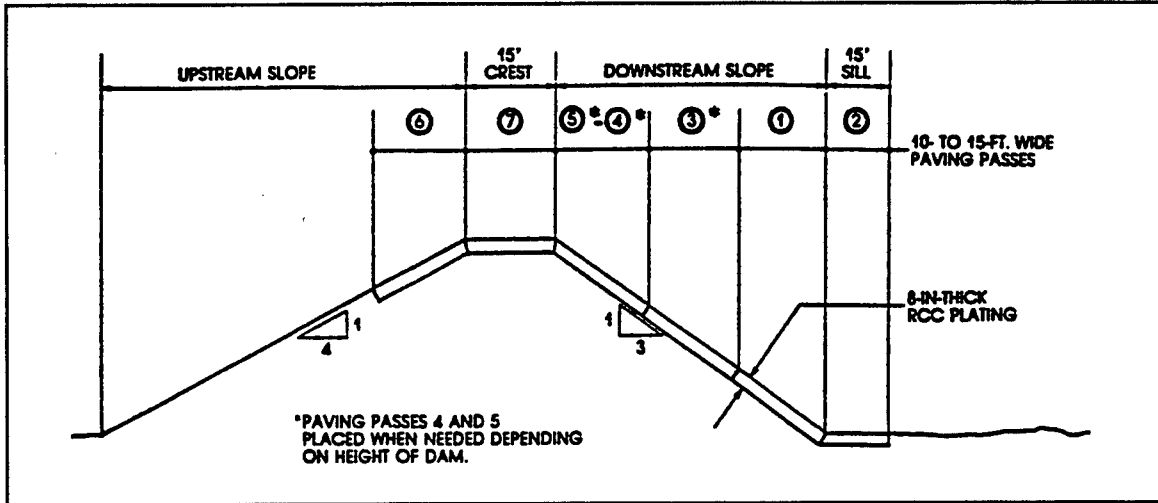
Figure 14. Paving sequence for placing RCC at Addicks and Barker Dams (courtesy of Munn 1988). (Multiply inches by 25.4 to obtain millimetres and feet by 0.3048 to obtain metres)

A unique aspect of this project was that of the approximately 209,000 sq m (250,000 sq yd) of 203-mm- (8-in.) thick RCC placed, nearly 125,400 sq m (150,000 sq yd) were placed on the upstream and downstream slopes of the dams (Figure 14). It is believed this was the first time in the United States that RCC had been placed on a slope (Munn 1988). The contractor had to overcome two major problems when he began placing RCC on the slopes. First, the delivery system used for flat surfaces was not satisfactory during placement of the RCC on the slopes. Delivery was restricted from below because placement of the RCC was begun at the bottom of the slope, and the haul trucks rutted the substrate when delivering from above. As an alternative, the contractor used a pair of tracked loaders to transfer the mixture to the pavers, but they too damaged the substrate. Later, the contractor fitted two dozers with a 9-m (30-ft) conveyor which enabled them to deliver the mixture almost continuously from the trucks to the pavers. With this method of delivery, plating increased from 61 to almost 152 m (200 to almost 500 ft) per day (Munn 1988).

The paving sequence and the need for roller compaction behind the pavers were determined by the job specifications. Paving seams that were exposed for more than 1 hr were treated as cold joints. Because placement of the RCC on the slopes required more time, the paving sequence began with the lowest sloped downstream plating. The downstream apron was placed next by the second paver, which worked about 1/2 hr behind the first. If more than one sloping downstream pass was necessary, the two laydown machines alternated passes until they reached the crest. The upstream face was always the next-to-last pass and was placed by the first paver if only one downstream pass was required. The crest was placed last (Figure 14).

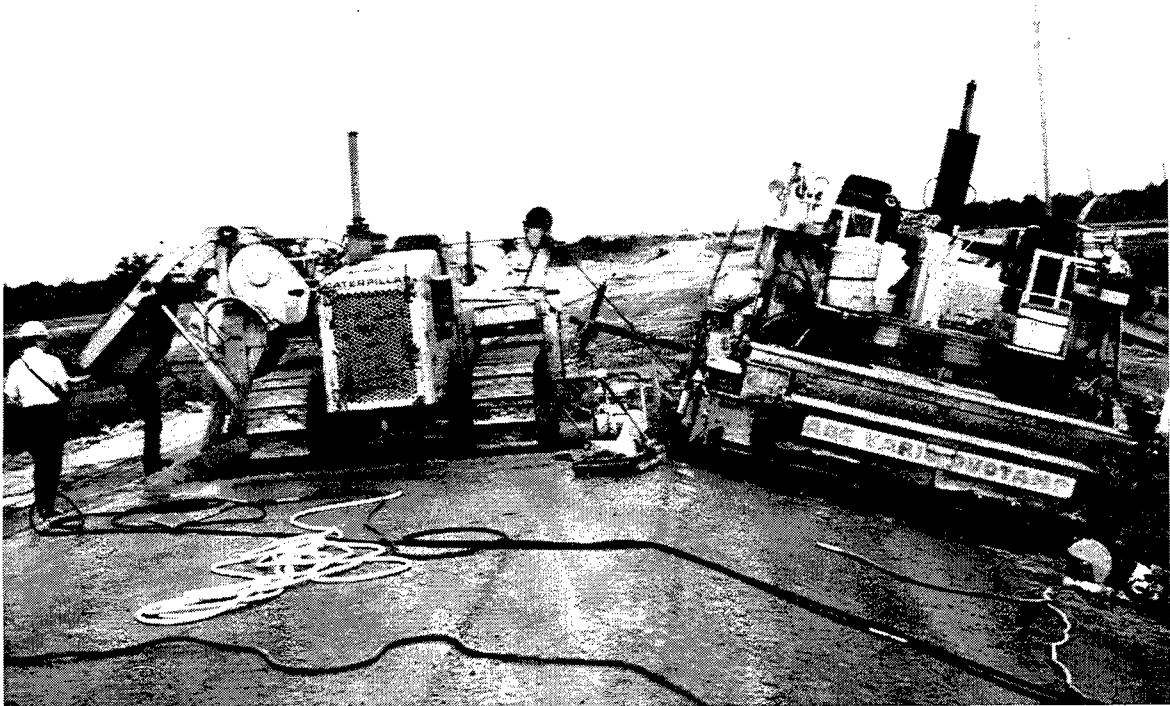
Figure 15. RCC paver connected to a bulldozer for paving slopes at Barker Dam

An additional problem was finding a way to place RCC on the downstream slope of the dams without having the 25,400-kg (56,000-lb) paver slide down the slope. The contractor installed a 18,140-kg (20-ton) winch on the end of the dozer and used it to control a 22.2-mm (7/8-in.) cable attached to the paving

machine; the two machines moved together, the bulldozer riding the crest to provide a counterweight to the paver (Figure 15)

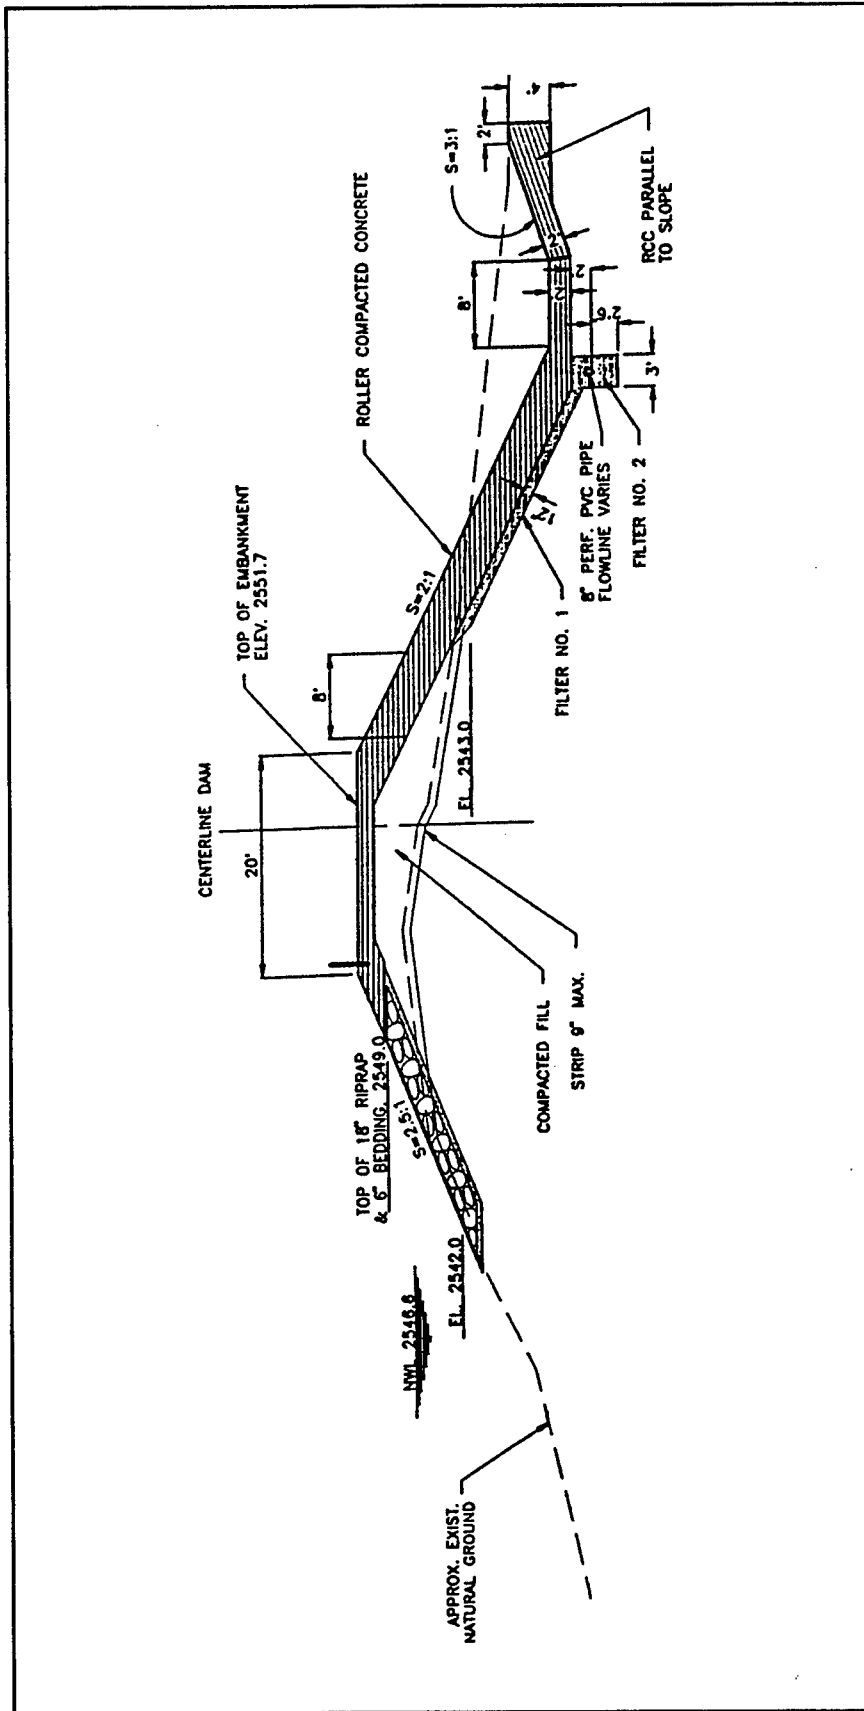
Figure 26. Plan for placing RCC on Comanche Trail Lake Dam (courtesy of Lemons, King, and Rutledge 1990, ASDSO). (Multiply inches by 25.4 to obtain millimetres and feet by 0.3048 to obtain metres)

A primary consideration in the use of RCC with an embankment dam is how much the subgrade and foundation will settle. Consolidation tests indicated the maximum settlement after rehabilitation of Comanche Trail Dam would be about 25 mm (1 in.). This amount was not considered significant, so plans to place RCC on the crest, downstream embankment, and in the spillway proceeded (Figure 26).

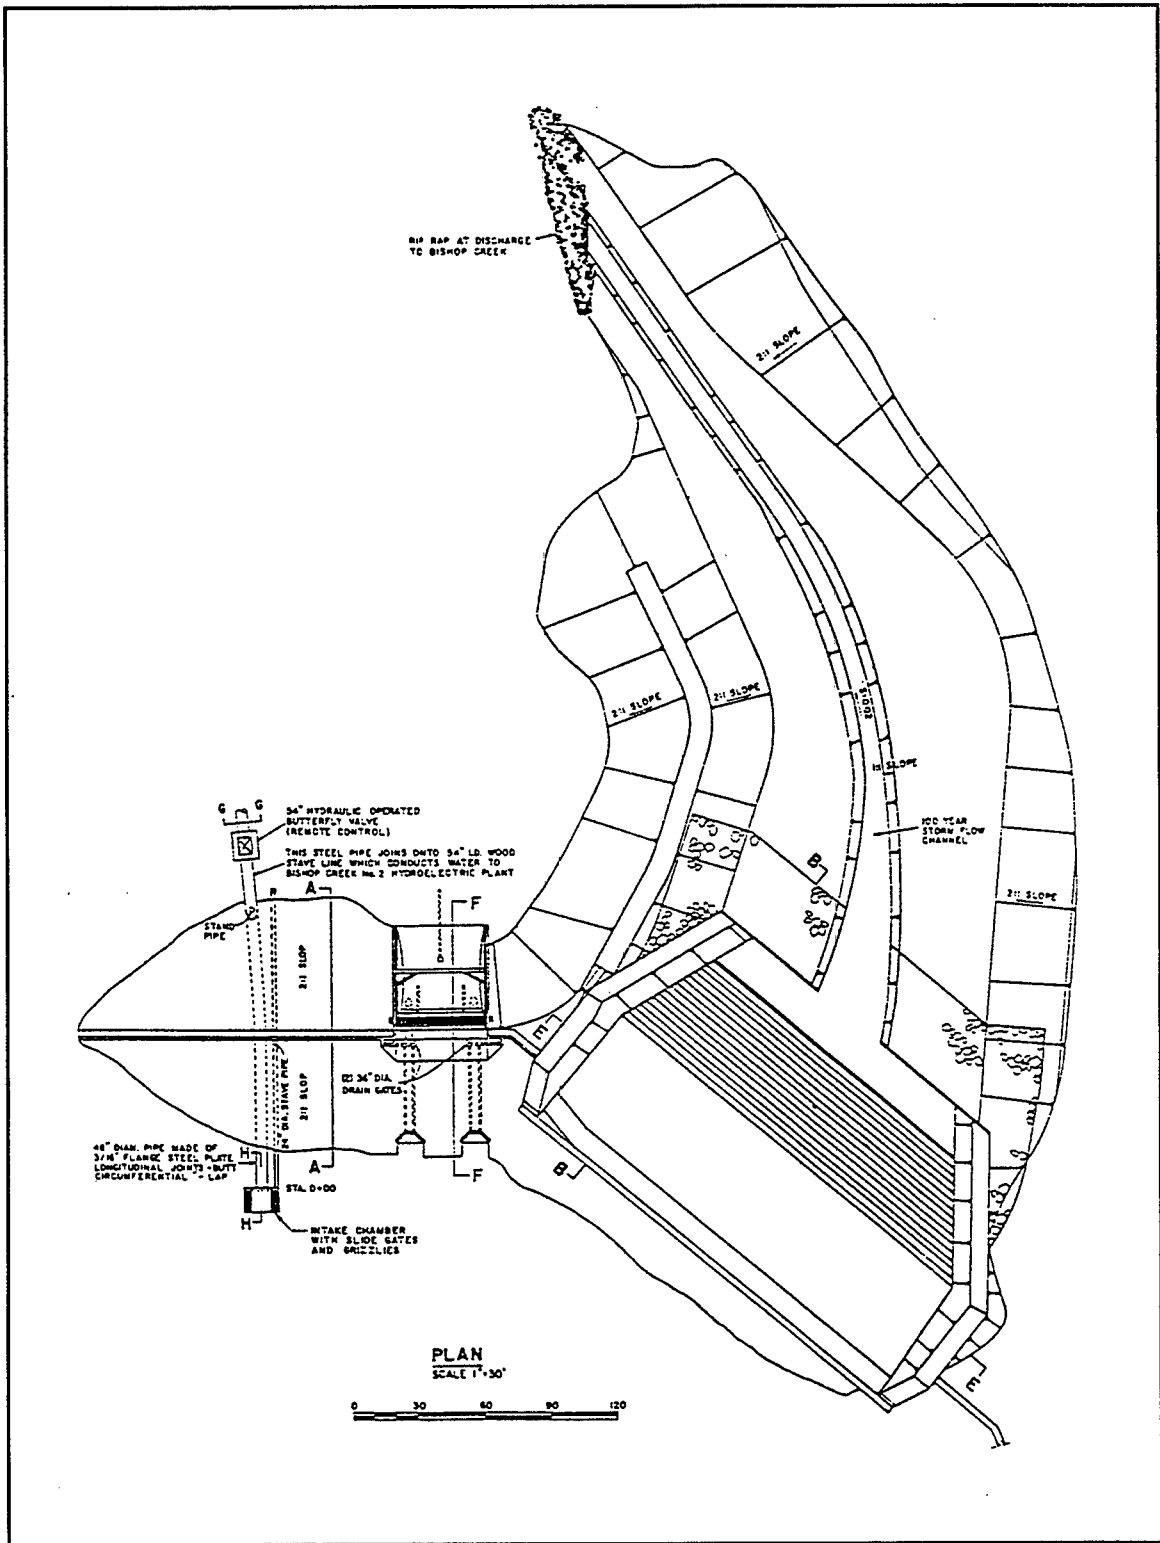
Figure 27. Drawing of RCC spillway constructed at Bishop Intake No. 2 (courtesy of Throckmorton and Knarr 1991, ASCE)

The RCC spillway alternative was selected because it was the most economical. The design included constructing a spillway chute on the right portion of the dam and armorplating the crest and downstream slope with RCC to provide protection from erosion in case of overtopping. The spillway chute is about 61 m (200 ft) wide and 3 m (9 ft) deep). A reinforced concrete ogee weir extends across the width of the chute. The top portion of the dam is covered with a 0.6-m- (2-ft-) thick RCC slab, and the downstream face is protected by a 0.9-m- (3-ft-) thick, stair-stepped RCC slab. The downstream slab extends to the toe of the dam where a 2.1-m- (7-ft-) deep by 5.5-m- (18-ft-) wide RCC cutoff trench has been constructed. Riprap placed downstream of this trench protects the earthen embankment from erosion (Figure 27).

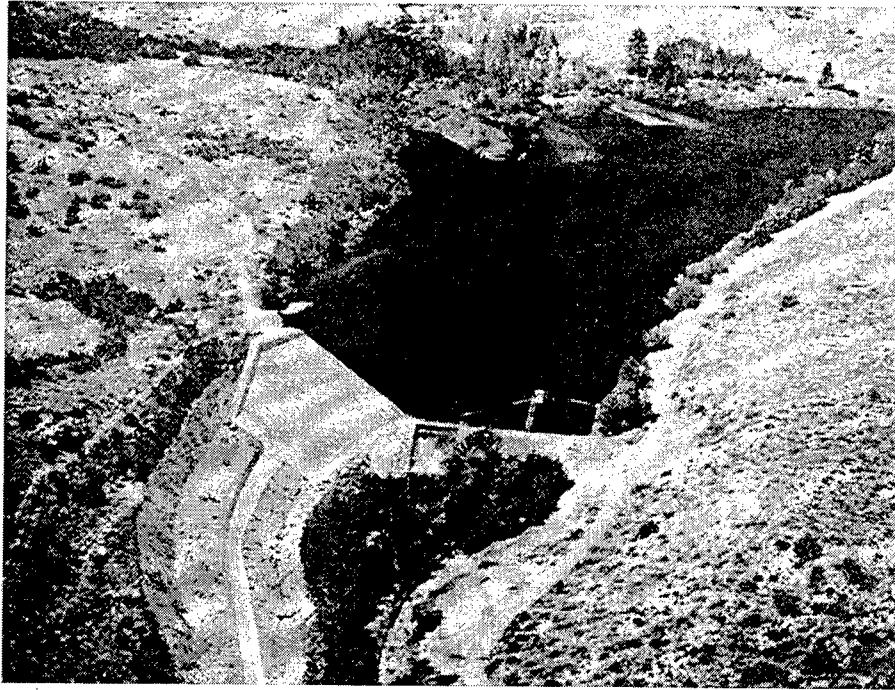
Figure 28. Completed RCC spillway at Bishop Intake No. 2 (courtesy of Throckmorton and Knarr 1991, ASCE)

Work was completed in October 1989 (Figure 28) at an approximate cost of \$958,973. This cost is estimated to be about \$500,000 less than the cost for a structural concrete spillway.

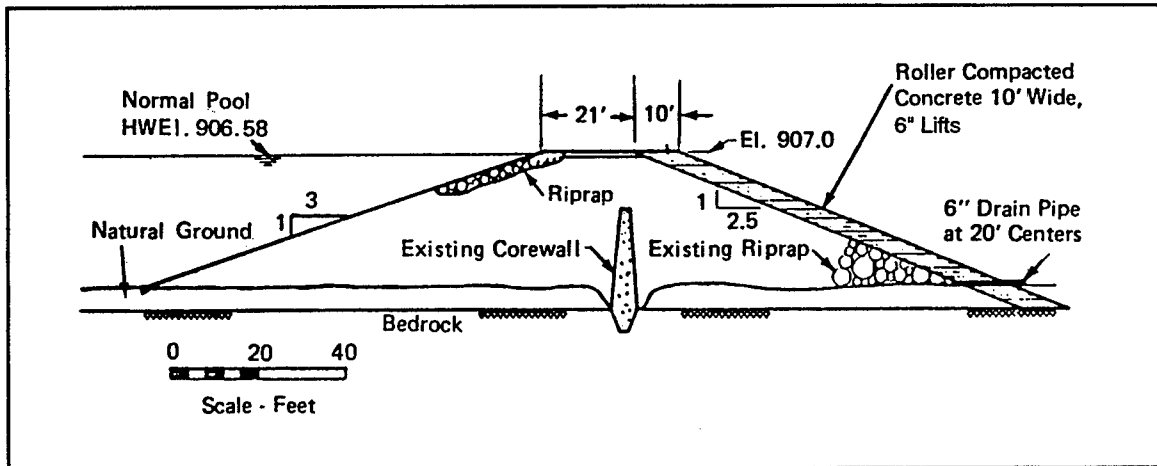
During a routine 5-year safety inspection, the Federal Energy Regulatory Commission (FERC) determined that the discharge capacity of the two spillways — 934 cms (33,000 cfs) — could not handle the calculated PMF peak discharge of 4,163 cms (147,000 cfs). Subsequent analyses indicated that discharges greater than 2,832 cms (100,000 cfs) would produce minimal incremental downstream damage as a result of a dam failure. Therefore, it was concluded that the additional spillway capacity required was about 1,900 cms (67,000 cfs). Four alternative designs were considered to achieve this additional capacity (Marold 1992). Preliminary studies indicated construction of an uncontrolled overflow spillway in the left embankment and protection of the

Figure 29. Cross section of the overflow spillway and RCC embankment protection at Boney Falls Dam (courtesy of Marold 1992, ASCE). (Multiply inches by 25.4 to obtain millimetres and feet by 0.3048 to obtain metres)

downstream side of the embankment with RCC would be the best option for economic and technical reasons (Figure 29).

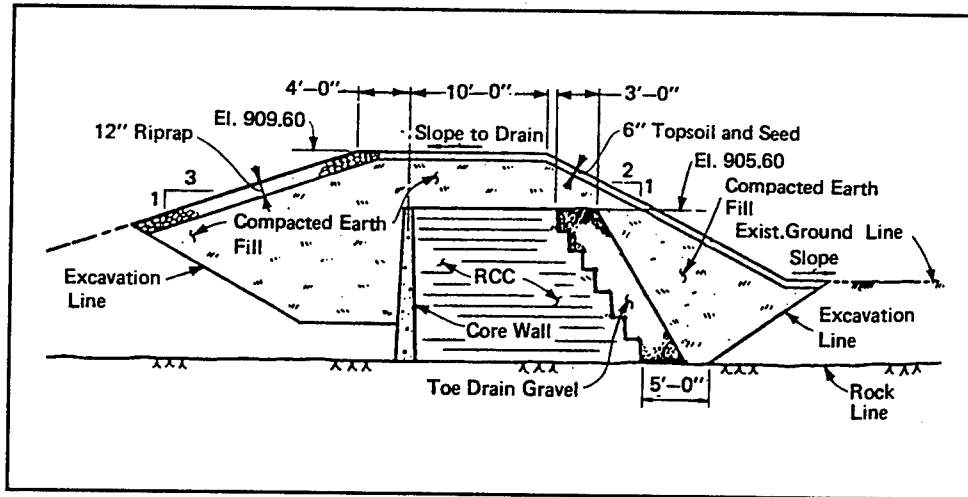
Figure 30. RCC spillway section with erodible earth-fill crest, Boney Falls Dam (courtesy of Marold 1992, ASCE). (Multiply inches by 25.4 to obtain millimetres and feet by 0.3048 to obtain metres)

To avoid a substantial seepage path that was located below the north-south section of the dam, the contractor decided to shorten the spillway section from 304.8 to 152.4 m (1,000 to 500 ft). This change meant the crest of the RCC gravity section had to be lower to carry the same volume as the longer paved RCC designed section. The revised plan called for the crest of the new RCC emergency spillway to be set 0.3 m (1 ft) below normal pool and to be covered with 1.2 m (4 ft) of earth fill, which would serve as an erodible fuse plug. The earth fill over the spillway would wash out when the reservoir water came within 152 mm (6 in.) of the dam crest. The fuse plug would lower the reservoir by only 0.3 m (1 ft) and would require a short reconstruction time were it to wash

out (Marold 1992). The spillway was to be 152 m (500 ft) long, 4.9 m (16 ft) high, 6.4 m (21 ft) wide at the base and 3.4 m (11 ft) wide at the top (Figure 30).

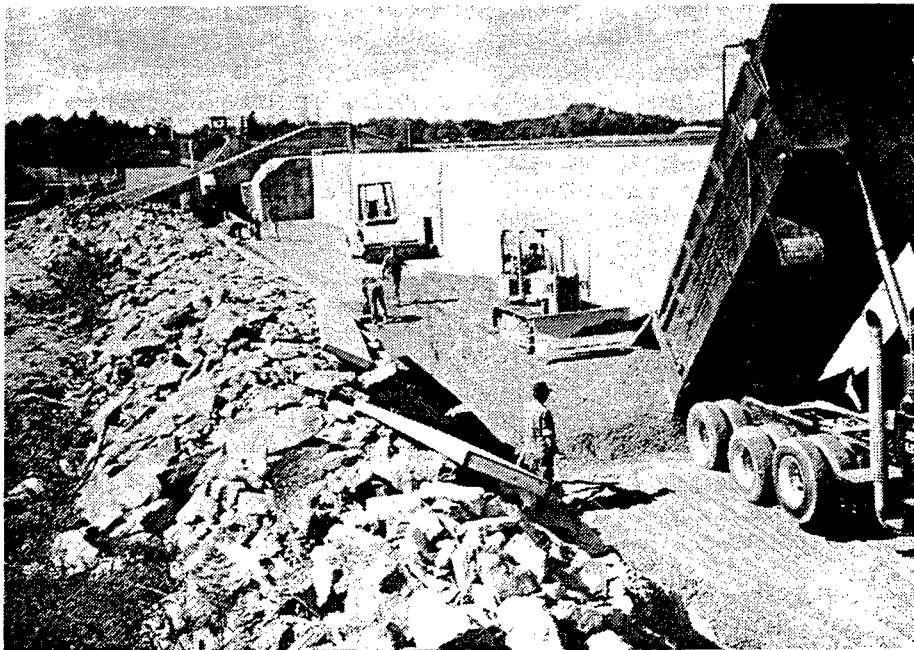
Figure 31. Placement of RCC adjacent to existing concrete core, Boney Falls Spillway (courtesy of Marold 1992, ASCE)

The RCC was transported in dump trucks and spread with a D-8 dozer (Figure 31). To minimize segregation, whenever possible the RCC was dumped

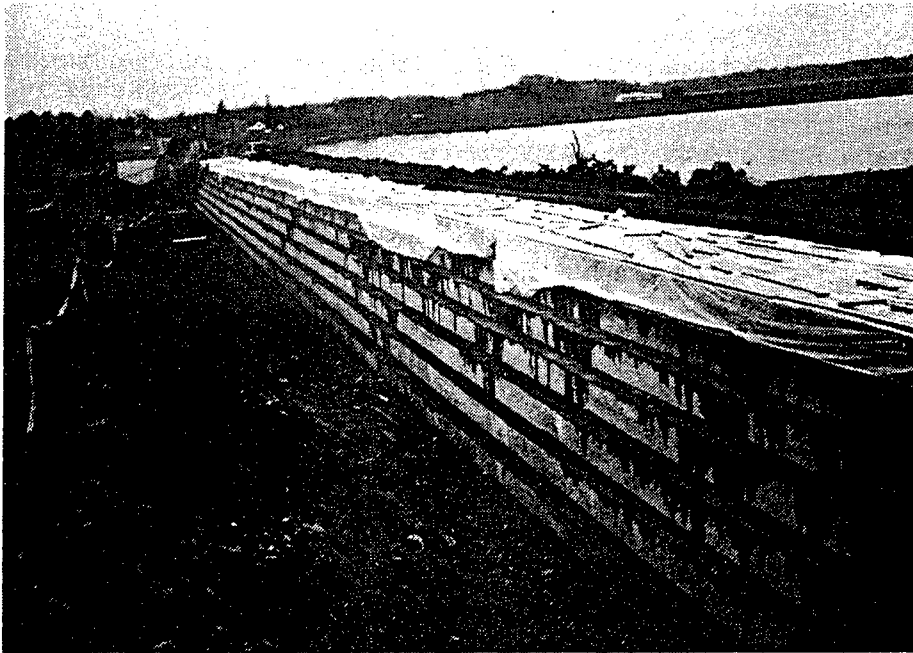
Approximately 1 year after construction, measurements of water levels in three observation wells and measurements of leakage through the gravel drainage layer on the downstream side indicated that the RCC spillway has effectively reduced the headwater across the foundation level by 60 to 100 percent and is performing successfully (Marold 1992). The completed RCC spillway is shown in Figure 32.

Figure 32. The completed RCC emergency spillway at Boney Falls (courtesy of Marold 1992, ASCE)

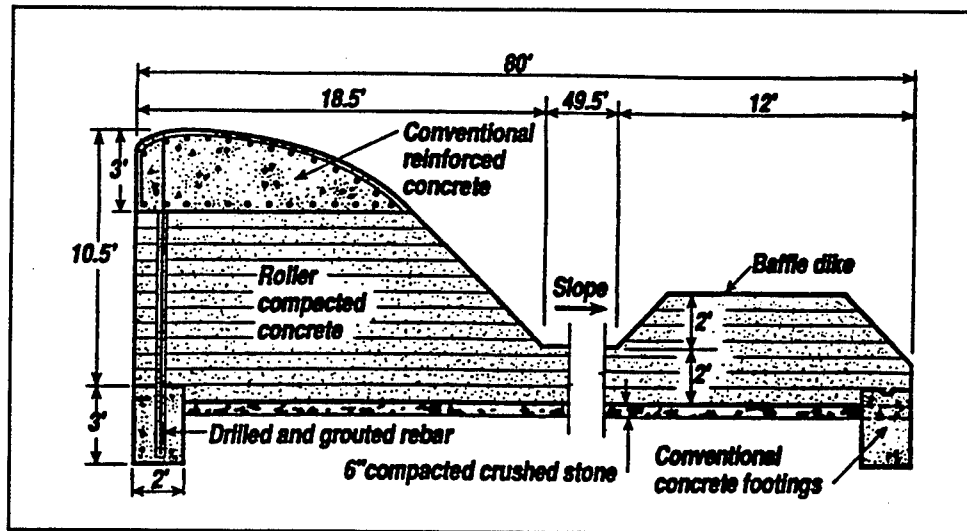
Figure 33. Emergency spillway, Tellico Reservoir Saddle Dam (courtesy of *RCC Newsletter* 1989b)

In 1988-1989, the Tennessee Valley Authority (TVA), as part of its on-going dam safety program, concluded that the saddle dam along the reservoir would be susceptible to overtopping and potential failure in the event of the PMF. To prevent dam failure in such an event, TVA decided to replace part of the saddle dam with an RCC emergency spillway (*RCC Newsletter* 1989b). The new ungated spillway is 609.6 m (2,000 ft) long, 3.2 m (10.5 ft) high, and 2.4 m (80 ft) wide. It has an uncontrolled ogee crest of conventional reinforced concrete and slotted end sills or baffle dikes (Figure 33). The crest elevation is at the approximate level of the PMF. The width of the ogee section is 5.63 m (18.48 ft), and the height of the crest is 4.11 m (13.5 ft) from the bottom of the shear key. A horizontal apron-type energy dissipator extends 18.75 m (61.52 ft) downstream of the ogee section; a 0.6-m-, 76-mm- (2-ft-, 3-in.-) high by 4.3-m- (14-ft-) wide endsill at the downstream end of the apron provides additional energy dissipation. RCC was selected for construction of the apron, endsill, and spillway section.

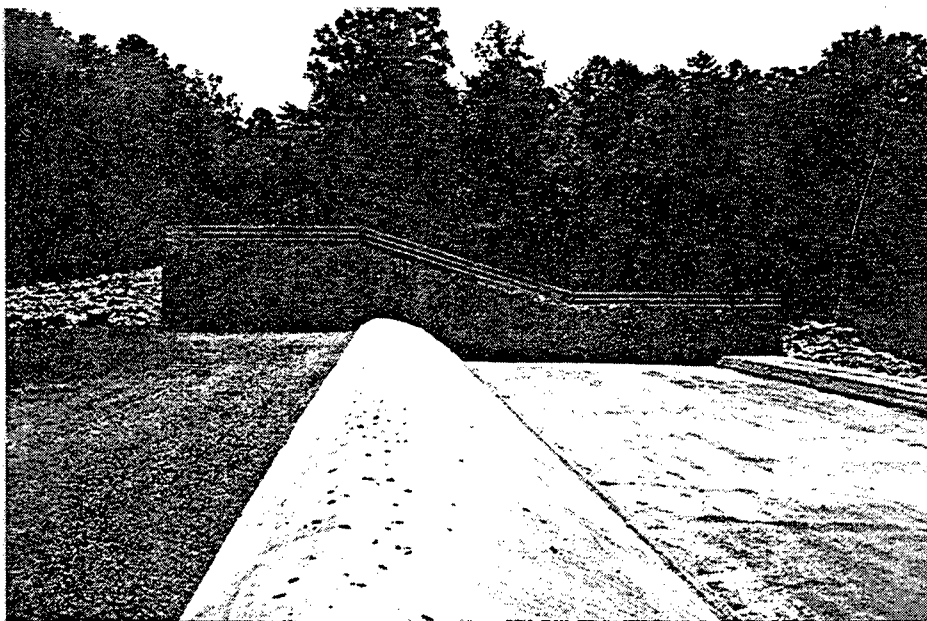
Figure 34. Portion of completed spillway, Tellico Reservoir Saddle Dam

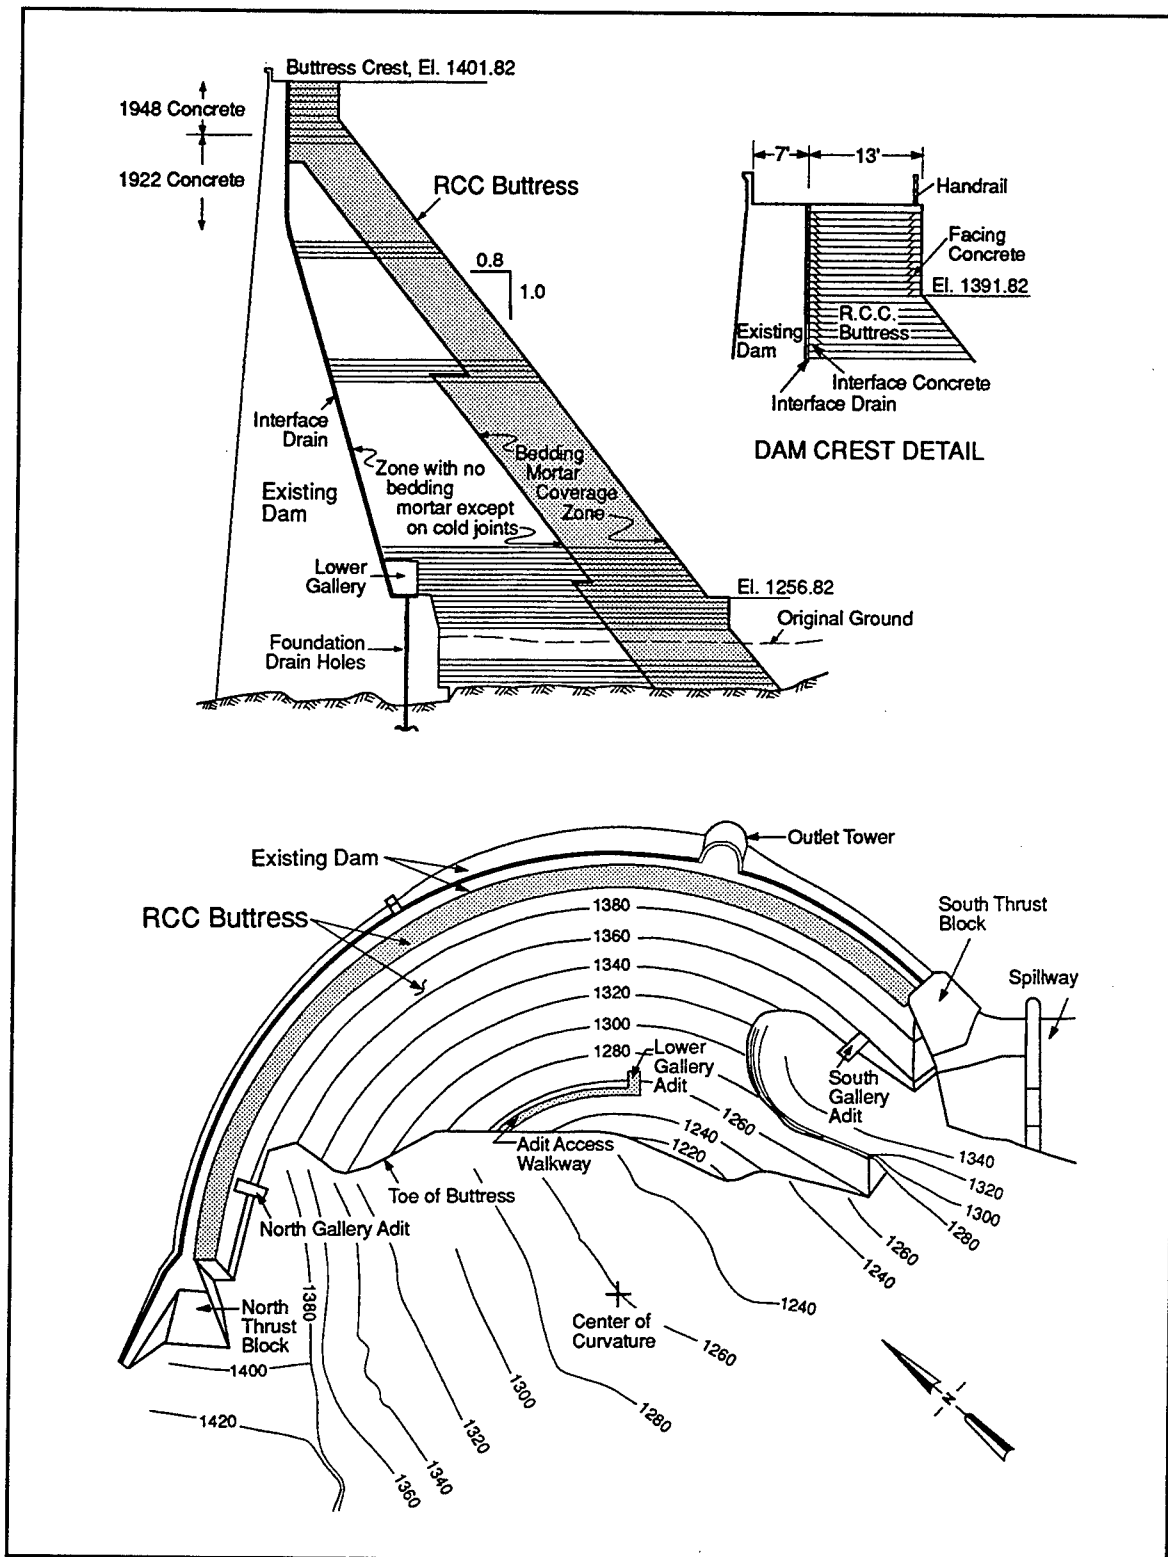
Figure 35. Cross section and plan of RCC buttress, Gibraltar Dam (courtesy of Wong et al. 1992, ASCE)

The RCC buttress increased the width of the dam crest by 4 m (13 ft). The face of the buttress is vertical for the top 3 m (10 ft) and then slopes at 0.8H:1V to the toe (Figure 35). The structural analyses of the RCC buttress were based on the assumption that the strengthened dam will respond to loading as a monolithic structure. Provisions required to ensure adequate bonding between the existing dam and the RCC buttress included sandblasting the downstream face of the existing dam, placement of a zone of conventional concrete at the interface, and installation of interface drainage pipes. A drainage gallery system (Figure 36) was included within the RCC buttress to allow for collection of inflows from the interface drains, foundation drains, and buttress drains and for monitoring and maintenance of the drainage system.

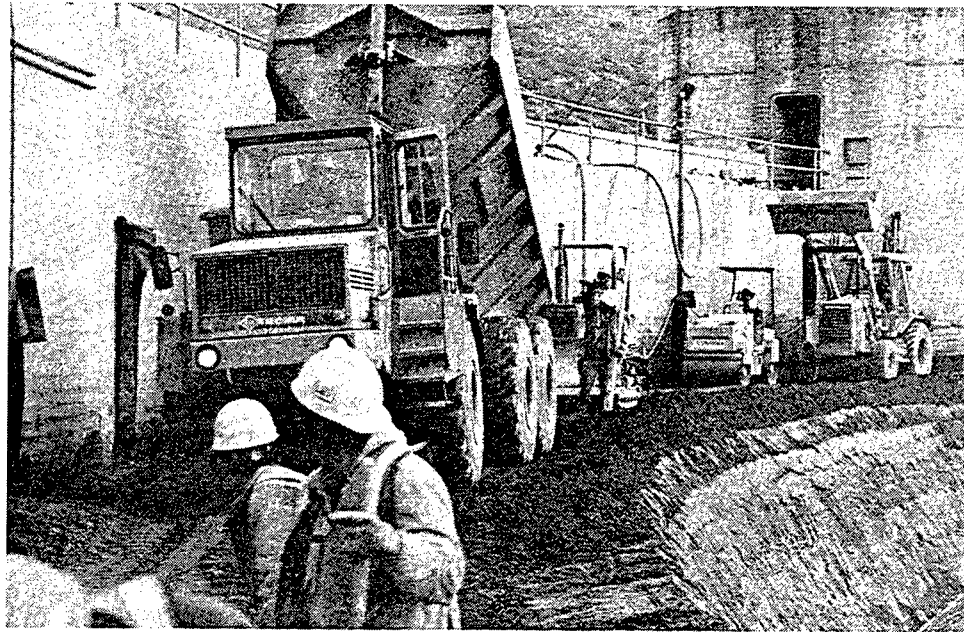
Figure 37. Smaller dozers at work in narrow placement area near the top of the buttress at Gibraltar Dam (courtesy of Wong et al. 1992, ASCE)

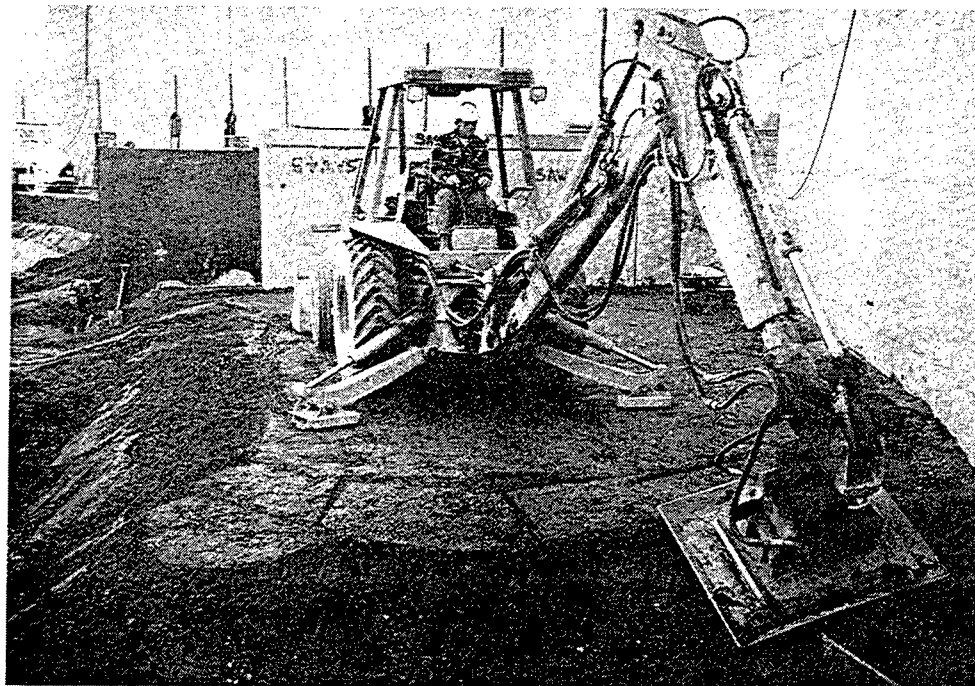
Figure 38. Slope compactor being used at Gibraltar Dam (courtesy of Wong et al. 1992, ASCE)

Thorough compaction was essential at the interface of the existing structure and the RCC. The fluid nature of interface concrete (25- to 102-mm (1-to 4-in.) slump) was such that the 9,070-kg (10-ton) vibratory roller did not effectively compact the RCC within 305 to 381 mm (12 to 15 in.) of the existing dam. Therefore, the contractor used a one-man gas-powered "wacker"-type tamper, vibrating sled compactors, and small 1,810- to 2,720-kg (2- to 3-ton) dual-drum vibratory rollers in these areas. A vibratory plate compactor mounted on a rubber-tired backhoe (Figure 38) was used to smooth and compact the sloped, unformed portions of the downstream face.

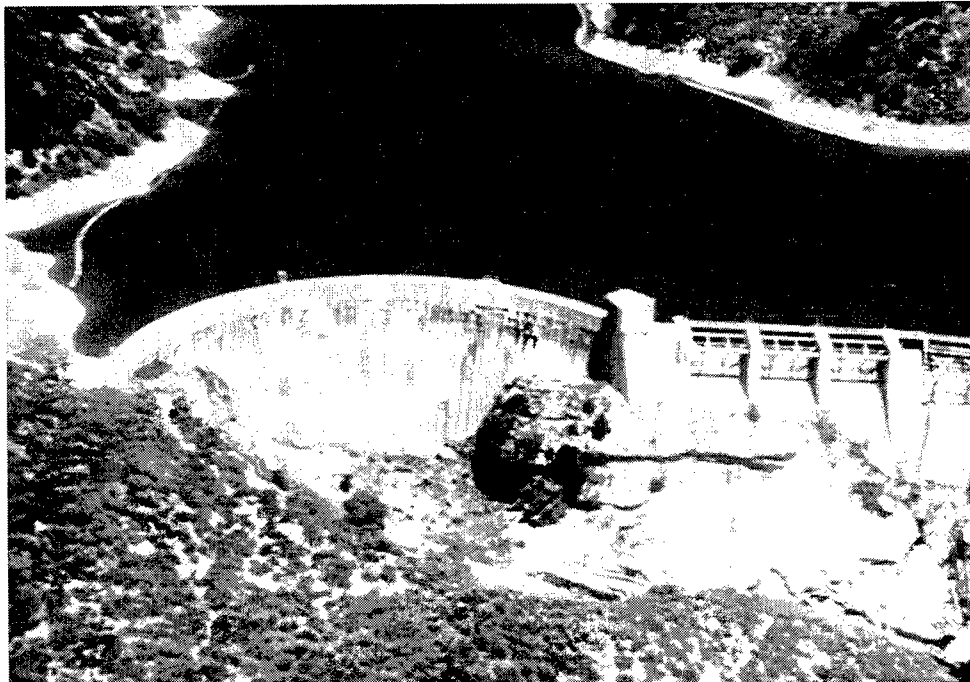
Figure 39. Gibraltar Dam after being strengthened with an RCC buttress (courtesy of Wong et al. 1992, ASCE)
