Technical Report REMR-CS-53  
April 1997

# **Applications of Roller-Compacted Concrete in Rehabilitation and Replacement of Hydraulic Structures**

*by James E. McDonald, Nancy F. Curtis*

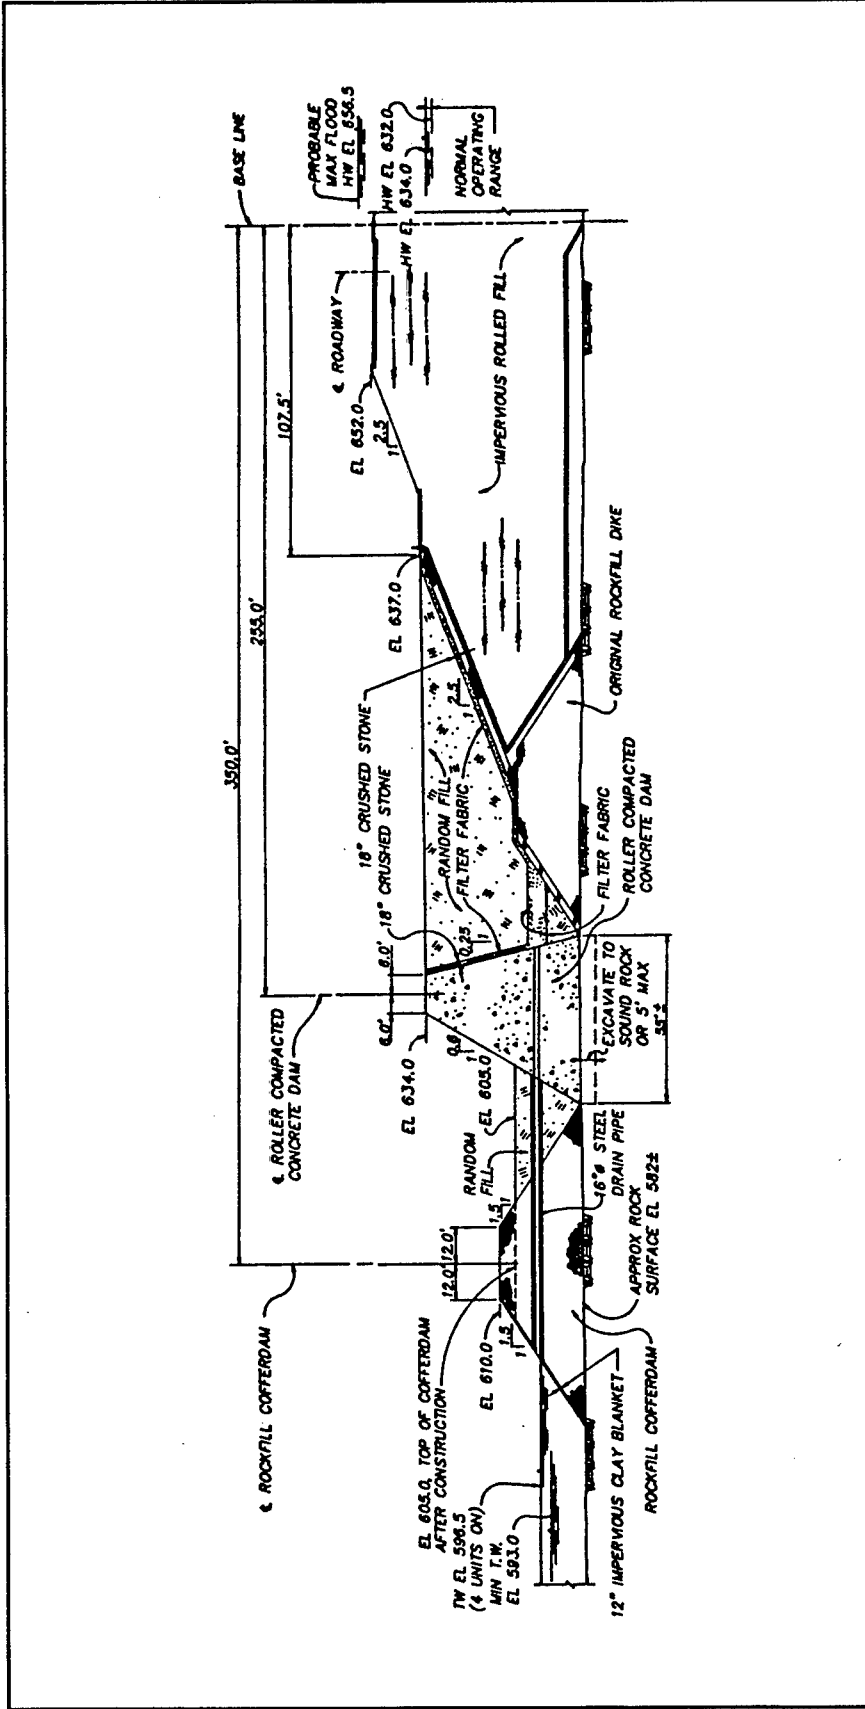
Figure 41. Right embankment modifications, Nickajack Dam (courtesy of Newell, Manson, and Wagner 1991, ASCE). (Multiply feet by 0.3048 to obtain metres and inches by 25.4 to obtain millimetres)

A decision was made to construct an RCC dam downstream of the north embankment (Figure 41) and to increase the height of the south embankment. During extreme floods, the north embankment would overflow and erode to the top of the RCC dam. The RCC dam would become an emergency spillway that would maintain the normal maximum pool in the reservoir (Newell, Manson, and Wagner 1991).

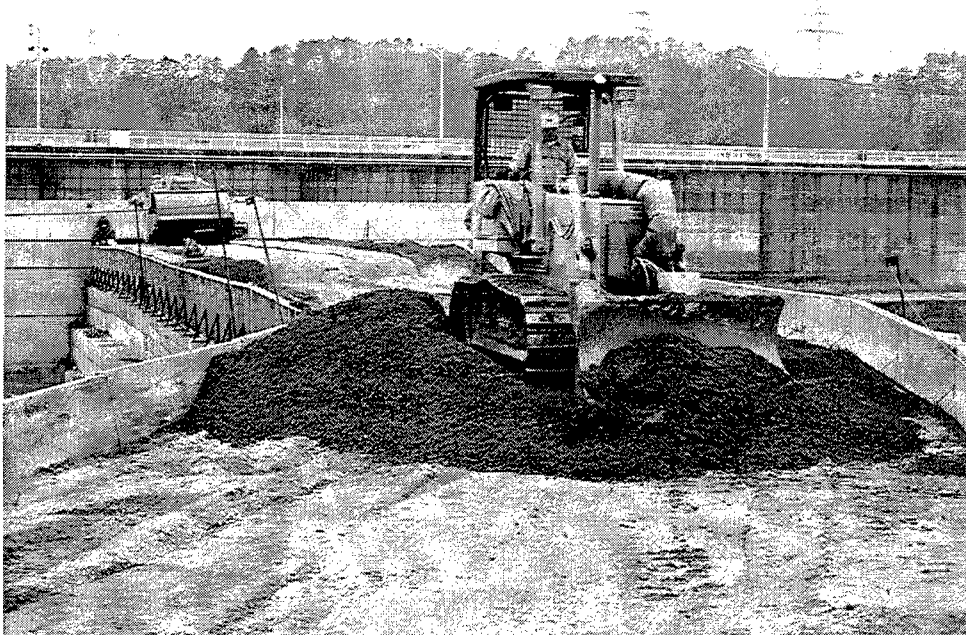
Figure 45. Spreading and compaction of RCC at Nickajack Dam

Tensile bonding of the lifts was not considered in the design of the structure; therefore bedding mixtures were used only to cover the foundation rock. Following dumping, the RCC was spread in 0.31-m (1-ft) lifts with a dozer and compacted with a single-drum vibratory roller (Figure 45). The downstream and upstream faces of the dam were formed with 0.6- and 1.2-m- (2- and 4-ft-) high jump forms (Figures 46 and 47). Because of the inefficiency of the smaller compaction equipment used next to the forms, the project manager opted to use conventional concrete along the formed faces. The face concrete mixture (No. 8) was proportioned for a maximum slump of 25 mm (1 in.). Except for being consolidated internally, it was placed in essentially the same manner as the RCC. The results of this change was an improvement in the texture of the surface of the faces (Cannon 1993). The RCC was covered with a tarp for curing (Figure 48).

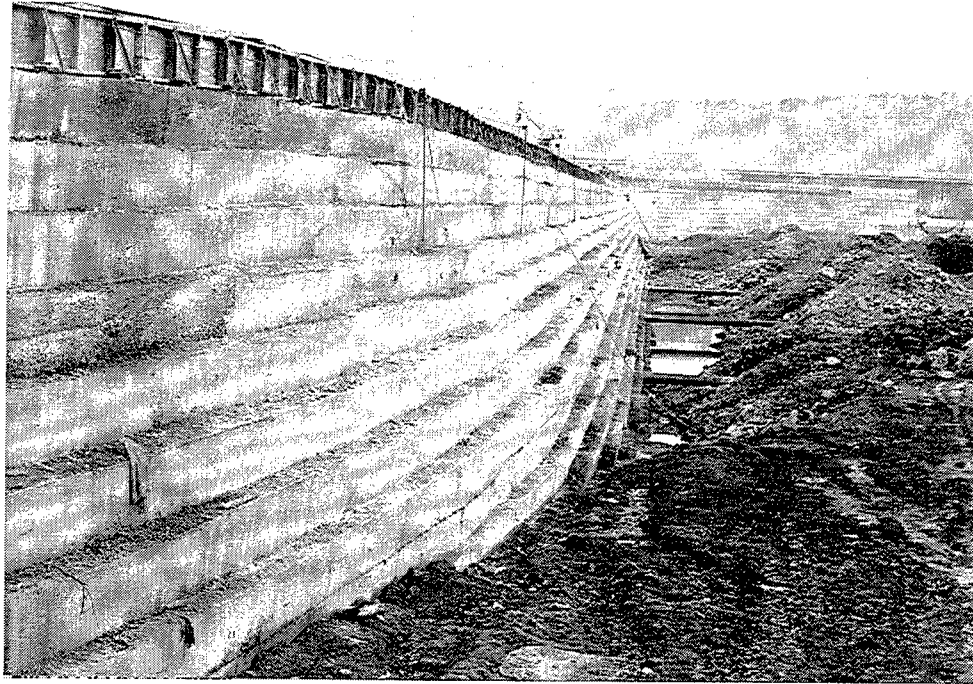
**Figure 47. Downstream face of RCC section, Nickajack Dam**

The top of the dam, the downstream face, and the upper 0.3 m (10 ft) of the upstream face were inspected about 7 months after the last RCC placement. There were no full section cracks within the structure. Most of the cracks were of the hair-line type that were difficult to follow. Crack spacing appeared to be related more to the 0.6-m (2-ft) lift placements and exposure to cold weather on the downstream face rather than the cooling of the mass from hydration temperatures. Most of the cracks were no longer than the length of three lifts; however, the longest crack, which was near the center, did extend the length of

six lifts. The minimal cracking in the structure was attributed to the combined effects of the intermittent placing sequence, the longer than normal exposure of lifts, the relatively high tensile strength of the concrete, the relatively low heat generating properties of the concrete, and a rather mild winter (Cannon 1993).

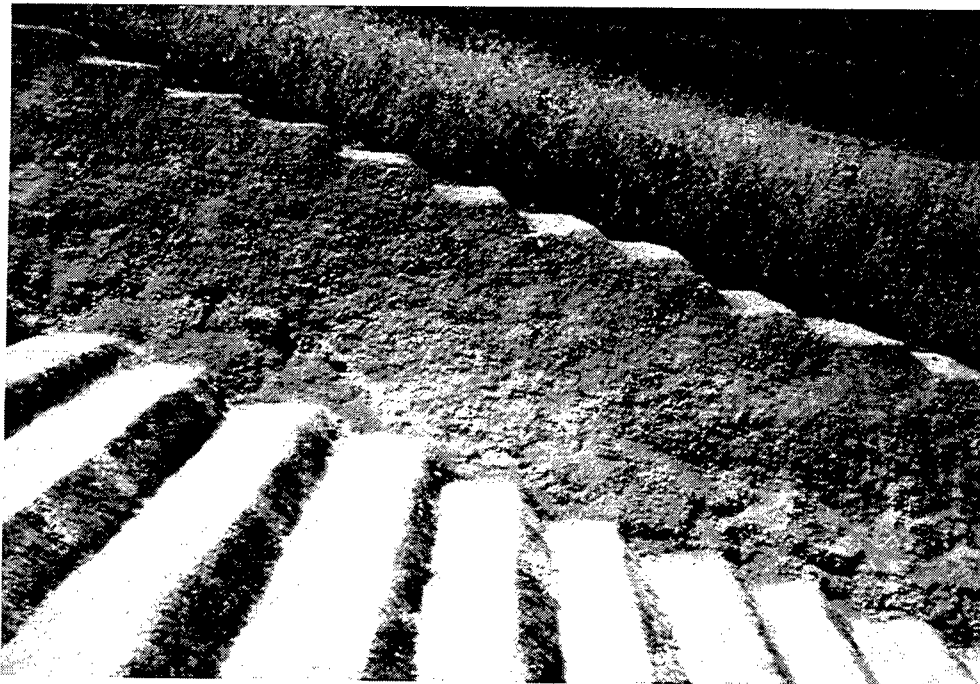
Figure 52. Completed steps and wall, Ringtown No. 5 Dam

The RCC for the steps was overplaced and compacted approximately 0.3 m (1 ft) beyond the proposed step location. The excess material was trimmed to the required 0.8H:0.1V slope (Figures 51 and 52). The trimmed material was mixed into the succeeding lift. The walls were trimmed to a final slope of 1H:1V.

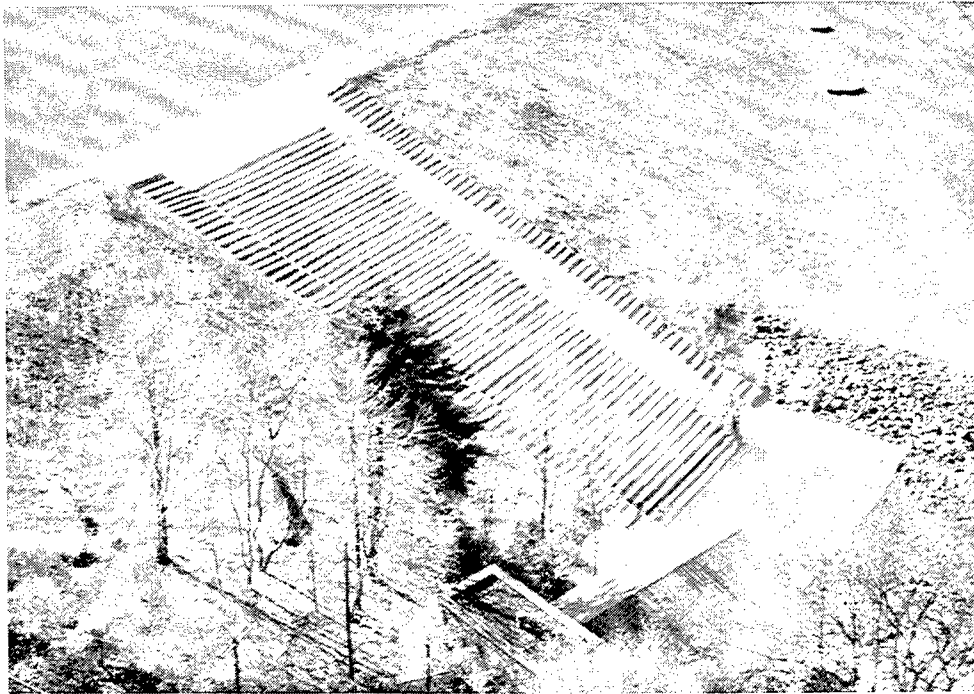
Figure 53. Completed spillway, Ringtown No. 5 Dam

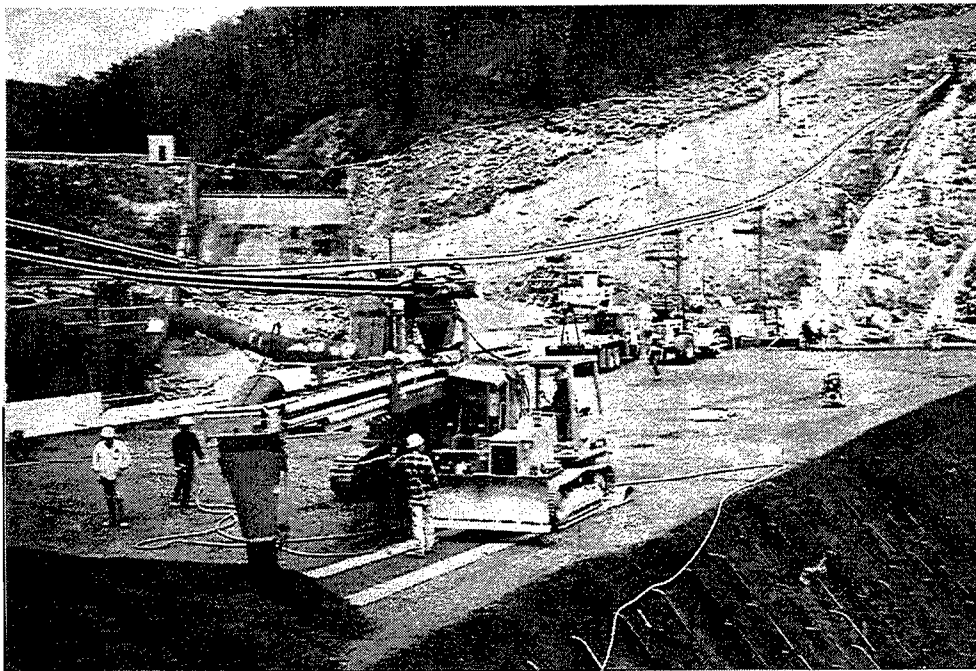
Figure 105. RCC placement, Siegrist Dam

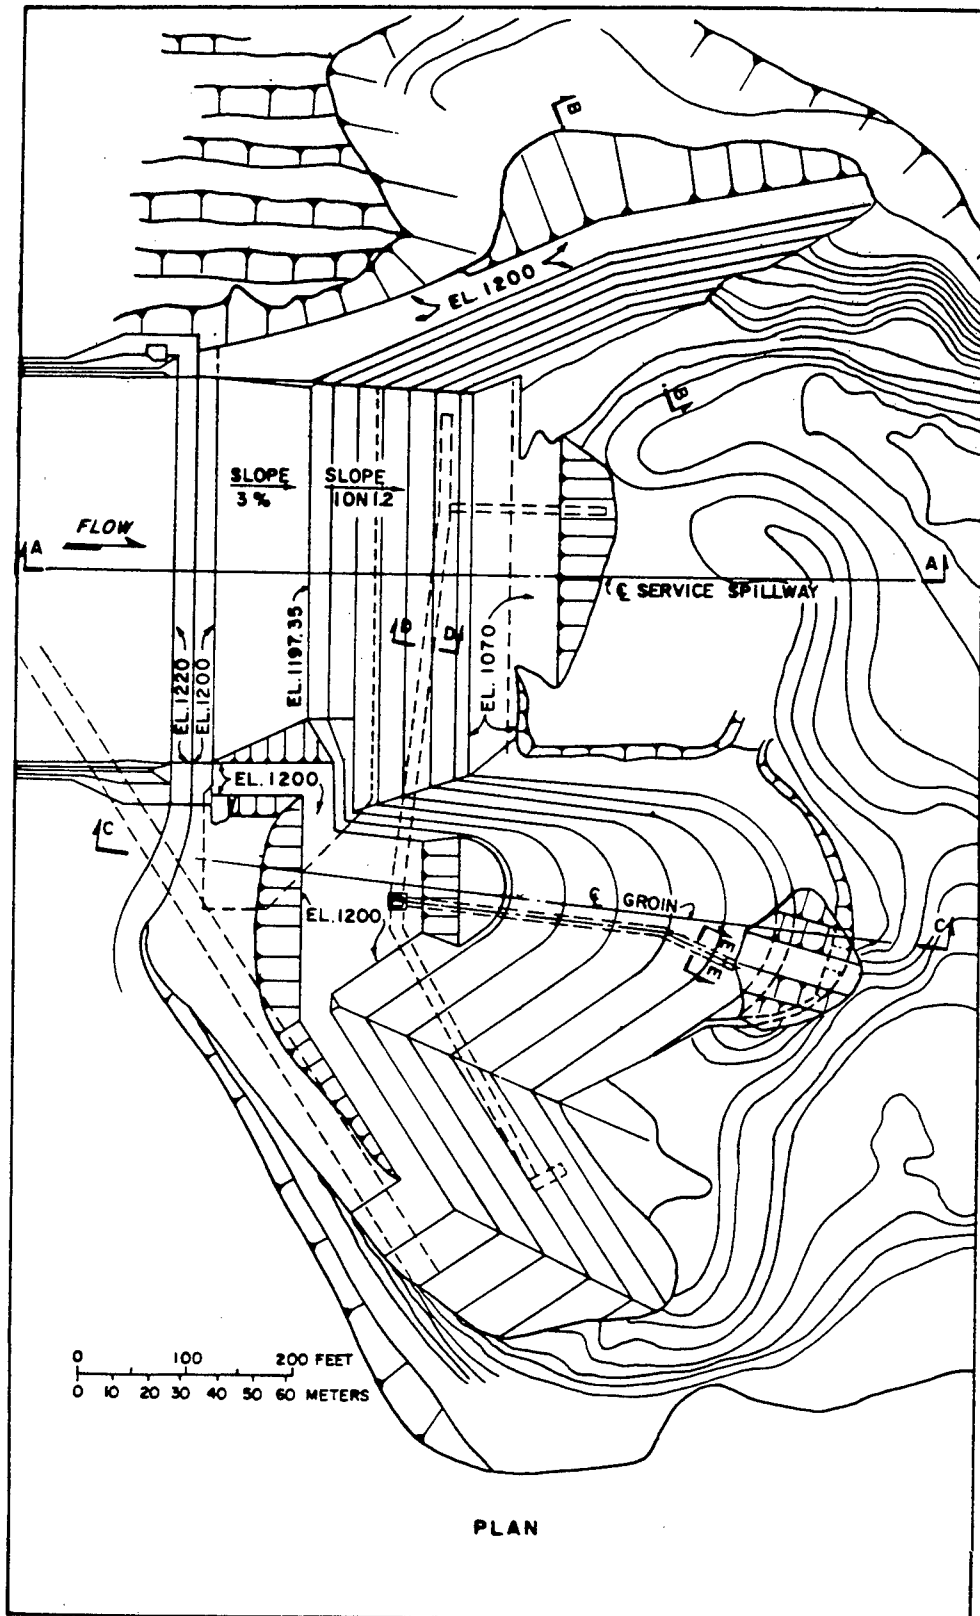
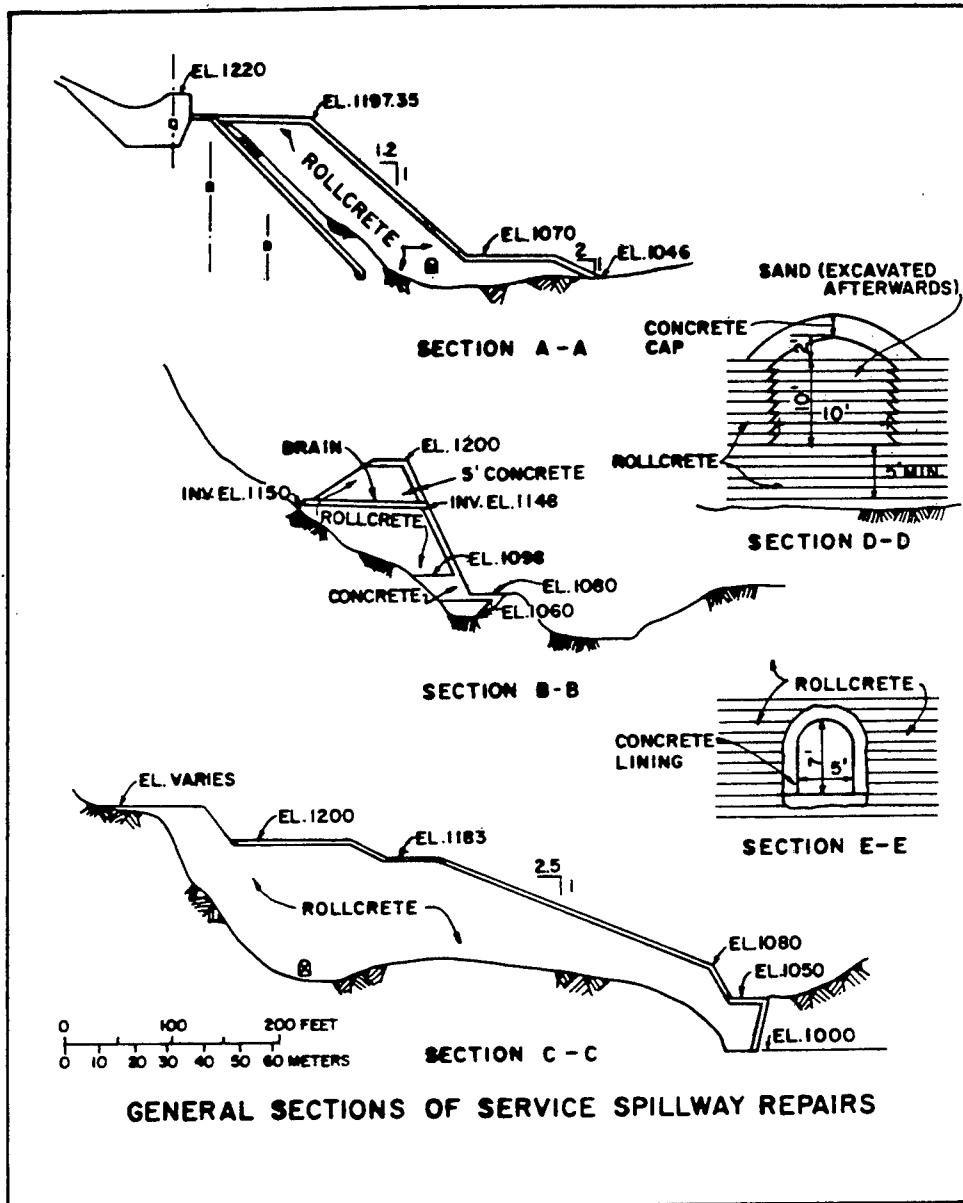
In the summer of 1977, after only 26 days of operation, the plunge pool at the service spillway was eroded to the extent that it threatened to undermine the spillway flip bucket. In addition to this damage, minor erosion was discovered downstream of the auxiliary spillway. Erosion at both locations was caused by back eddies and peripheral flows. To solve the erosion problem at the service spillway plunge pool, engineers decided to remove the rock ridge that was causing the back eddies and peripheral flows and to provide barriers on the sides of the spillway jet. At the auxiliary spillway, two minor barriers were to be constructed to stop back eddies on the left side of the plunge pool. The general plan and typical sections for the repair are shown in Figure 108.

Figure 108. Service spillway repairs at Tarbela Dam (courtesy Johnson and Chao 1979) (Continued)

The estimated amount of concrete-like material that would be needed was a minimum of 535,000 cu m (700,000 cu yd). This material would have to be produced and placed in approximately 4 months. Because of these factors, RCC was selected as the material for the project. Because there was some uncertainty about how well RCC could withstand the abrasion caused by high-velocity flows filled with debris, a decision was made to face the RCC with a 1.5-m- (5-ft-) thick layer of conventional concrete. However, conventional concrete was not placed on one RCC strut on top of the dike to the left of the plunge pool.

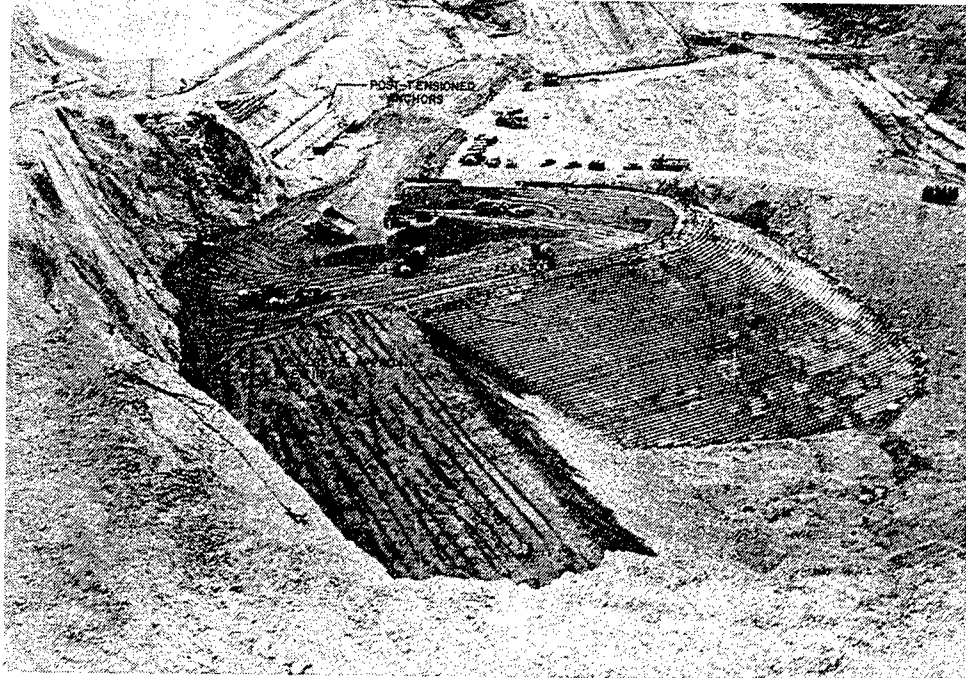
Figure 109. RCC placement at the service spillway, Tarbela Dam (courtesy of Johnson and Chao 1979)

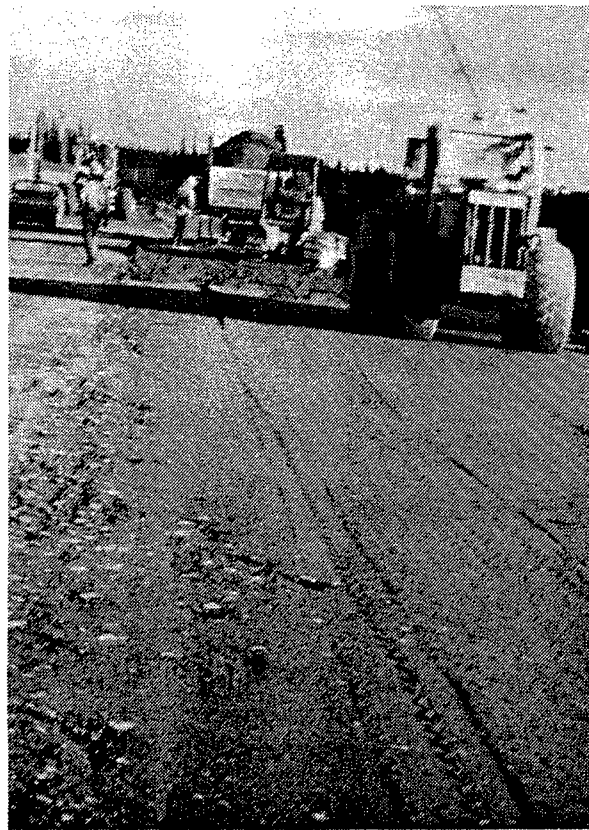
Figure 110. RCC placement at the Chena Floodway Sill (courtesy of Anderson 1984)

The RCC mixture for the project contained approximately 178 kg/cu m (300 lb/cu yd) of cement and 119 kg/cu m (200 lb/cu yd). The nominal maximum size of the aggregate was 38-mm (1-1/2 in.). The RCC was transported to the site in end-dump trucks where it was leveled with a dozer and compacted with a vibratory roller (Figure 110). A total of 12,770 cu m (16,700 cu

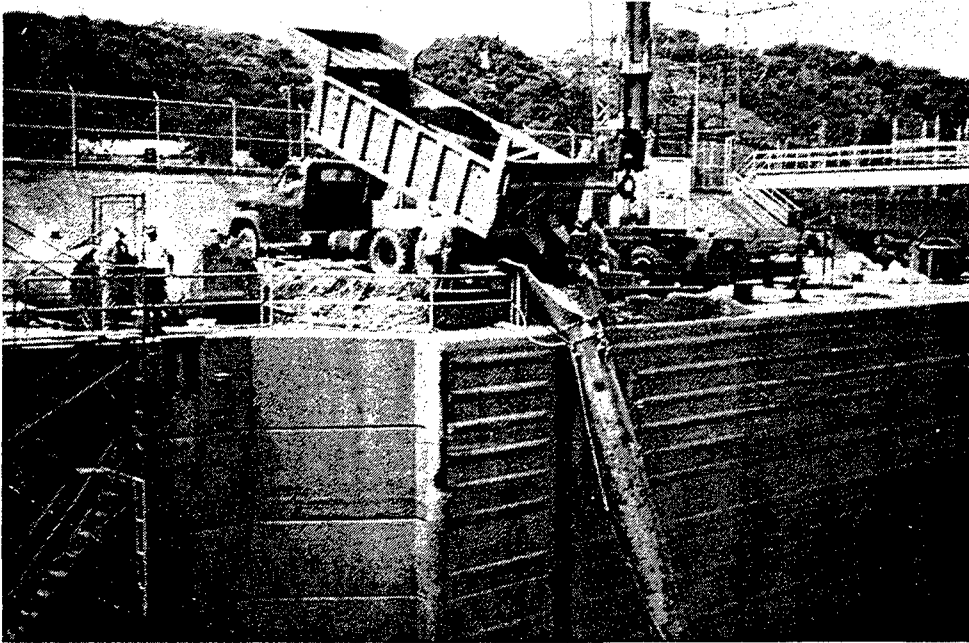
Figure 111. RCC being dumped into a drop pipe at the top of New Cumberland Lock (courtesy of Anderson 1984)

A drop pipe was used to transfer the RCC from the top of the lock wall to the lock floor where it was placed with a front end loader, leveled with a dozer, and compacted with a vibratory roller (Figures 111 through 113). The RCC was placed in 0.3-m (1-ft) layers to a maximum thickness of 1.5 m (5 ft). A total of 1,645 cu m (2,152 cu yd) of RCC was placed at a cost of \$95/cu m (\$73/cu yd).

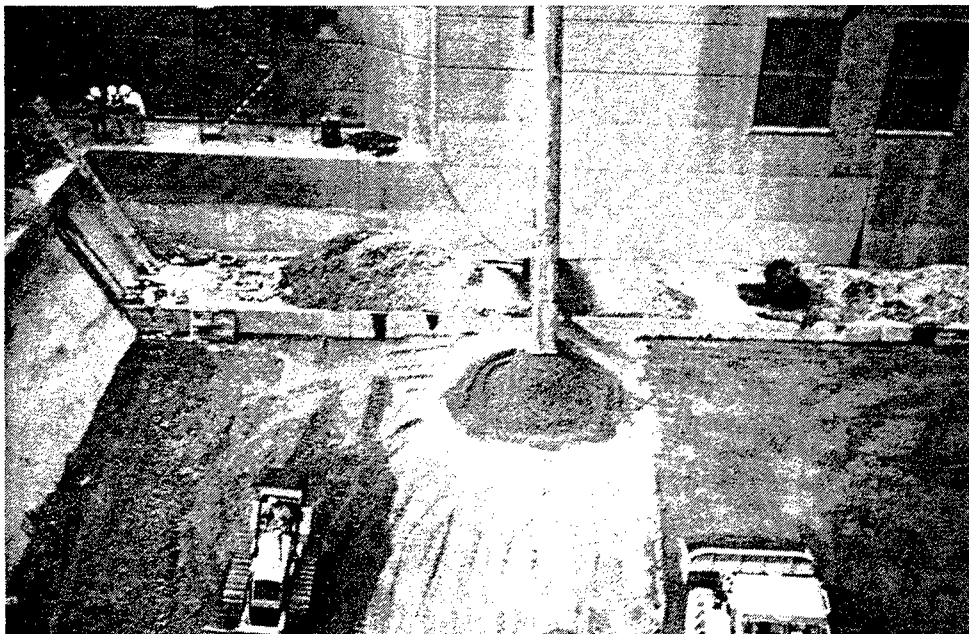
Figure 112. RCC delivered to the lock floor via a drop pipe at New Cumberland Lock (courtesy of Anderson 1984)

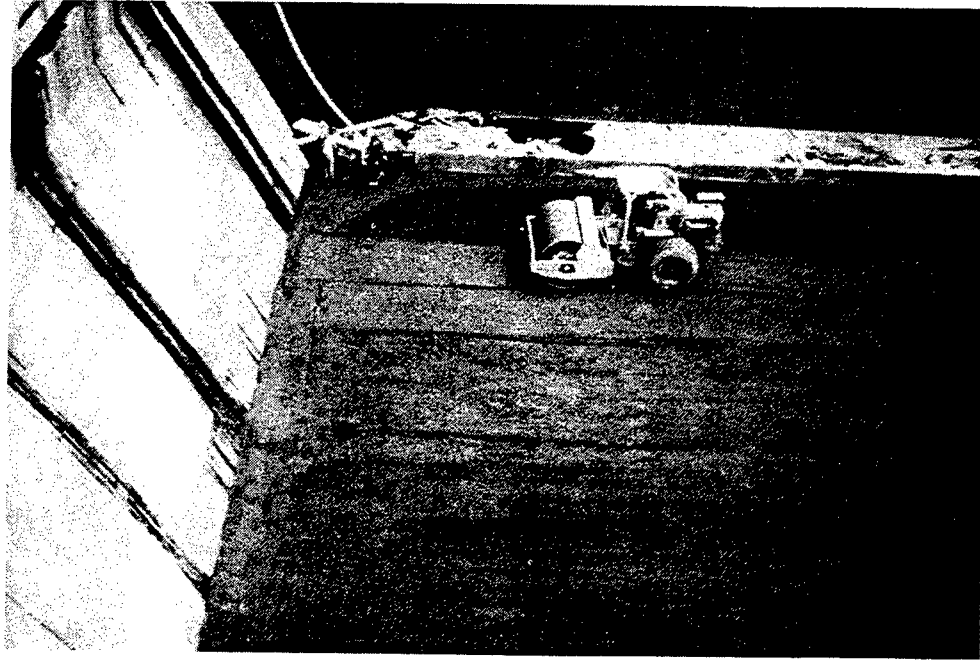
Figure 113. RCC being compacted, New Cumberland Lock (courtesy of Anderson 1984)
