Technical Manual: Conduits through Embankment Dams

Best Practices for Design, Construction, Problem
Identification and Evaluation, Inspection,
Maintenance, Renovation, and Repair

September 2005

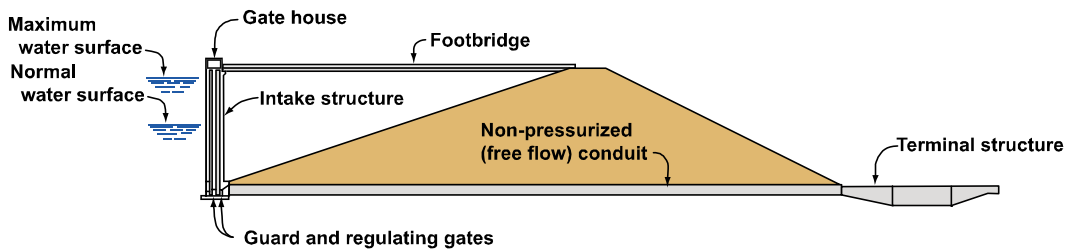
Figure 1.—Nonpressurized outlet works.

- *Nonpressurized flow*.—Open channel flow at atmospheric pressure for part or all of the conduit length (figure 1). This type of flow is also referred to as “free flow.”
- *Pressure flow*.—Pressurized flow throughout the conduit length to the point of regulation or control or terminal structure (figure 2)

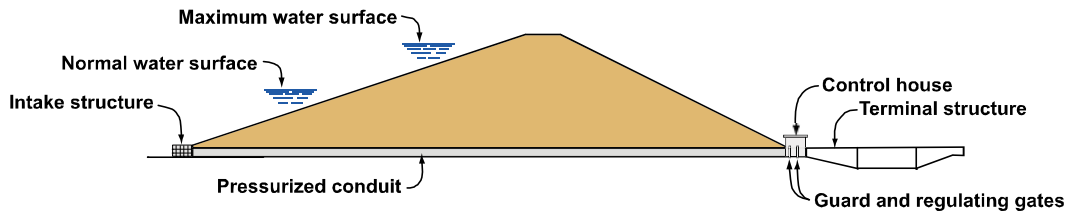
Figure 2.—Pressurized outlet works.

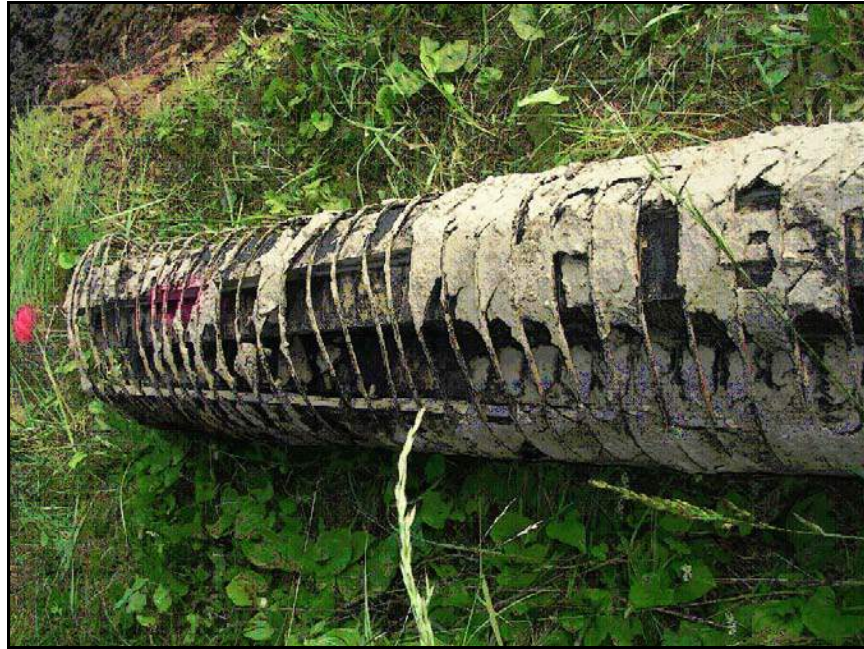
Figure 3.—A 15-inch diameter, wire-wrapped wood stave pipe used as an outlet works conduit within a 75-year old embankment dam. The outlet works conduit was removed and replaced due to deterioration and backward erosion piping concerns.

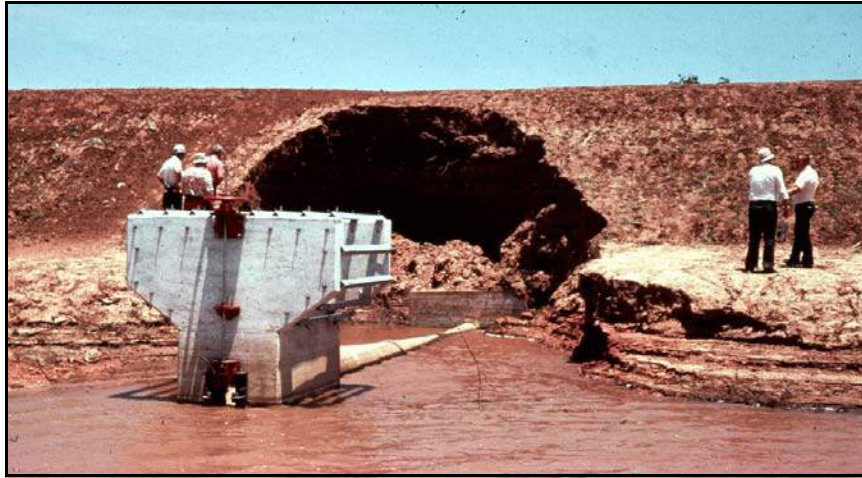
Figure 5.—Embankment dam failure caused by internal erosion of earthfill near the conduit. Flow was not directly along the contact between earthfill and conduit, but in the earthfill away from conduit. Hydraulic fracture in highly dispersive clay embankment soils caused the failure. The embankment design included antiseep collars, but not a filter diaphragm.

Historically, a single term, “piping,” has been commonly used in literature to describe all erosional processes involved in embankment dam failures. The reason for this is that frequently after a failure, a tunnel-shaped feature resembling a pipe is observed. See figure 5 for an example. In this document, two terms will be used to describe failures of embankment dams associated with uncontrolled flow of water, rather than using a single generic term. The two terms that will be used in this document are:

Often, the end result of internal erosion along the hydraulic fracture is a tunnel-shaped void (see figure 5). Loss of the reservoir contents can occur by water flowing through the tunnel-shaped void. Where the tunnel-shaped void enlarges sufficiently (see figure 5), the roof of the tunnel collapses, leaving a v-shaped notch in the embankment dam like that shown in figure 6. If the reservoir had contained a little more storage and the flow had continued a little longer through the tunnel-shaped void, the embankment dam shown in figure 5 would have collapsed and looked similar to the embankment dam in figure 6.

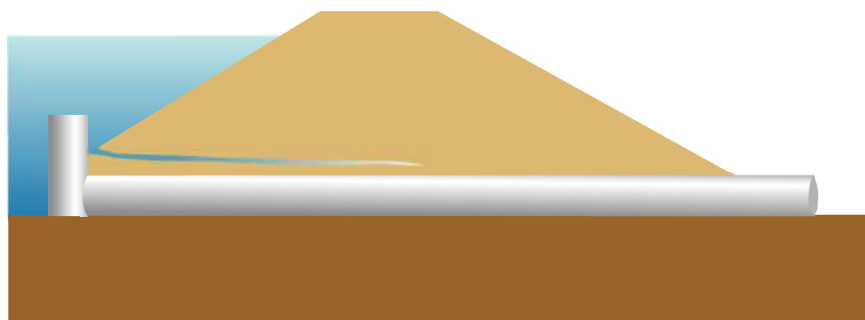
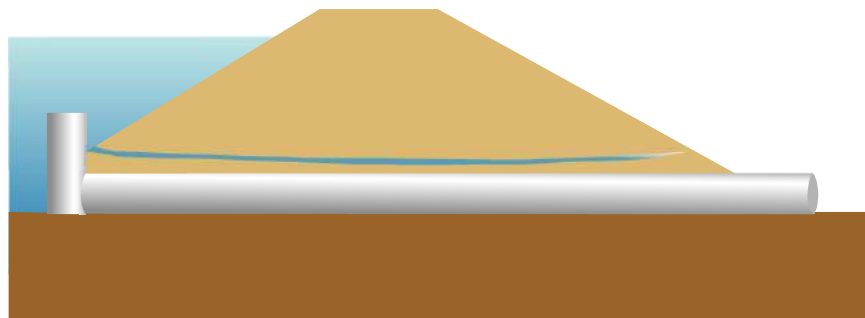
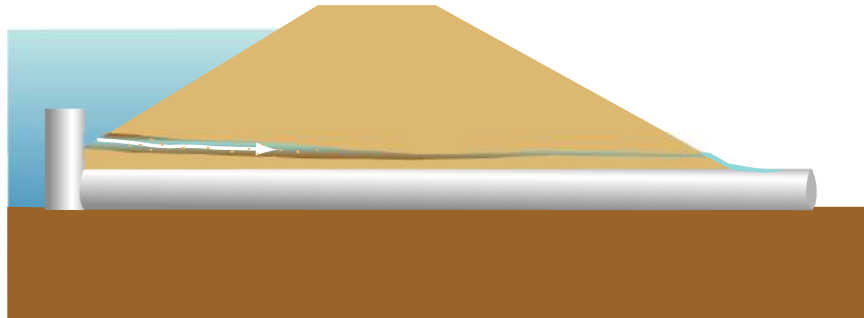
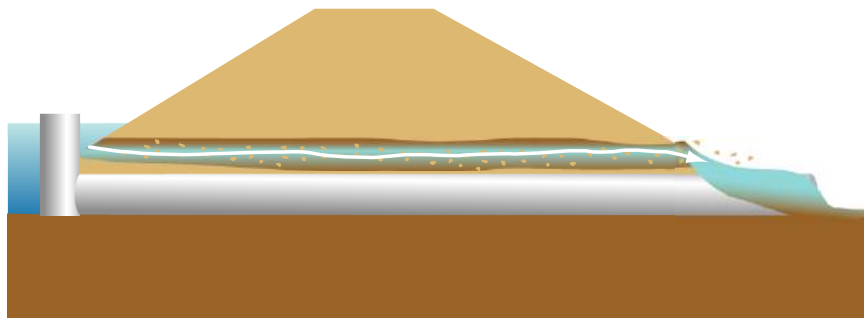
Figure 7.—The internal erosion process as a result of a hydraulic fracture.

An embankment dam with a low reservoir water level.

The reservoir water level rises, inducing a hydraulic fracture within the embankment dam due to poor construction or defective soils.

The hydraulic fracture extends through the embankment dam as a result of arching of the overlying embankment, resulting in low stress concentrations in the soil and a reservoir level high enough to cause the fracture. Conduits often create differential settlement and arching of the earthfill, because settlement of the embankment dam is less above the conduit than on either side of it.

Water from the reservoir penetrates the hydraulic fracture, initiating internal erosion of the side walls of the fracture.

The internal erosion process continues as water flowing in the hydraulic fracture widens the walls of the fracture. Intergranular seepage is not involved in the process, and the soils surrounding the fracture are unsaturated. Intergranular seepage rarely has time to develop, since this type of failure occurs most frequently on first filling of the reservoir.

A vortex may form at the location where water in the reservoir enters the upstream end of the hydraulic fracture.

- Figure 7 illustrates the internal erosion process as a result of a hydraulic fracture through the embankment dam.
- Figure 8 illustrates the internal erosion process as a result of low density embankment materials under the haunches of a pipe due to poor compaction.
- Figure 9 illustrates the internal erosion process associated with the creation of a void caused by excessive compactive energy used to compact embankment materials against the conduit.
- Figure 10 shows the backward erosion piping process associated with intergranular seepage and the subsequent backward erosion of soil particles.

for failures in the earthfill above a conduit is that most embankment dams are not constructed of soils susceptible to backward erosion piping without proper design features to prevent the backward erosion piping. The *Introduction* of this document contains extensive discussions of factors that are important in distinguishing between internal erosion and backward erosion piping mechanisms of particle erosion. Figure 7 illustrates the sequence in development of Failure Mode 4.

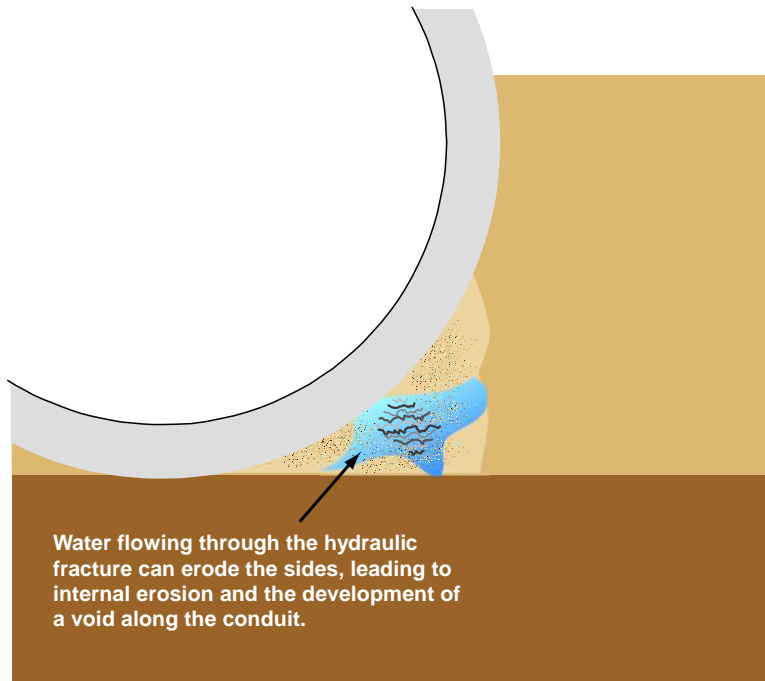
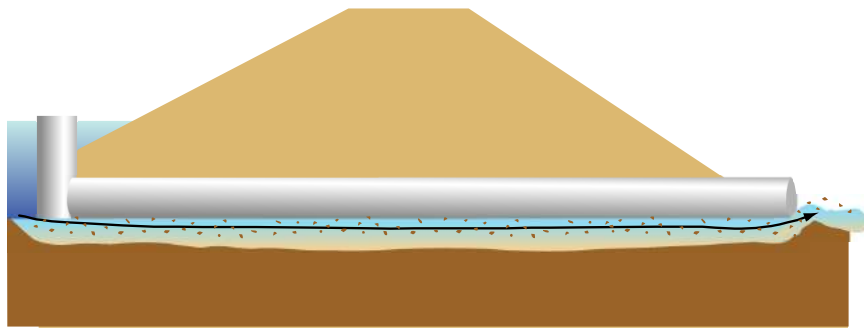
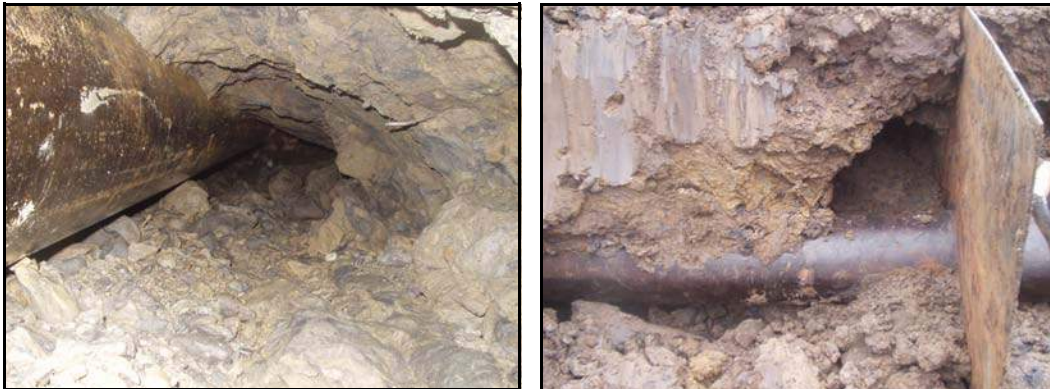
Figure 8.—The internal erosion process as a result of low density embankment materials under the haunches of a pipe due to poor compaction.

Poor compaction causes arching to occur in the area of the conduit's haunches. This creates a low density zone subject to hydraulic fracture.

The hydraulic fracture can propagate in a downstream direction and initiate flowing water from the reservoir.

Water from the reservoir penetrates the hydraulic fracture, initiating internal erosion of the side walls.

Flowing water from the reservoir continues the internal erosion process within the hydraulic fracture. Intergranular seepage is not necessarily involved in this process, and the embankment materials surrounding the void may be unsaturated.

A void was formed along the conduit due to water flowing through a hydraulic fracture.

As previously discussed, Failure Mode No. 3 may involve either a backward erosion piping or internal erosion mechanism of particle erosion. The *Introduction* of this document includes extensive discussions of factors that should be evaluated to determine which of these mechanisms is likely for a specific situation. Figures 8 and 9 illustrate failure mechanisms resulting from internal erosion along a conduit.

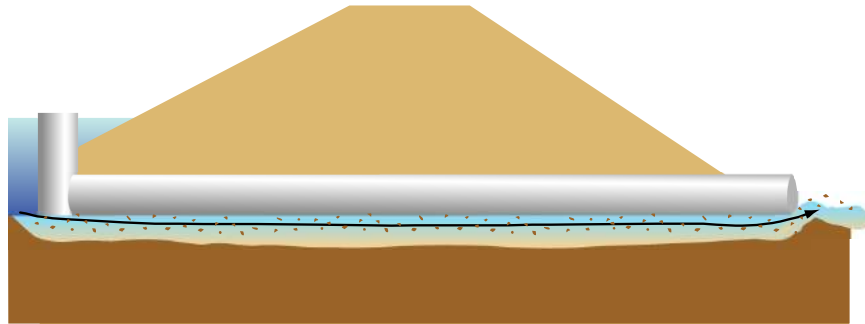
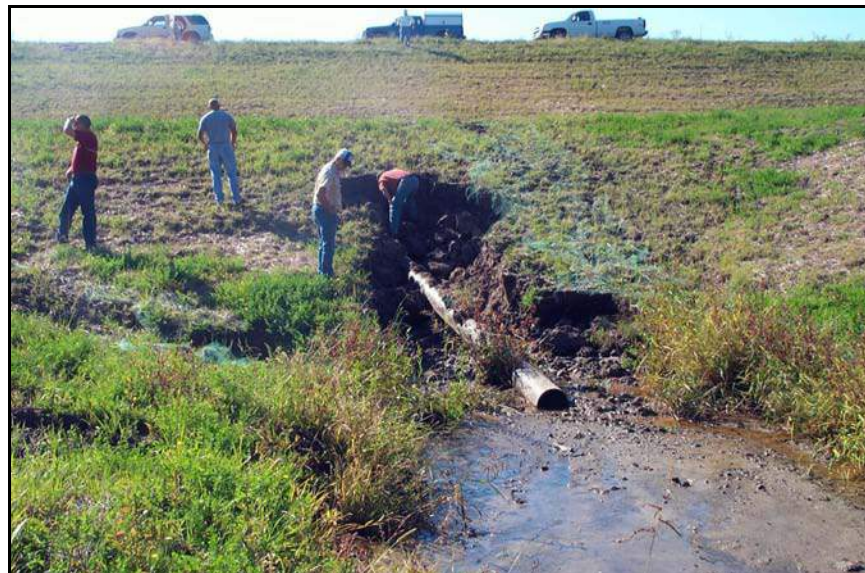
Figure 9.—The internal erosion process associated with the creation of a void caused by excessive compactive energy used to compact embankment materials against the conduit.

If too much compactive energy is applied while attempting to compact the embankment materials under the haunches of the conduit, a void can occur beneath the conduit.

The void can extend beneath the entire length of the conduit.

Water from the reservoir can penetrate the void, initiating internal erosion of the side walls.

Flowing water from the reservoir continues the internal erosion process within the void. Intergranular seepage is not necessarily involved in this process, and the soils surrounding the void may be unsaturated.

The resulting failure often leaves a tunnel-shaped void along the conduit.

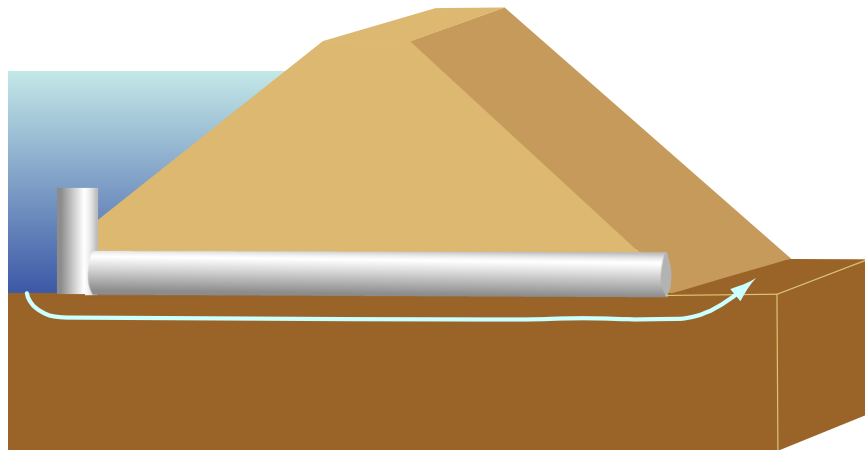
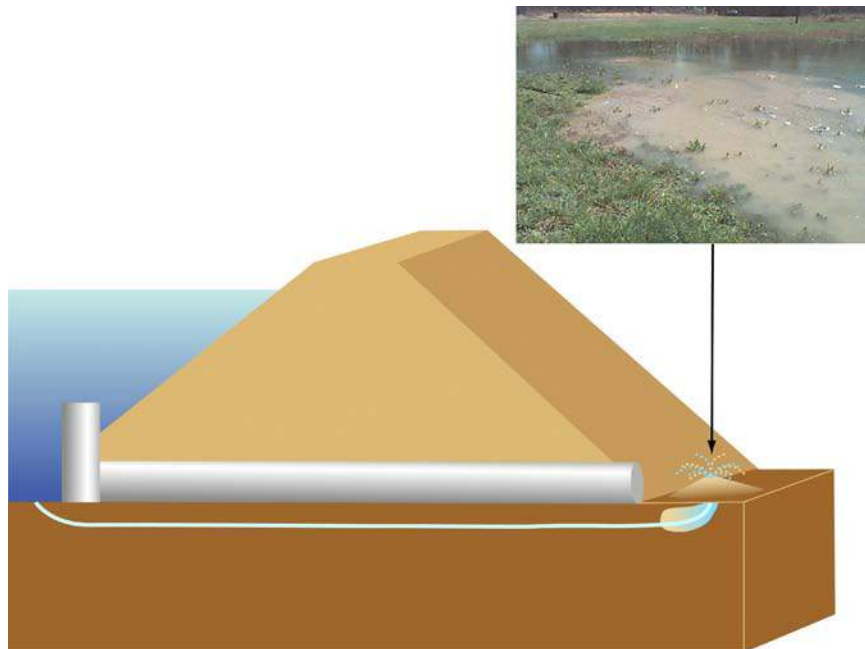
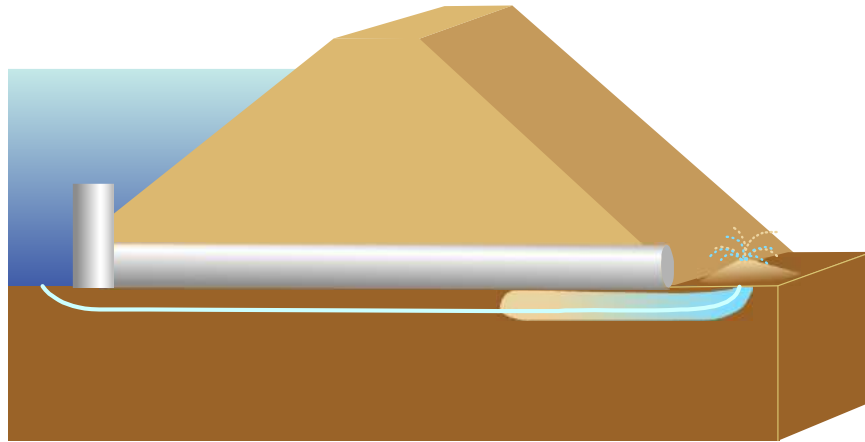
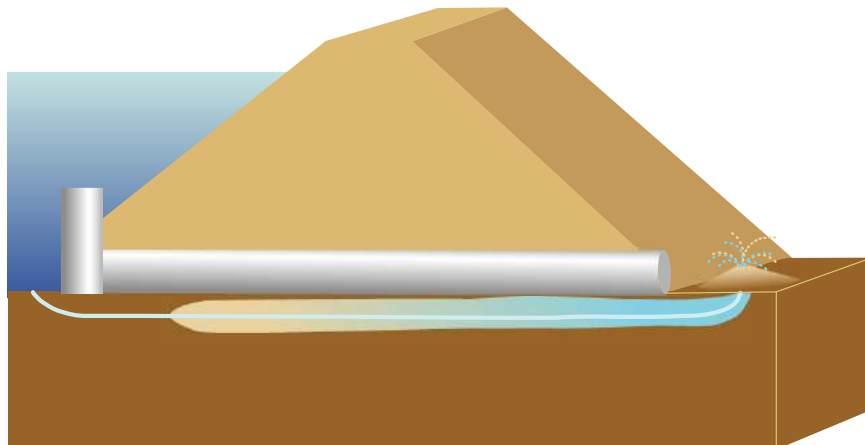
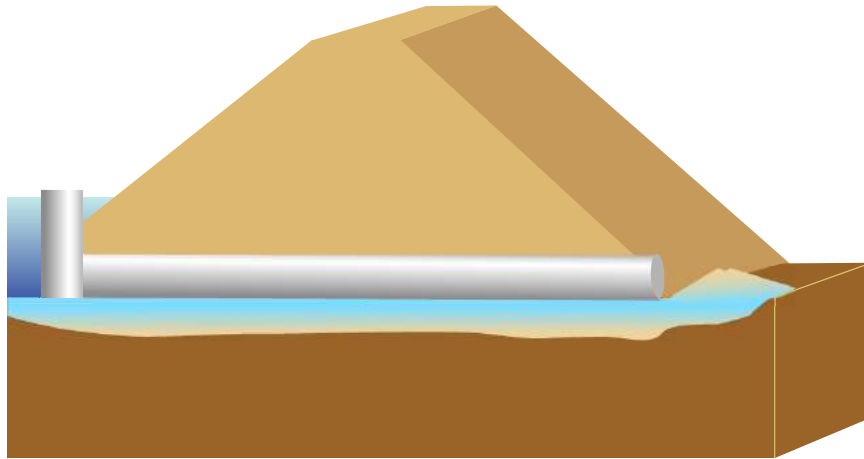
Figure 10.—The backward erosion piping process associated with intergranular seepage and the subsequent backward erosion of soil particles.

Backward erosion piping begins in fine sand foundation materials at the toe of an embankment dam. The foundation is assumed to be a soil susceptible to piping such as fine, poorly graded sand. A filter zone is not provided at the seepage discharge face (or the filter has been improperly designed), allowing backward erosion piping to begin.

Intergranular seepage flow conditions exist within the foundation under the embankment dam, and soil particles are removed. The particles are deposited (sand boils) on the ground surface at the downstream toe, or washed away if flow is higher.

The process of dislodging soil particles continues at an escalating rate because of the hydraulic gradient increase. As the backward erosion piping gets closer to the reservoir, seepage quantity also increases.

A tunnel develops due to the continued erosion of the soils in the foundation. This assumes the overlying embankment dam, foundation layer, or conduit is able to support the tunnel that is forming. The soil exposed to flow in the developing tunnel is erodible, and the walls of the tunnel can grow larger at the same time that the discharge face moves upstream.

Eventually, the tunnel erosion feature reaches the reservoir. Outflow will then increase substantially, leading to direct erosion of the embankment dam and complete breach or draining of the reservoir through the tunnel that develops.

The resulting failure often completely destroys the embankment dam, leaving few traces of the original piping tunnel. The failure of this embankment dam was attributed to piping of foundation sands. Photo courtesy of National Oceanic and Atmospheric Administration.

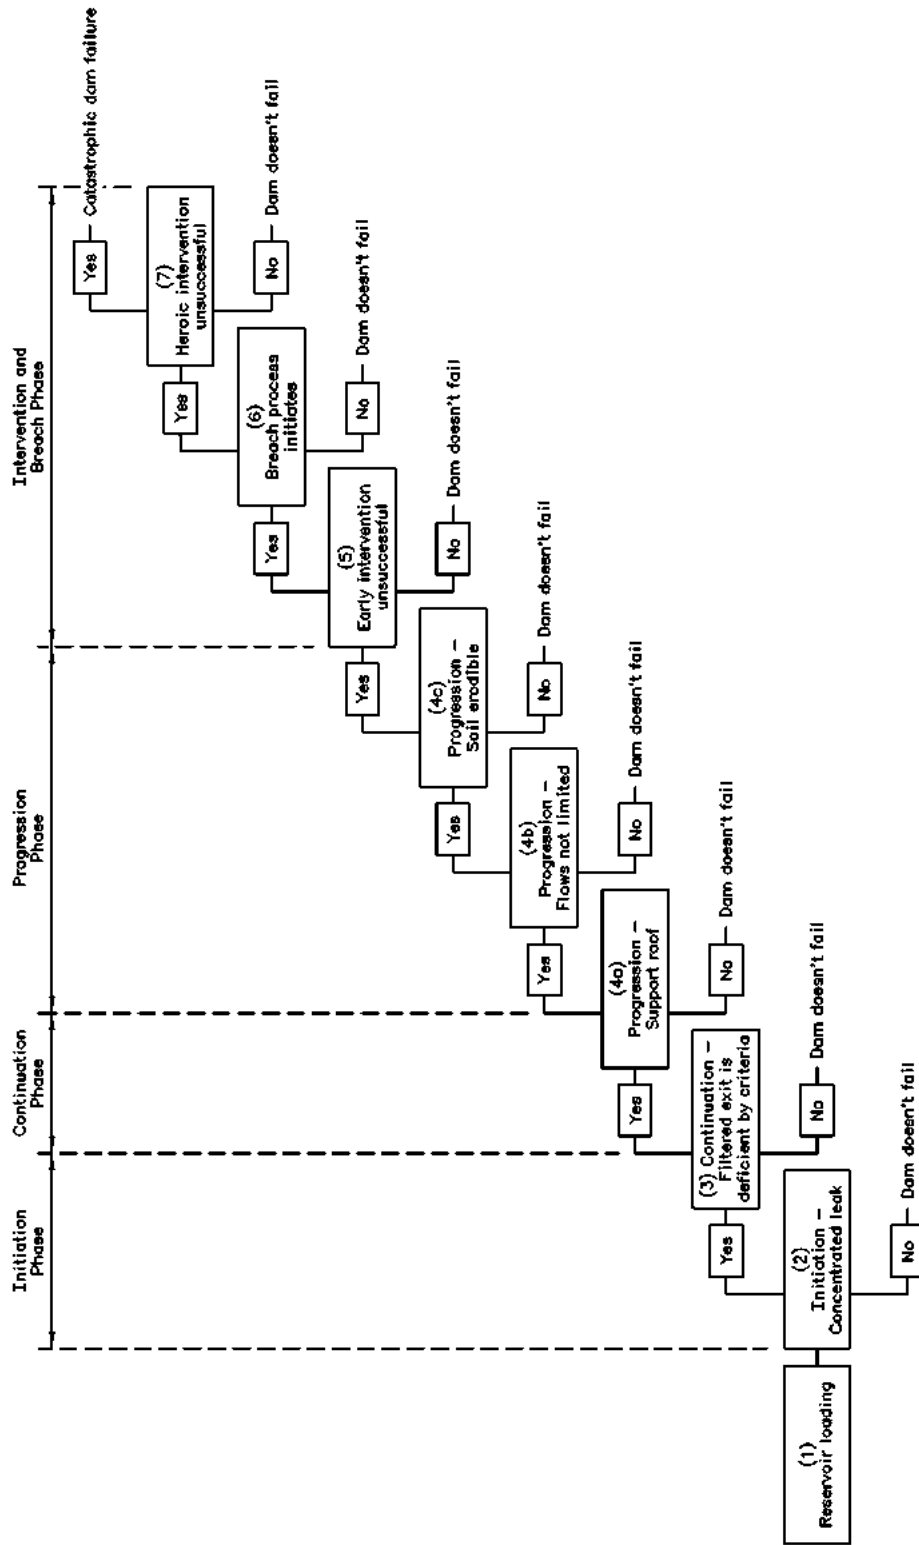
1. The reservoir rises, causing a water load on the embankment dam. The information is generally derived from the statistical historic record of reservoir operations. Normally, it is the probability of a reservoir to rise onto a portion of the embankment dam that might contain a flaw and not usually the time that the reservoir exists at a specific elevation.

Figure 11.—Example of an event tree used to illustrate the internal erosion process.

Understanding the steps involved in a failure mode as the result of internal erosion or backward piping erosion is important in designing defensive measures to prevent these failures. An event tree can be used to understand the series of events that can lead to embankment dam failure by internal erosion or backward erosion piping. An event tree used by the Bureau of Reclamation (Reclamation, 2000, p. 15) for internal erosion of an existing embankment dam is shown in figure 11. The steps or “nodes” of the event tree shown on figure 11 are generally described as follows:

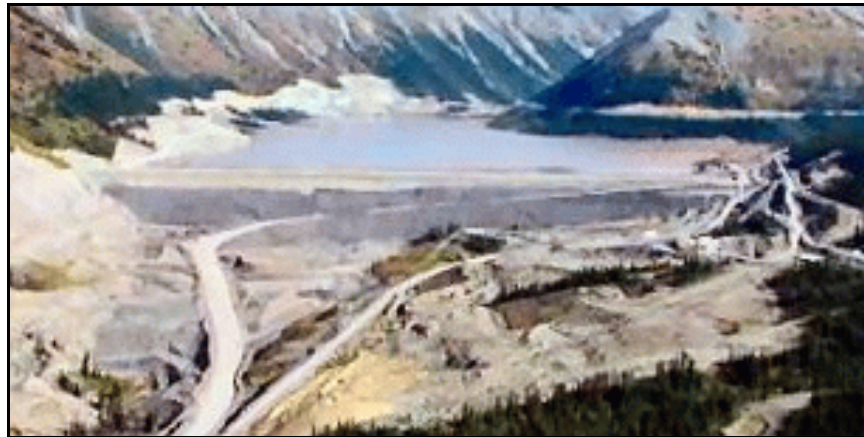
Figure 12.—An example of a tailings dam.

Tailings and slurry dams are an integral and vital component of mining operations. Tailings dams permanently retain mining, chemical, and industrial waste products (e.g., ground-up rock that remains after the mineral value has been removed from the ore). Figure 12 shows an example of a tailings dam. A slurry dam permanently retains waste created by the processing and washing of coal. These structures retain the waste products and allow them to settle out, enabling reclamation (recycling) of the slurry water, and permanent retention and eventual restoration of the site.

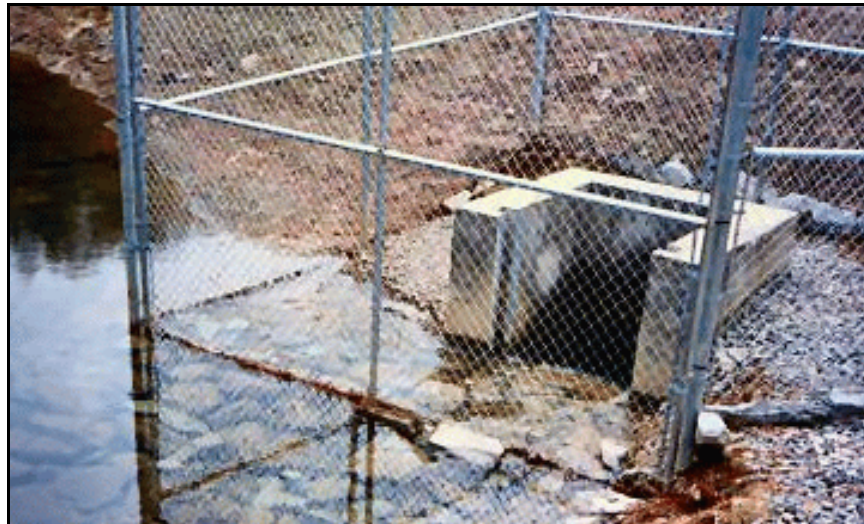
Figure 13.—An example of a decant intake structure.

In the past, decant pipes were constructed of CMP. However, in many cases the acidity of the refuse caused corrosion problems. Protective coatings were

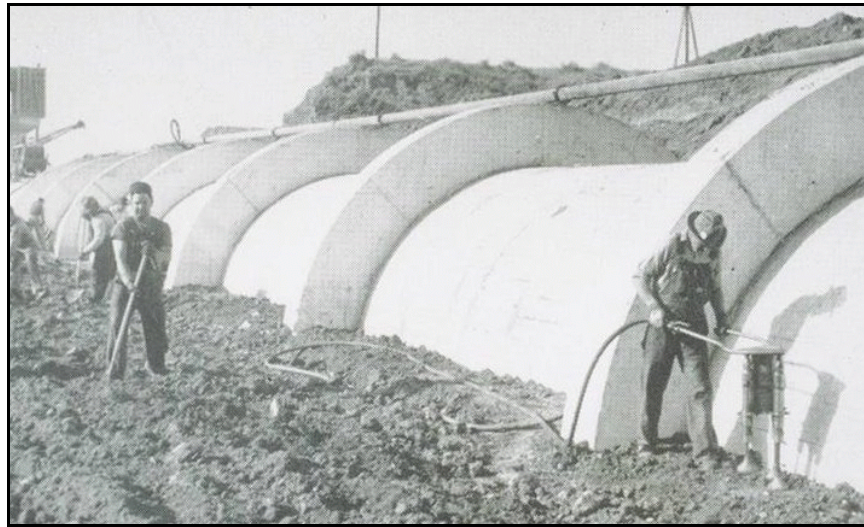
Figure 16.—Good compaction around antiseep collars was difficult to achieve.

Figures 14 through 16 show examples of the construction difficulties involved with compaction around antiseep collars. Appendix A gives a detailed history of the design rationale used for antiseep collars and reasons for their being discontinued. Figures 17 and 18 show examples of the ineffectiveness of antiseep collars in preventing embankment dam failure resulting from internal erosion near conduits.

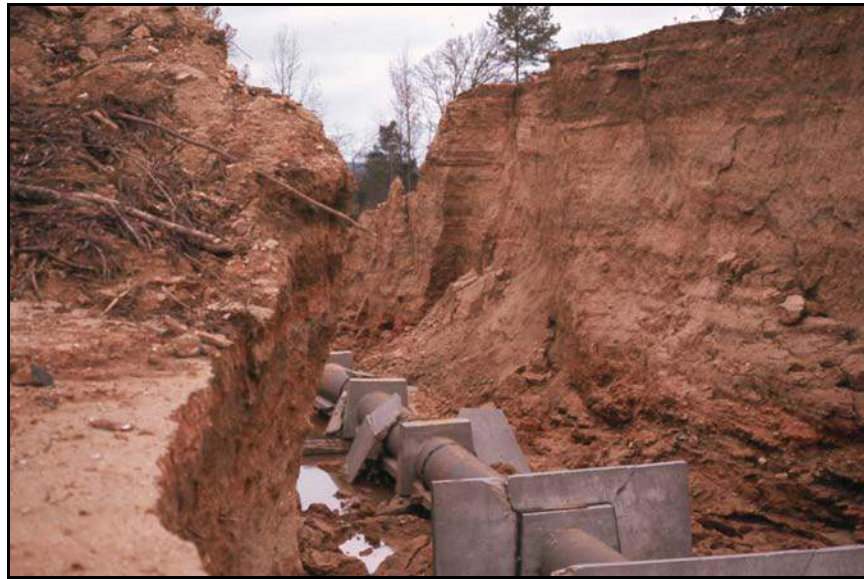
Figure 17.—Failure of an embankment dam following first filling. The failure was attributed to internal erosion because the time required for seepage to develop through the compacted embankment and cause failure was very short. Also, the soils are not the type ordinarily considered susceptible to backward erosion piping. Antiseep collars were not effective in preventing the failure.

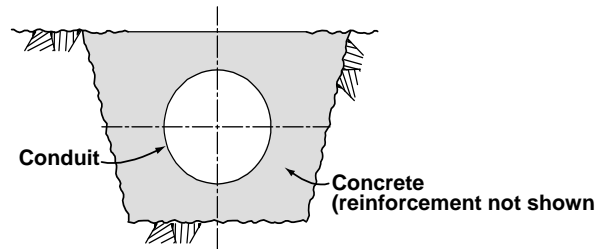
Figure 19.—Conduit constructed in a trench in firm rock.

- *Locate the conduit in a trench.*—Locate the conduit in a trench section in firm rock when the rock is at or near the ground surface (figure 19). For this option, the construction specifications should include provisions for rock excavation to be performed to eliminate or minimize open fractures or other damage to the rock beyond the limits of the excavation. Concrete should extend to an upper limit of the top of the conduit or to the original rock surface, if lower than the top of the conduit.

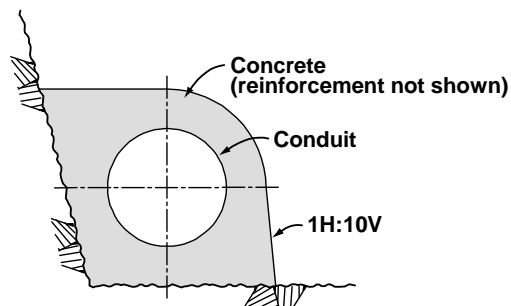
Figure 20.—Conduit cast against excavated rock slope.

- *Locate the conduit on a bench.*—Locate the conduit on a bench excavated along the base of an abutment when geological conditions and topography are favorable. Placing concrete on the abutment side or placing the conduit against the excavated rock reduces or eliminates requirements for earthfill compaction against one side of the conduit (figure 20).

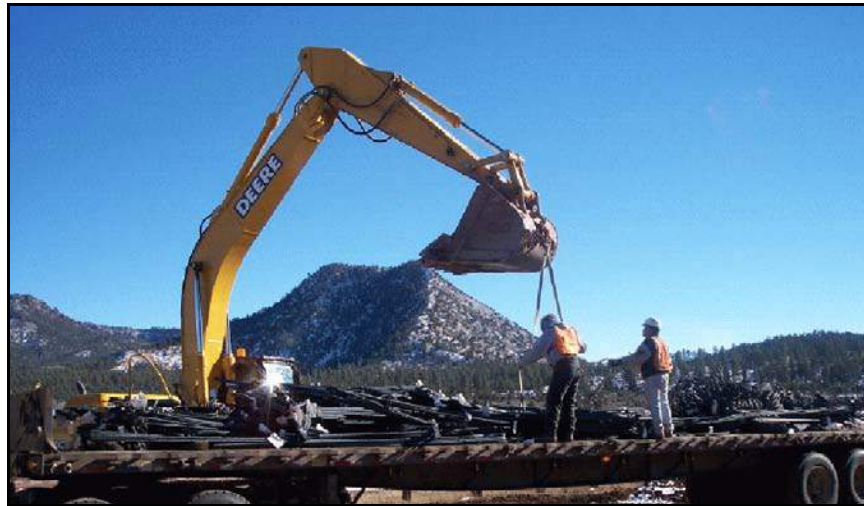
Figure 21.—Reinforcement being unloaded for use in cast-in-place concrete.

Reinforced cast-in-place concrete is placed and allowed to cure in the location where it is required to be in the completed conduit. Reinforced cast-in-place concrete is made by mixing cement, fine and coarse aggregates, sand, and water. Admixtures are frequently added to the concrete immediately before or during its mixing to increase the workability, strength, or density, or to lower its freezing point. A framework of reinforcing steel is constructed, and forms to contain the wet concrete mix are built around the reinforcement. The wet concrete mix is placed inside the forms and around the reinforcing steel. Typically, consolidation of the concrete mix is obtained by vibration. The final solidified mass becomes reinforced cast-in-place concrete. Reinforced cast-in-place concrete conduits are built at the construction site. Figure 21 shows typical reinforcement used with cast-in-place concrete.

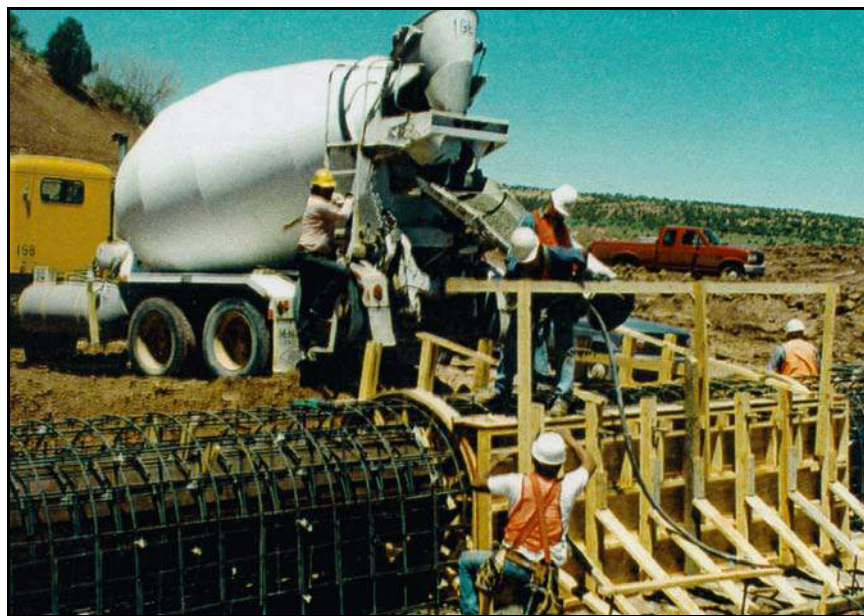
Figure 22.—Concrete placement for a reinforced cast-in-place conduit.

Reinforced cast-in-place concrete conduits (figure 22) have a long history of use by the major dam design agencies. Reinforced cast-in-place concrete conduits are very adaptable in their application and can be designed to fit specific project requirements and site conditions. A variety of design shapes are possible. For guidance on selecting the proper shape see section 4.1. Properly designed and constructed reinforced cast-in-place concrete should have a service life of 100 years or longer.

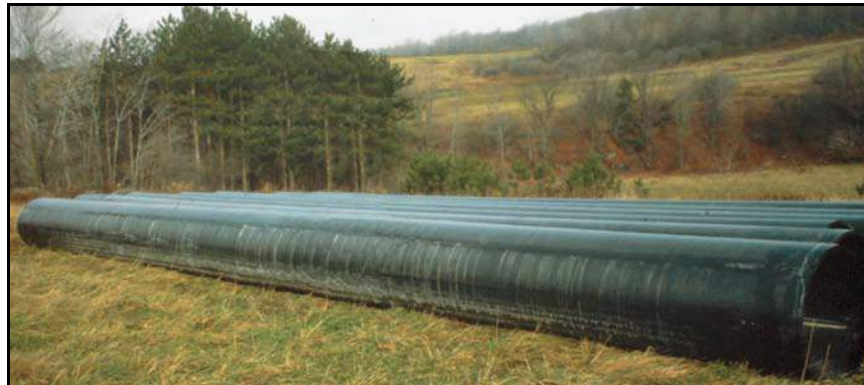
Figure 24.—HDPE pipe to be used for sliplining of an existing conduit.

Solid wall, high density polyethylene (HDPE) is the most commonly used thermoplastic material for sliplining of existing conduits. Figure 24 shows an example of HDPE pipe. HDPE pipe is an inert material and as such is not subject to corrosion or deterioration, has a long service life, and requires little maintenance. This is especially important in small conduits that are not easily renovated and cannot be easily inspected. HDPE has been used in sliplining of existing conduits, since the early 1980s. HDPE is typically available in sizes up to 63 inches in diameter. The manufacturer can fabricate HDPE pipe fittings, such as bends, flanges, reducers, and transitions. Specialized fittings can also be custom fabricated. HDPE pipe is typically black. However, HDPE pipe is also available with gray and white pigmentation to reduce glare and improve conduit inspection using closed circuit television (CCTV) equipment. For guidance on the use of HDPE pipe in conduit sliplining applications, see section 12.1.1.

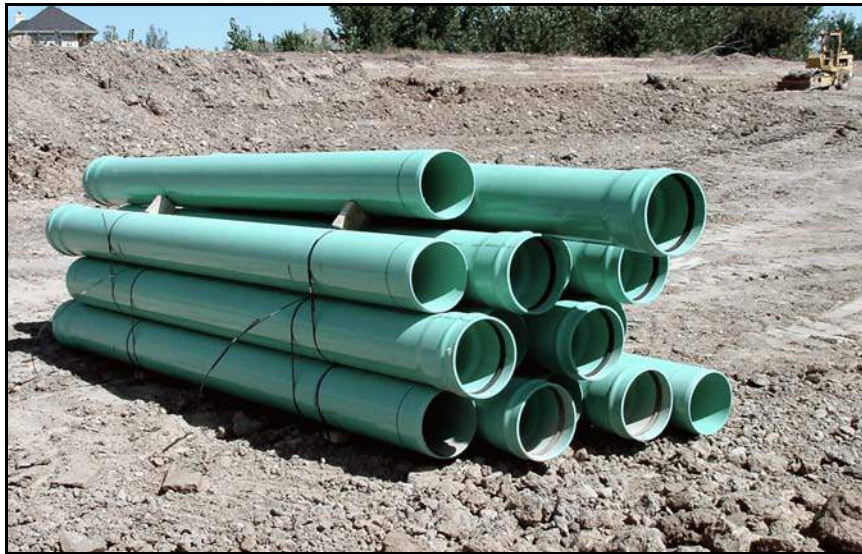
Figure 25.—PVC pipe has infrequently been used in conduit applications within low hazard embankment dams. The bell and spigot joint connection used for this type of pipe limits its use for most conduits.

PVC pipe (figure 25) is not as commonly used as HDPE pipe as a conduit or slipliner due to concerns with lack of watertightness and other inherent disadvantages. The major disadvantage with PVC pipe is the bell and spigot joint connections. This type of joint connection has the potential for leakage or can separate as the embankment dam settles. The bell and spigot joint integrity must be tested for leaks to ensure that the gasket has not rolled off during installation. Use of PVC bell and spigot joints should only be considered for nonpressurized, low hazard dam applications. PVC is typically available in sizes up to 48 inches in diameter.

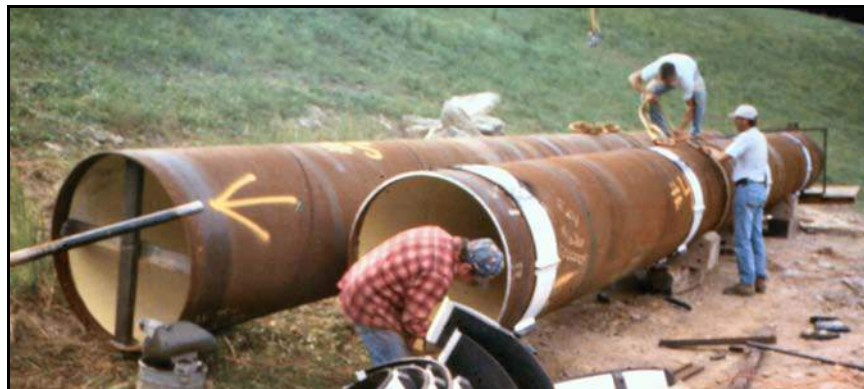
Figure 27.—Steel pipe slipliner being prepared for insertion into an existing conduit.

Steel pipe has been used in some sliplining applications (figure 27), but has more often been used as a liner in reinforced cast-in-place conduits. Steel pipe has been used in sliplining of existing conduits since the 1980s. Steel pipe used as conduit liner has been used since about the early 1920s. The advantages of using steel pipe for conduits include:

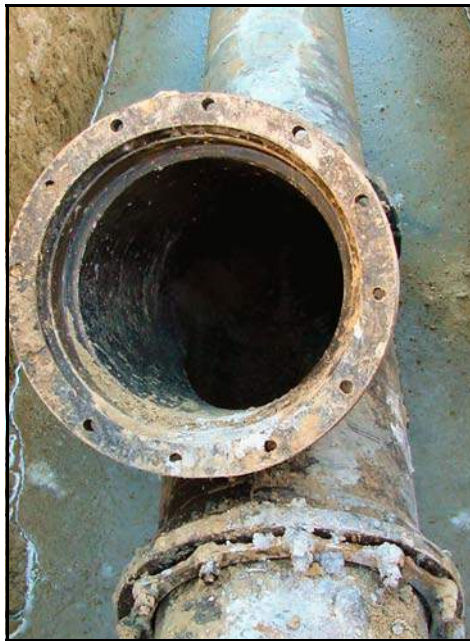
Figure 29.—Flanged joints of ductile iron pipe improve the watertightness of the joint.

- Manufactured to tight tolerance in a controlled environment.
- Long service life, if proper linings and coatings are used.
- High tensile and compressive strength.
- Flanged joints (figure 29) provide improved watertightness over bell and spigot connections.

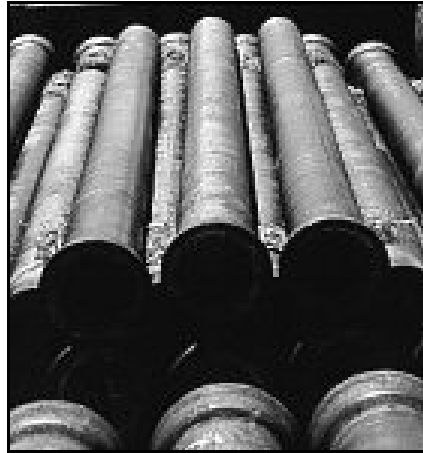
Figure 30.—Cast iron pipe is not considered acceptable for use in conduit applications.

Cast-iron is metallic iron containing more than 2 percent dissolved carbon within its matrix and less than 4.5 percent (as opposed to steel, which contains less than 2 percent). Cast-iron (figure 30) pipe cannot be wrought, so it must be manufactured by casting in a foundry. The molten iron is poured into a vertical annular mold. The mold is removed after the iron cools and solidifies. Commercial availability of cast-iron pipe typically is up to 15 inches diameter. Cast-iron pipe has been around for centuries, and used for storm water and sewer systems. The available length for single pieces is up to 40 feet. Many cast-iron pipes have been in service over 100 years.

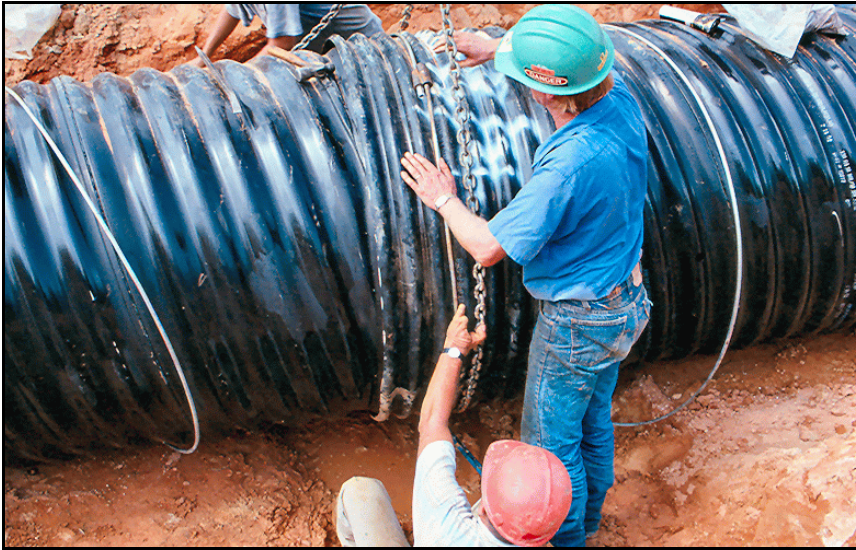
Figure 31.—A CMP conduit being installed.

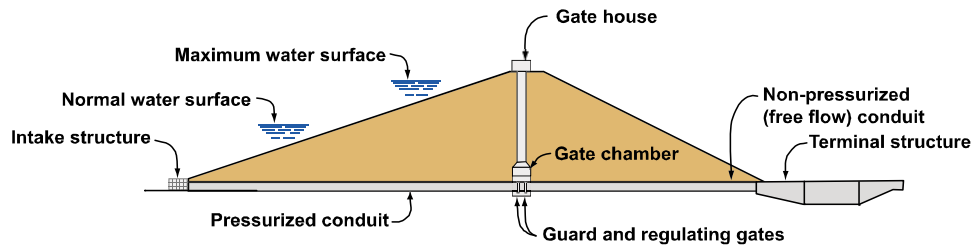
Figure 34.—Arrangement 2—Intermediate control without downstream access.—The control feature is located at an intermediate point within the conduit.

- Arrangement 1—Intermediate control with downstream access (figure 33)
- Arrangement 2—Intermediate control without downstream access (figure 34)
- Arrangement 3—Upstream control (figure 35)

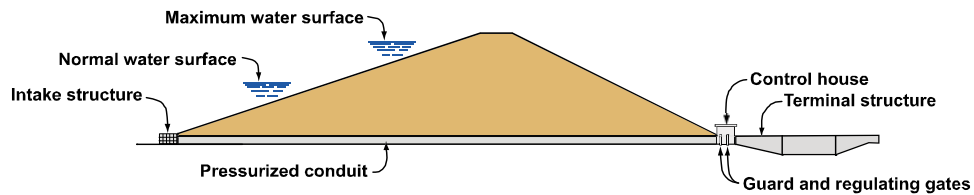
Figure 36.—Arrangement 4—Downstream control.—The control feature is located at the downstream end of the conduit.

In this type of arrangement (figure 36), gates or valves are located at or just upstream of the terminal structure (on the downstream side of the embankment dam). The specific aspects of this arrangement are:

- *Flow conditions.*—Pressure flow exists throughout the entire length of conduit from the intake structure to the gates or valves at the terminal structure.
- *Design considerations.*—The external hydrostatic pressure around a conduit normally diminishes with increasing distance from the reservoir. At the downstream portion of the pressure conduit, there may be excess internal hydrostatic pressure. The potential exists for leakage out of the conduit

- *Access.*—Access for inspection and maintenance can be seldom (i.e., either the reservoir must be drained, or divers must perform inspections after gates or valves are closed, or the conduit must be unwatered after an upstream bulkhead is installed). At some sites, a submerged upstream gate or valve is provided for closure to facilitate access for inspection. Arrangement 4 is discouraged unless the embankment dam is low hazard with minimal downstream consequences.

- *Risk.*—This type of arrangement is considered to have more risk than arrangements 1, 2, and 3. If the conduit develops a defect upstream from the downstream control structure, a high pressure differential will exist due to the internal hydrostatic pressure from the full reservoir head and the lack of external hydrostatic pressure. A conduit defect in the area upstream from the control structure could result in water flowing out of the conduit. In this arrangement, no emergency closure exists upstream from the control structure. Even if an upstream emergency closure gate is provided in a submerged intake structure, a leak from a defect in the conduit may not be identified in time to prevent an embankment dam failure.

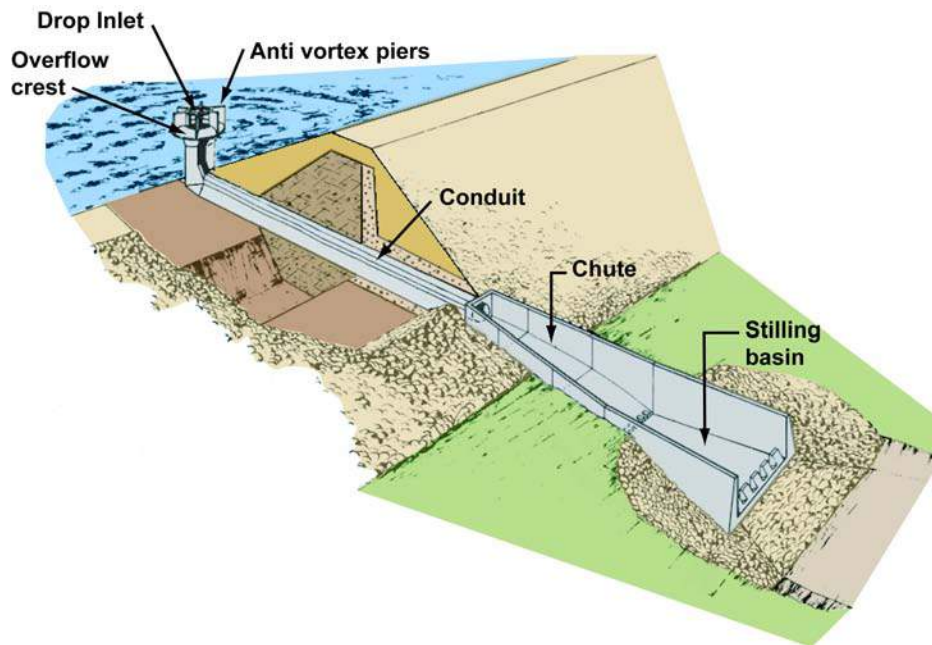
Figure 39.—A drop inlet spillway conduit through an embankment dam.

Spillways utilizing conduits are generally shaft or drop inlet type. These types of spillways typically consist of an entrance (crest) structure with or without control devices, a conduit, and a terminal structure. Figure 39 shows an example of a drop inlet type of spillway called a morning glory. The drop spillway is often referred to as a “principal spillway.” Figure 40 shows an example of a riser structure for a principal spillway. A spillway provides flood control regulation for floods, either in combination with an outlet works, or as the only flood control facility. Typically, the spillway is used to release surplus water or floodwater that cannot be contained in the allotted reservoir storage space. The discharge capacity of a spillway conduit is determined by the results of flood routings and is influenced by the flood surcharge volume available above the spillway crest. Where little flood surcharge volume is available, the spillway must be large enough to pass the peak of the flood. If the reservoir has a large storage capacity above the normal water surface, a portion of the flood volume can be retained temporarily, and the spillway discharge capacity may be considerably reduced.

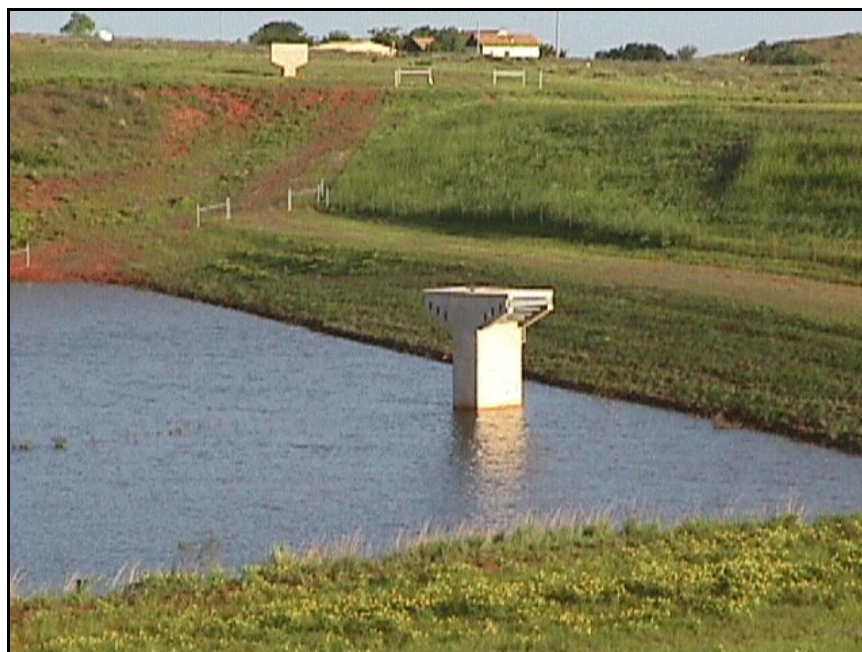
Figure 40.—The riser structure for a principal spillway.

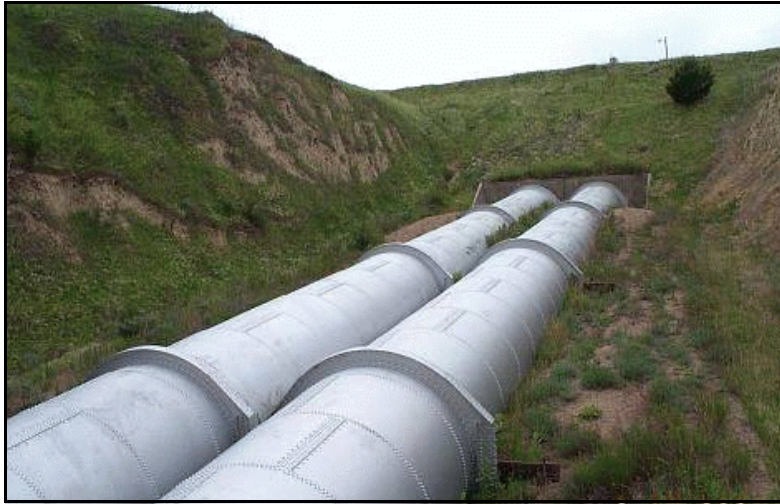
Figure 41.—Penstocks extending through an embankment dam.

Power conduits (also known as “penstocks”) are used to transport water from an intake structure located in the reservoir to a downstream facility for the generation of power. Figure 41 shows an example of penstocks extending through an embankment dam. The power conduit typically operates in a pressurized condition. The power conduit is usually constructed of steel pipe encased by reinforced

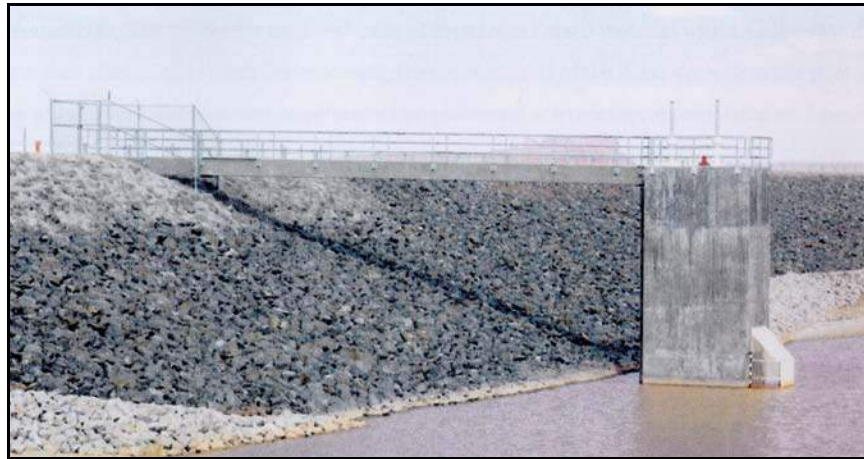
Figure 42.—Typical outlet works intake structure.

Intake structures.—In addition to forming the entrance to the conduit, an intake structure may accommodate control devices, support necessary auxiliary appurtenances (such as trashracks, fishscreens, and bypass devices), and include temporary diversion openings and provisions for installation of bulkhead or stoplog closure devices.

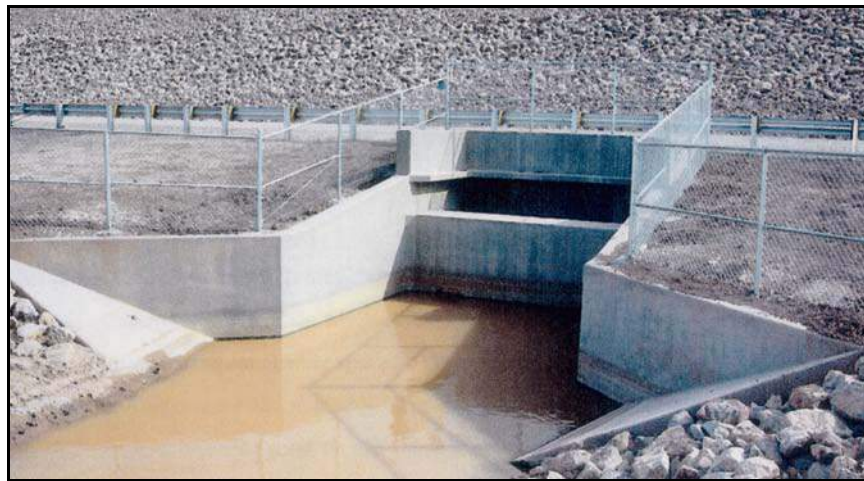
Figure 43.—Typical outlet works terminal structure.

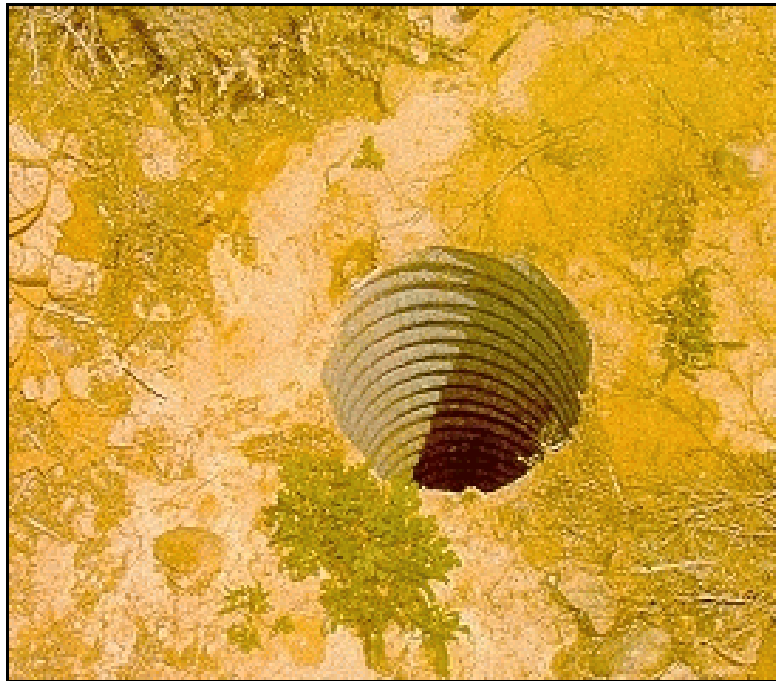
Figure 44.—No intake structure exists for this outlet works. This conduit is prone to plugging with trash and debris.
