Technical Manual: Conduits through Embankment Dams

Best Practices for Design, Construction, Problem
Identification and Evaluation, Inspection,
Maintenance, Renovation, and Repair

September 2005

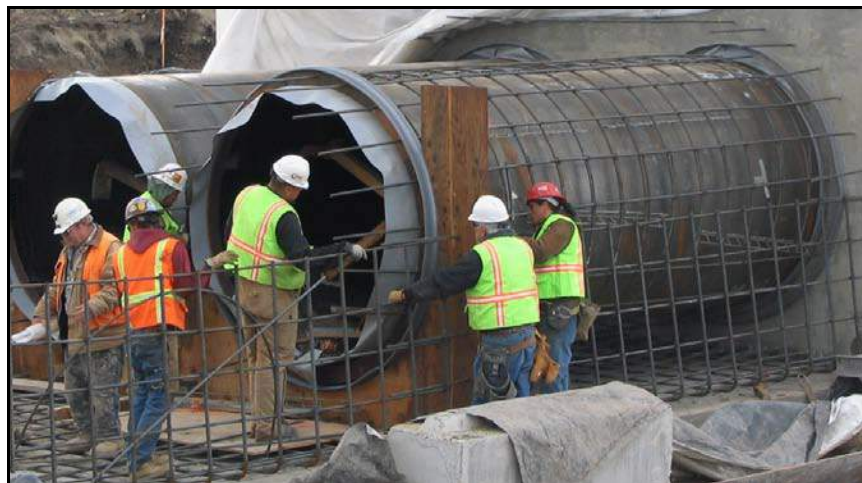
Figure 53.—A multibarrel outlet works conduit under construction.

In some special situations, double or triple barrel conduits may be required. Operational and/or flow capacity requirements usually determine the number of barrels required. Structural design of multibarrel conduits should adhere to the guidance in this section. Figure 53 shows an example of a double barrel conduit under construction.

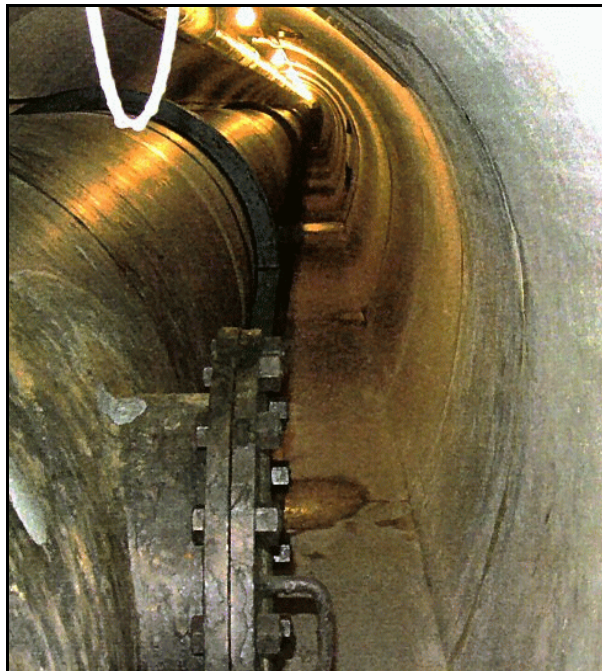
Figure 55.—An example of the interior of conduit shape B.

Figures 54, 55, and 56 show the interiors of conduit shapes A, B, and C, respectively. Conduit shape A is typically used for pressure flow. Conduit shapes B and C are typically used for nonpressurized flow conditions. Conduit shapes B and C are also used as the larger downstream access conduit in arrangement 1, as discussed in

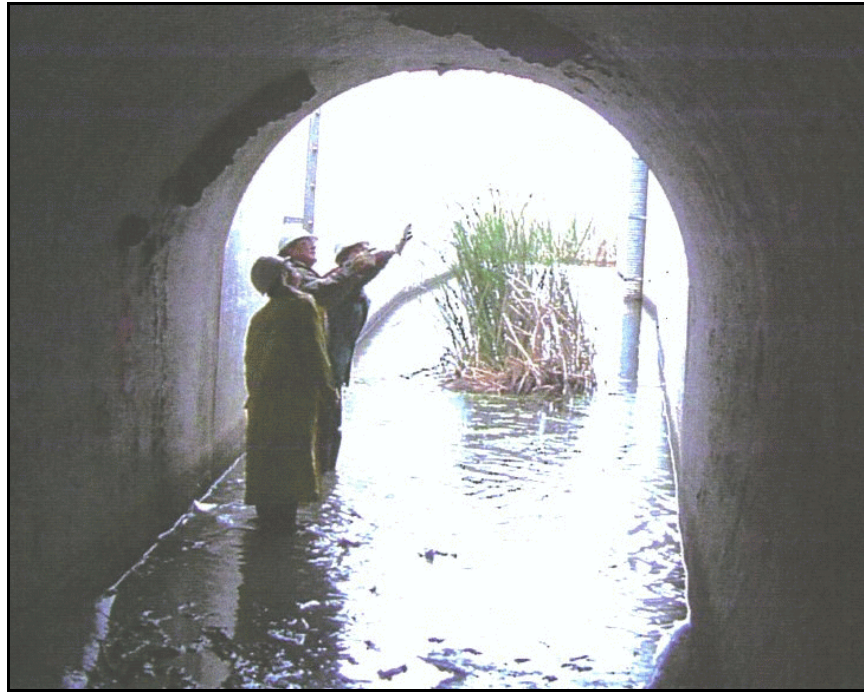
Figure 56.—An example of the interior of conduit shape C.

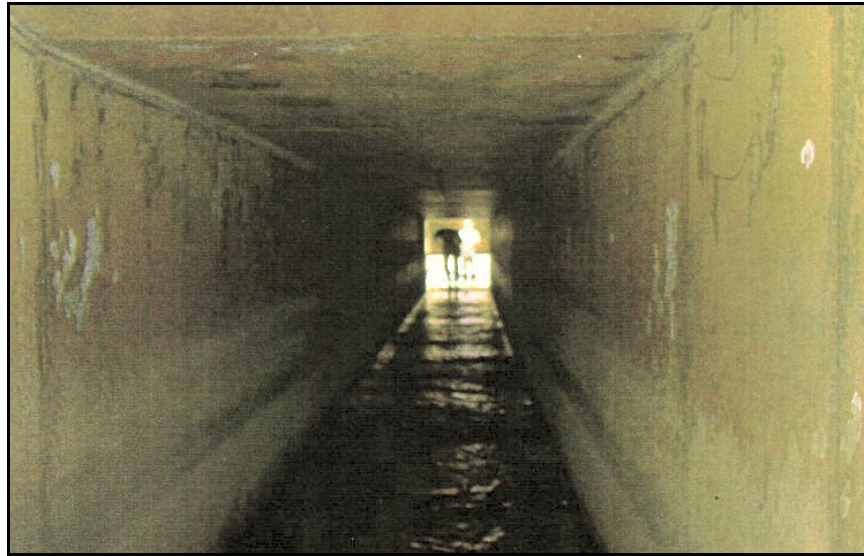
Figure 59.—A box shape is not commonly used for conduits. The designer needs to carefully consider the advantages and disadvantages of this shape.

advantages and disadvantages of this shape before making a final selection for use. Figure 59 shows an example of the interior of a box shape.

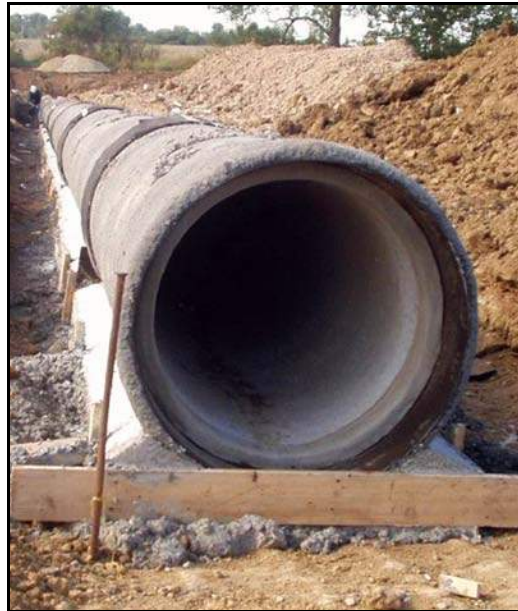
Figure 60.—Precast concrete using bedding as support.

Designers of conduits through low hazard embankment dams often use concrete bedding beneath fully circular conduits. Bedding generally comes up to about 25 percent of the conduit height to provide support and facilitate compaction under the haunches. Bedding often has joints located at the circular pipe joints so as to not interfere with pipe movement. Figure 60 shows a precast circular conduit using bedding for support. For guidance on the use of bedding in conjunction with fully circular conduits, see NRCS's *The Structural Design of Underground Conduits* (1958) and USACE's *Culverts, Conduits, and Pipes* (1998a). The selection of whether to use cradles or bedding is typically a function of the height of the embankment dam. Cradles are often used for higher dams, where more lateral support is required. Regardless of whether a cradle or bedding is used, the use of a filter diaphragm or collar is a valuable defensive design measure that should be employed, even for low hazard classification sites with favorable conditions.

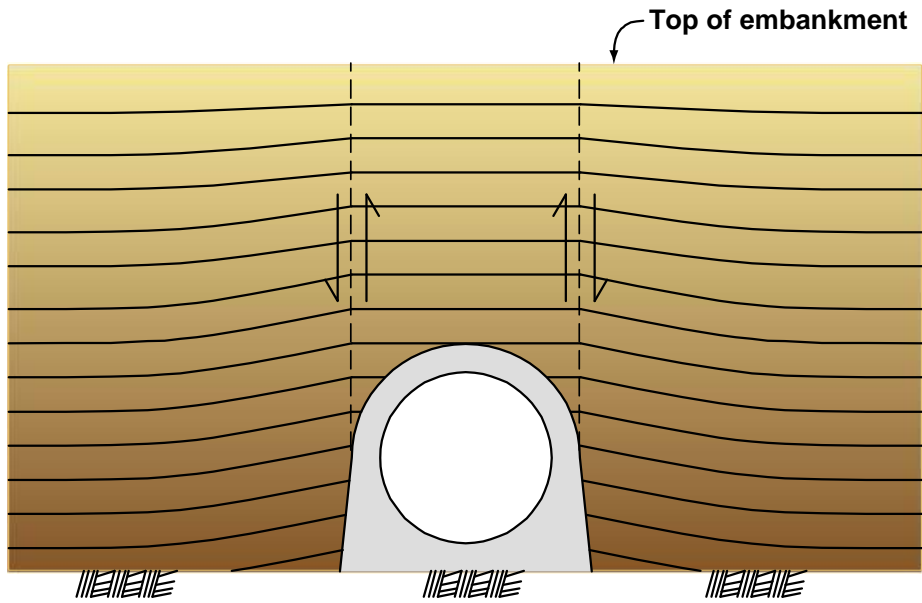
Figure 61.—Conduit constructed prior to earthfill placement. Friction factors increase embankment load on the conduit as adjacent earthfill settles more than earthfill overlying the conduit.

to be a combination of the weight of the fill directly above the conduit and the frictional forces, acting either upward or downward, from the adjacent fill. This loading is also known as the “projection” condition. When the adjacent fill settles more than the overlying fill, downward frictional forces are induced, which can increase the resultant load on the conduit by as much as 50 percent of the weight of the fill above the conduit (figure 61). Conversely, a greater settlement immediately above the conduit results in an arching condition, which reduces the load on the conduit by as much as 50 percent of the weight of the fill above the conduit (figure 62). This loading is also known as the “trench” condition. This condition may occur for conduits placed in a trench. Some publications indicate that higher increases in load may be applicable (by as much as 200% over the prism load based on the Marston theory); see NRCS’s *The Structural Design of Underground Conduits* (1958, p. 1-7). The practice of constructing conduits within trenches with vertical side walls in embankment dams is not recommended. Loss of positive contact of the fill next to the conduit is possible due to the effects of arching. For guidance on the selection of proper excavation for side slopes, see section 5.1.

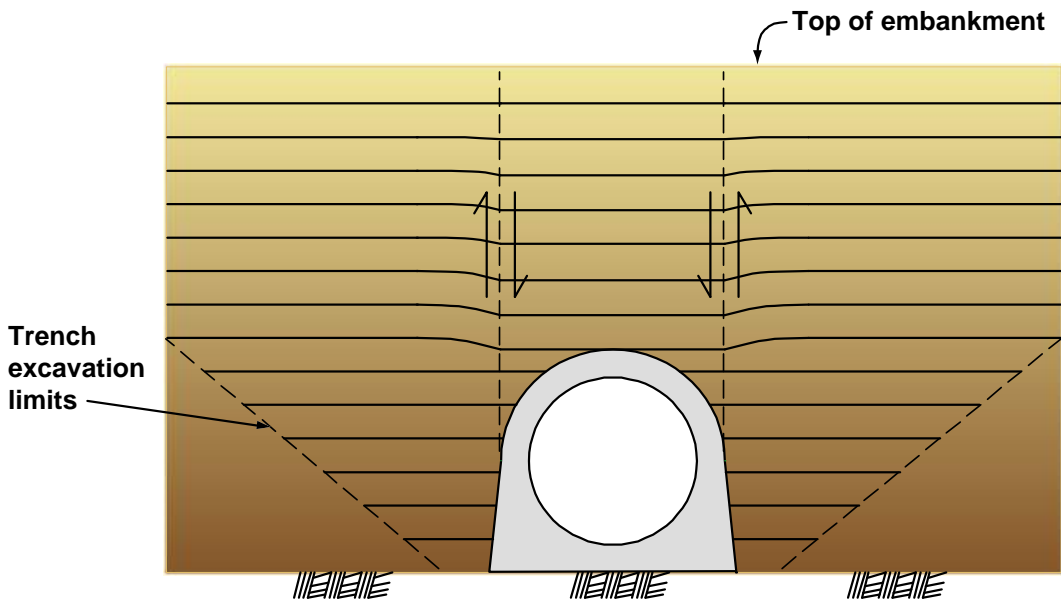
Figure 62.—Conduit constructed within a trench excavated into the embankment. Friction factors decrease embankment load on the conduit as earthfill over conduit settles downward relative to adjacent embankment.

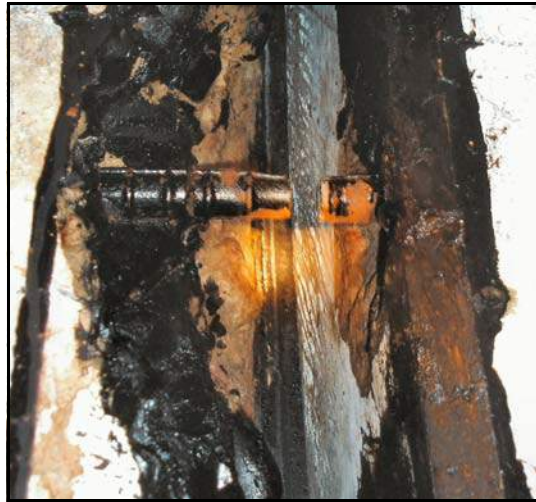
Figure 63.—Longitudinal reinforcement across a conduit joint experienced tensile failure caused by lateral spreading of the embankment dam.

the conduit and for bending stresses due to nonuniform foundation conditions along the length of the conduit section. Figure 63 shows an example of longitudinal reinforcement that experienced tensile failure caused by lateral spreading of the embankment dam.

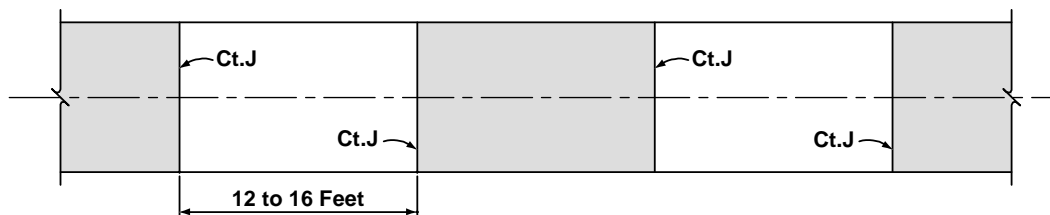
Figure 64.—Concrete placement for a reinforced cast-in-place conduit.

Reclamation's experience has shown that cracking in reinforced cast-in-place conduits due to shrinkage and temperature can be minimized by placing conduits in 12- to 16-foot sections (figure 64). The interfaces between conduit sections are typically control joints. Control joints are used to provide for control of initial shrinkage stresses. Waterstops should be used across all control joints, and a bond breaker, such as curing compound, should be applied to control the joint surfaces to direct cracking toward the joints. The longitudinal reinforcement is continuous across the control joint to limit movement between adjoining ends of conduit sections. The conduit sections should be constructed in an alternating pattern, such that any concrete volume shrinkage occurs prior to adjoining conduit sections being placed. The preferred placement method for transverse sections of concrete in small

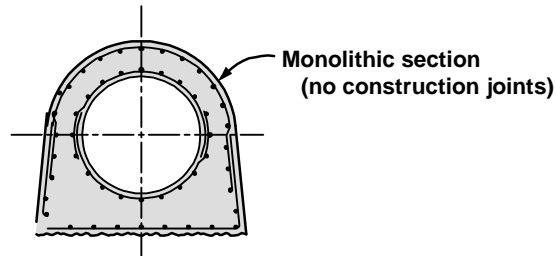
Figure 65.—Concrete placement for a reinforced cast-in-place conduit.

conduits (less than 3 feet in diameter) is by continuous placement, to ensure monolithic integrity (figure 65). In larger conduits, horizontal construction joints typically located at springline have been used to facilitate concrete placement. Horizontal construction joints are also useful in preventing flotation of steel liners during concrete placement. For guidance on the use of control and construction joints and waterstops, see section 4.3. For guidance on construction practices for the placement of concrete, see Reclamation's *Design of Small Dams* (1987a, p. 659), and the USACE's *Standard Practice for Concrete for Civil Works Structures* (2001b).

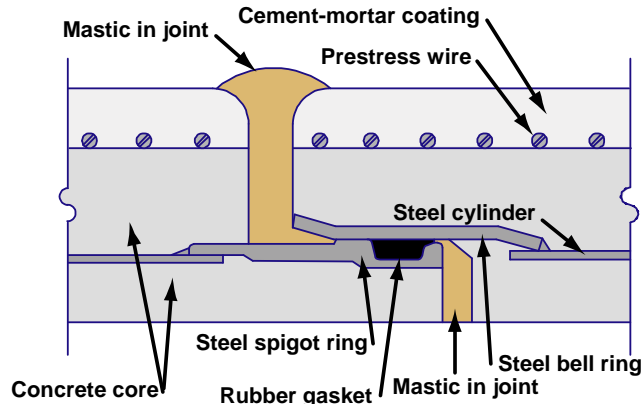
Figure 68.—Prestressed concrete cylinder pipe (PCCP) details (lined cylinder).

engaged to the fully extended condition of the joint when the adjoining pipe sections are in parallel, concentric alignment while maintaining full confinement of the gasket. The joint limiting angle of the joint is defined as the maximum deflection angle between adjoining pipe sections that the joint will permit before the outer surface of the spigot comes into direct contact with inside of the mating bell or sleeve. Part of the elongation and rotational capacity of the joint to accommodate expected settlement and movement along the conduit is lost due to installation tolerances and designed conduit camber. Standard and deep joints are usually available from most manufacturers. Where joint capacity is inadequate, shorter lengths of pipe can be used to decrease the movement of each individual joint. Figures 66, 67, 68, and 69 illustrate the joint details of AWWA C300, C301, and C302, as RCCP, PCCP, and RCP respectively.

For all precast concrete pipe, a rubber gasket (figures 66-69) provides the primary barrier against movement of water or soil into or out of the conduit. The spigot end

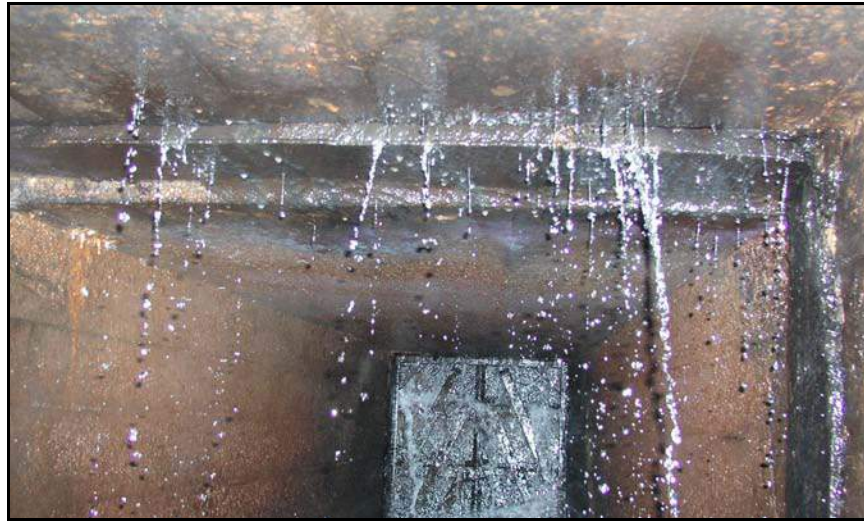
Figure 70.—Water seeping through a joint in an outlet works conduit. The joint has experienced differential settlement. This joint had no longitudinal reinforcement extending across the joint. The mortar joint filling has cracked and deteriorated.

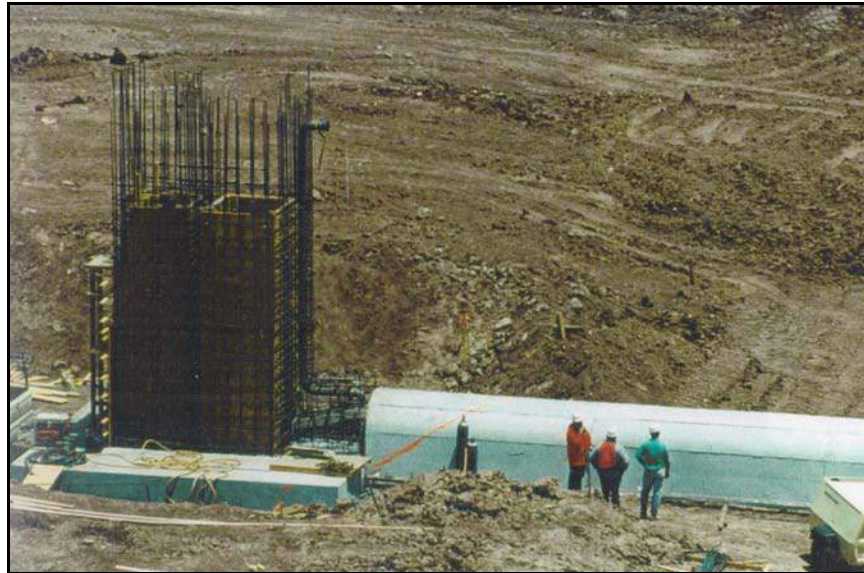
Figure 72.—Special design considerations are required in locations where differential settlement between two structures can occur.

Special precautions should be taken for joints where the conduit connects to a structure, such as an intake structure (figure 72). This location may be in an area susceptible to differential settlement due to the differing weights of the two structures and the foundation beneath them. An engineered fill to limit settlement may be needed under the intake structure, when the structure and conduit cannot be located on bedrock or a firm foundation. If the intake structure is constructed on a pile foundation, special precautions are also required for the first few joints of the conduit because high stresses can develop as a result of bending stresses caused by differential settlement. Extending the conduit and locating the intake structure beyond the limits affected by the embankment dam can reduce these stresses.

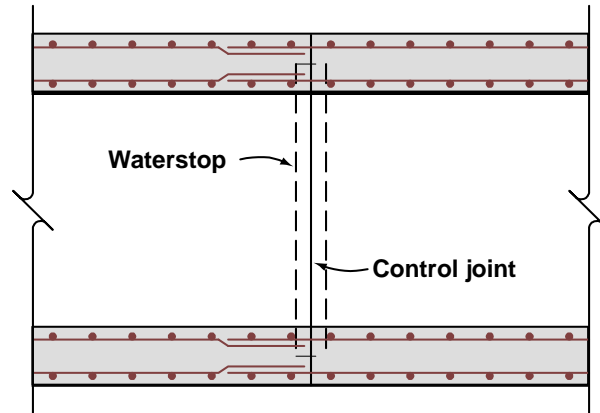
Figure 73.—Typical control joint used in reinforced cast-in-place concrete conduit construction. Longitudinal reinforcement is continuous through the joint.

- *Control joints.*—Control joints are typically used in reinforced cast-in-place concrete conduit to provide for control of initial shrinkage stresses and cracks of monolithic units. Control joints are constructed as described for contraction joints, except that reinforcement is always continuous across the joint. The reinforcement prevents the longitudinal forces from opening the joints. Waterstops should be placed across control joints to provide a watertight seal. The surface of concrete first placed at joints should be coated with sealing compound, so no bond develops between the ends of adjoining conduit sections. Figure 73 illustrates a typical control joint used in conduit construction. These joints are very effective in minimizing differential movement between conduit sections. A minimum of 7 days should elapse between adjacent placements at vertical control joints and 3 days between adjacent placements at horizontal joints.

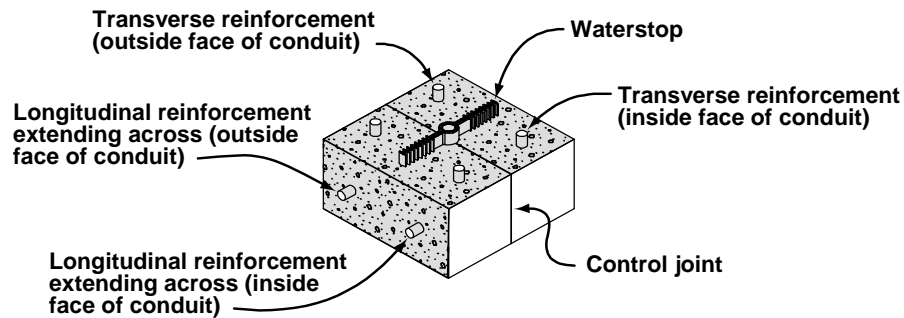
Figure 75.—Waterstop is placed across the joints of conduits to stop water from coming through the joint.

Waterstops are used to prevent the movement of water through joints of reinforced cast-in-place concrete conduits. Figure 75 illustrates how a waterstop is typically placed across the joint of a reinforced cast-in-place conduit. Waterstops are available in a variety of materials and shapes. The most common waterstops used in conduit construction are typically made of preformed flexible materials, the basic resin of which is virgin PVC. The waterstop is fabricated, such that the cross section is dense, homogeneous, and free from porosity and other imperfections. The waterstop is specially shaped, so it will interlock with the concrete. Figure 76 shows a waterstop with ribbed sides and a centerbulb profile. This type of waterstop (also referred to as dumbbell shaped) is very versatile, and the centerbulb can accommodate lateral, transverse, and shear movements. Larger centerbulb diameters are available to accommodate larger anticipated movements.

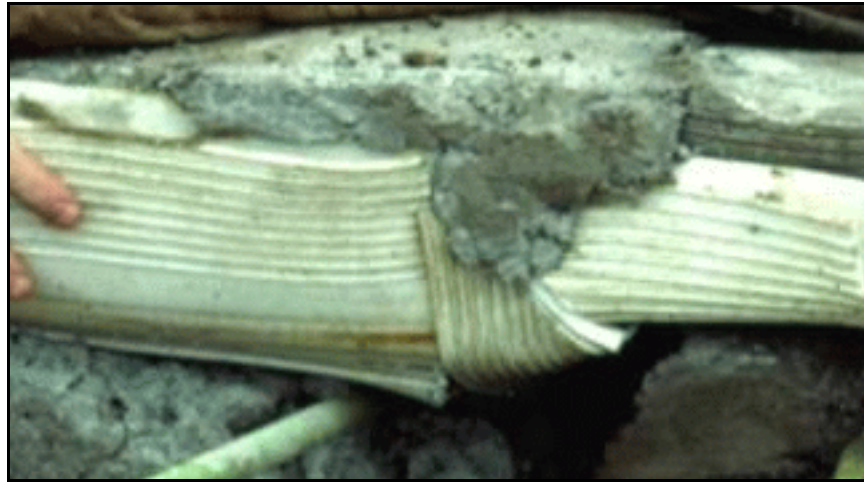
Figure 77.—A poorly secured waterstop moved during concrete placement.

- *Poorly secured waterstop.*—Poorly secured waterstop can result in uneven embedment or an undulating alignment. A poorly secured waterstop can move during concrete placement and may become ineffective in preventing the movement of water through the conduit joint. Figure 77 shows an example of a poorly secured waterstop that experienced movement during concrete

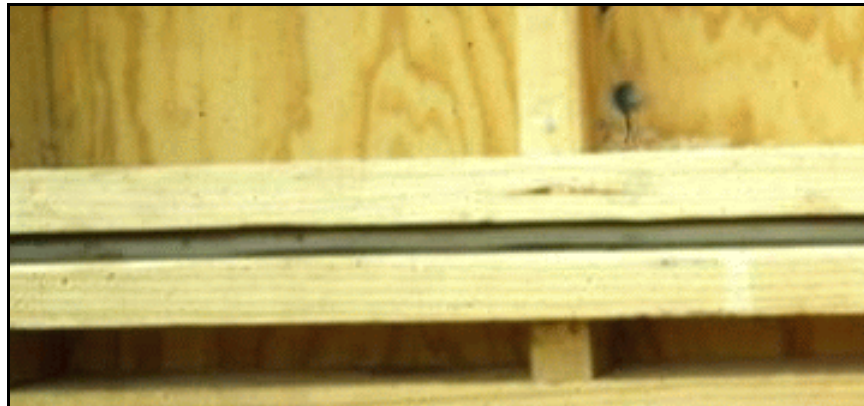
Figure 78.—Waterstop held firmly in place by use of a specially cut slot in the form.

placement. The most secure way to support waterstop during concrete placement is with the use of properly built forms (commonly referred to as split forms). Figure 78 shows an example of a waterstop inserted through a specially cut slot in the form. Additional support is provided to the waterstop on the nonplacement side, to ensure no movement occurs. Proper waterstop installation requires that one-half of the waterstop be embedded on each side of the joint. Nailing, stapling, or insertion of wire through the waterstop should not be allowed, since this may affect the integrity of the material and shorten the seepage path around the waterstop. Often contractors use hog ring fasteners crimped along the edge of the waterstop and wired to reinforcing steel to secure the waterstop. If hog rings are used, extreme care should be exercised not to pierce the waterstop when crimping, since this could result in shortening of the seepage path around the waterstop. Also, reinforcing bars should not be allowed to penetrate the waterstop.

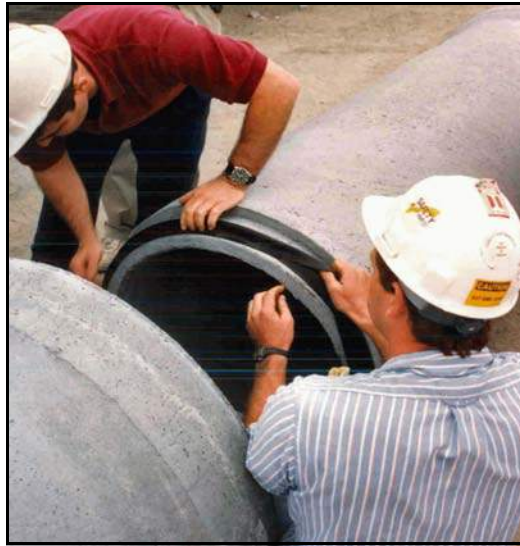
Figure 79.—A rubber gasket is installed at the spigot end of the precast concrete pipe.

of the joint is fabricated to contain a rectangular recess that holds a continuous solid rubber ring of circular cross section. The rubber gasket is compressed when the spigot is pushed into the bell end of the joint. Figure 79 shows an example of a rubber gasket being installed on a precast pipe. The gasket and steel rings, if used, are manufactured to high tolerances to ensure a reliable high pressure seal. Lubricating the gasket and inside face of the bell with vegetable soap can ease assembly. In embankment dams, a mastic sealing compound (figures 66-69) and metal or geotextile bands are typically placed around the outside length of the joint to prevent any movement of soil backfill into the joint space that might interfere with future joint movement.

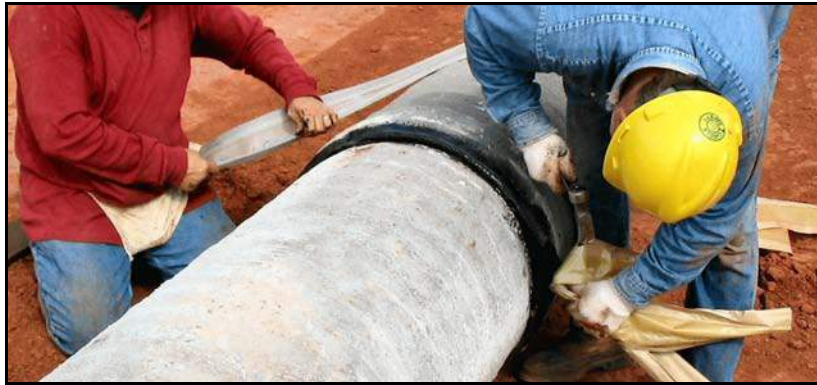
Figure 80.—Mastic being applied to exterior annular joint space of precast concrete pipe.

- A sealing compound (mastic) shall be applied to completely fill the exterior annular space between the placed pipe sections. Figure 80 shows mastic being applied to the annular space of a precast pipe.

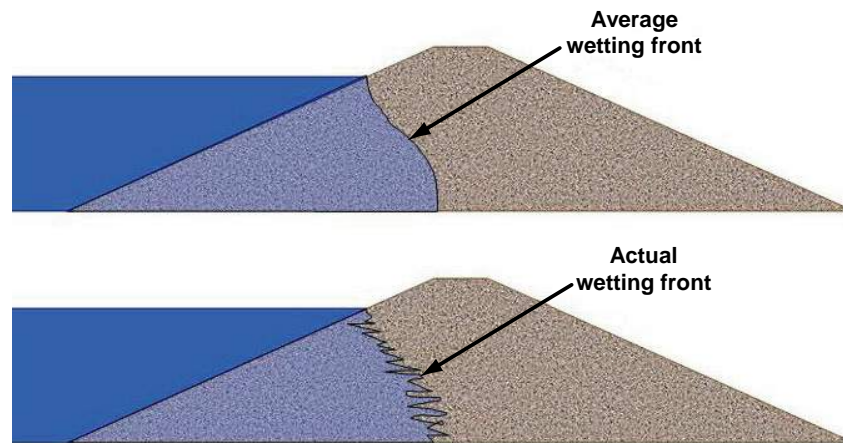
Figure 81.—On first filling, a high hydraulic gradient exists in the embankment dam as a wetting front moves through the dam. The wetting front will not be smooth. Projections will exist due to the different permeability of the embankment dam. The water pressure pushing against the soil can easily be greater than the lateral stress, and hydraulic fracture can result. Figure courtesy of ASDSO.

Hydraulic fracture of embankment dams can occur when the piezometric head of water within the dam is greater than the lateral effective stress on the earthfill. Sherard (1986, pp. 905-927) discusses hydraulic fracturing in detail. Figure 81 illustrates how on first filling, a wetting front moves through the embankment dam. Figure 82 shows an example of hydraulic fracture in an embankment dam. For an example of a project that experienced hydraulic fracture near a conduit, see the case history for Picketburg Dam in appendix B.

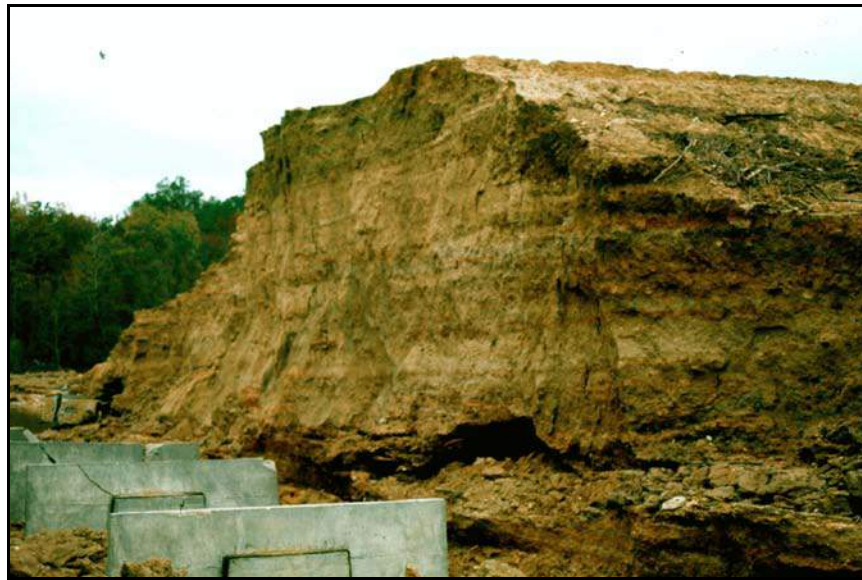
Figure 82.—The failure of this embankment dam located in South Carolina was attributed to hydraulic fracture. The eroded seam located to the right of the conduit may have been the hydraulic fracture that formed and allowed internal erosion and failure of the embankment dam. The embankment was composed of dispersive clays.

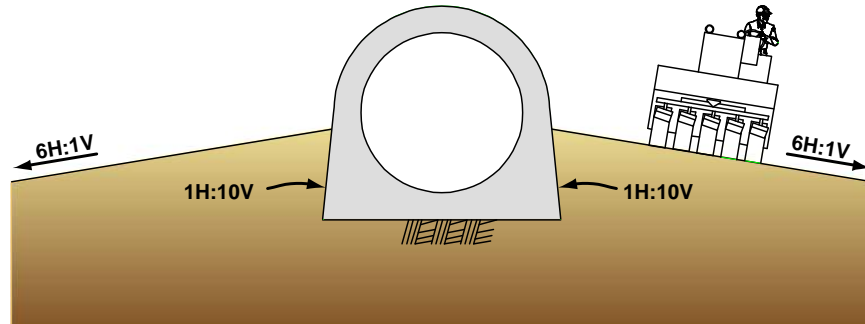
Figure 83.—Recommended earthfill ramp and conduit side slopes.

- *Ramping of earth material.*—The earthfill should be ramped against the conduit on a slope of 6H:1V (figure 83) to help force the earthfill against the conduit and to avoid contacting the conduit with the frame of the pneumatic roller used for compaction. Pneumatic rollers should be operated in a direction parallel to the conduit. The pneumatic roller may form rutting and a smooth surface on the earthfill layer that will need scarification before new layers are placed.

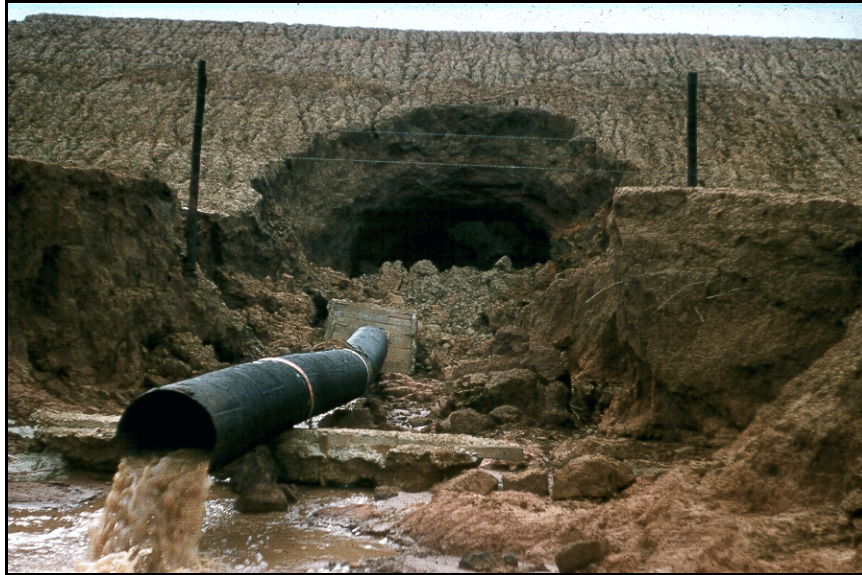
Figure 84.—An embankment dam in Mississippi constructed of dispersive clay soil, failed on first filling with low reservoir level. Failure was likely caused by cracks from differential settlement, hydraulic fracture, or poor compaction about the outlet works conduit. This embankment dam had no filter.

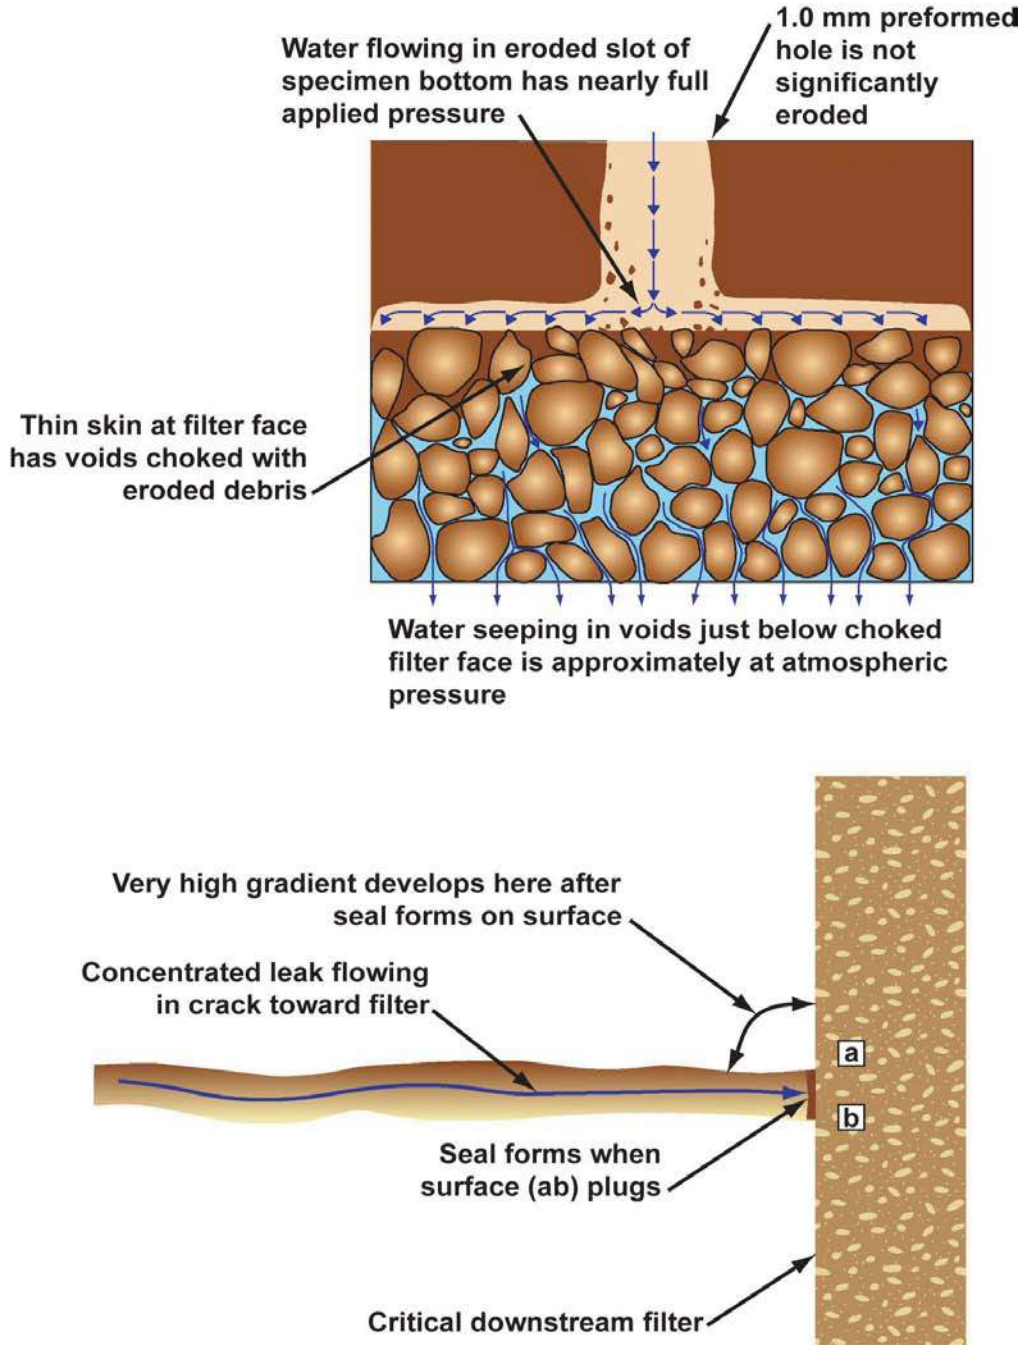
Figure 86.—Illustration of the mechanism of development of a filter seal resulting from the accumulation of eroding soil particles at the face of a designed filter zone, showing filter cake development (top), and sealing of concentrated leak (bottom). The filter seal results in a thin zone of soil with a slurry-like consistency and a permeability similar to that of the soils that eroded to form the seal (after Sherard, Dunnigan, and Talbot, 1984).

The concept behind the function of a filter in sealing a concentrated flow was developed largely from laboratory experiments under the guidance of Sherard as reported in several references (Sherard, Dunnigan, and Talbot, 1984). Figure 86 (top) is reproduced from this reference, and it illustrates filter cake development in the laboratory experiments. Figure 86 (bottom) shows the action of the filter in sealing a concentrated leak in an embankment dam.

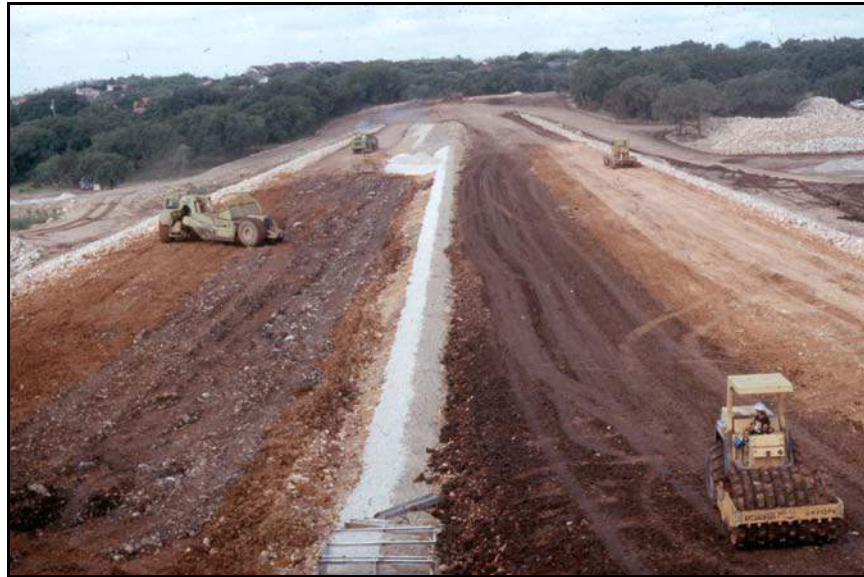
Figure 87.—Two stage chimney filter within an embankment dam located in Texas.

A chimney filter that extends upward to the highest probable pool level and extends across the length of the embankment from abutment to abutment is a common element for most high and significant hazard embankment dams. Chimney drains are also valuable for sites with a high permanent water storage level, because they intercept and lower the phreatic line and maintain a stronger downstream zone of unsaturated soil. Figure 87 shows a double gradation zone chimney filter being installed in the construction of a modern embankment dam.

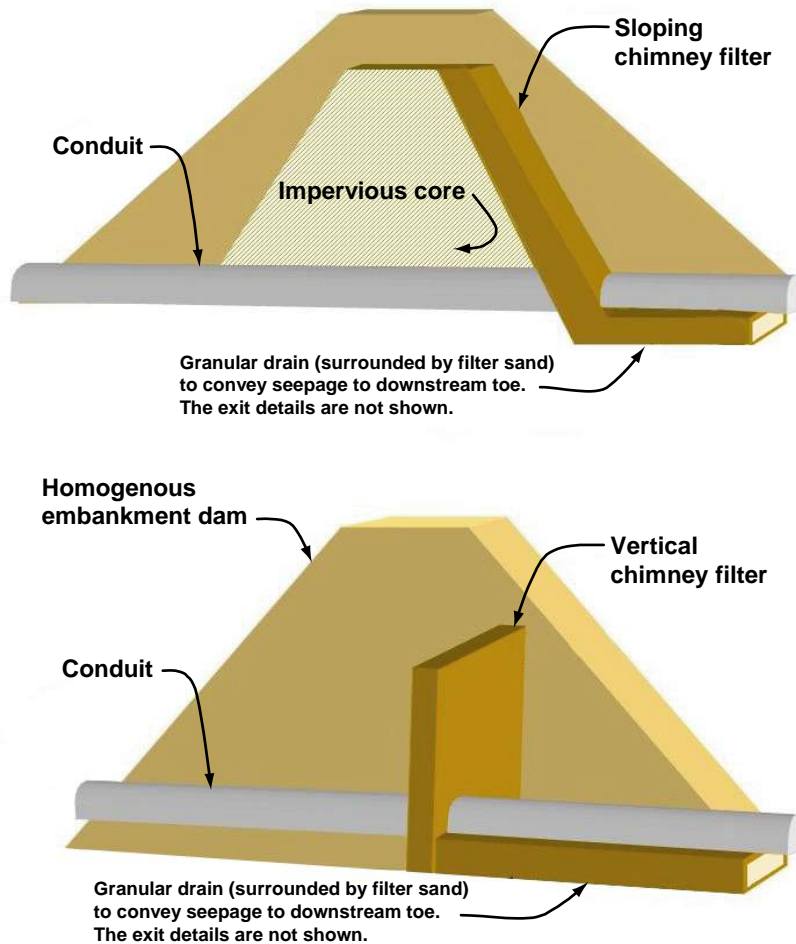
Figure 88.—Typical configurations for chimney filters used in the design of embankments with conduit penetration. A chimney filter may be constructed either on a slope (top) or with a vertical configuration (bottom) within the embankment dam.

Figure 88 (bottom) illustrates a design where an embankment chimney filter also serves as a filter diaphragm around the conduit. This example is for a homogeneous embankment with a vertical chimney filter. Chimney filters are typically installed in new construction or within embankment dams undergoing extensive renovation.

- *Sloping configuration.*—Filter diaphragms and chimney filters may also be constructed with a sloping configuration, as illustrated in figure 88 (top). This configuration is more common on larger embankment dams and those with distinct zones in the dam. The filter zone is often placed at the juncture between the core and shell zones in the dam as shown in figure 88 (top). This configuration reduces the effect of differential settlements between the filter zone and the adjacent embankment zones. Because sloping zones are typically

- *Vertical configuration.*—This configuration for a filter diaphragm is the one commonly used. Figure 88 (bottom) shows a vertical zone for the filter zone surrounding a conduit (In this case the zone is a combination filter diaphragm and chimney filter, but illustrates the shape for a design using a smaller filter diaphragm as well). Vertical filter diaphragms are commonly constructed using the trenching method, as shown in the paper by Hammer (2003). This shape of filter diaphragm is common in embankment dams that do not have distinct

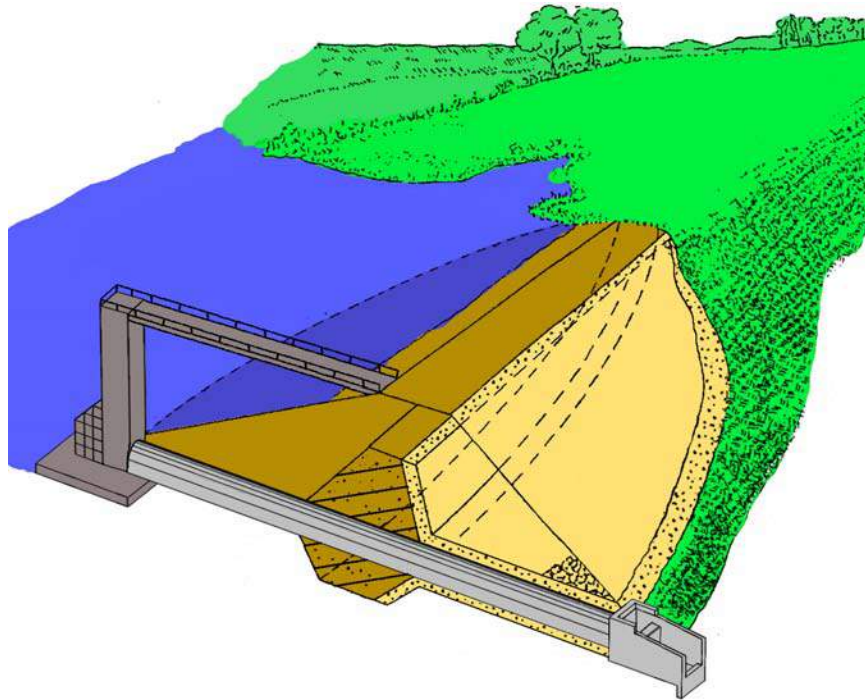
Figure 89.—Typical design used for embankment dams with distinctly different materials in the core zone and exterior shells of the dam.

Figure 89 provides another example of a typical design used for a high hazard embankment dam. This design includes a chimney filter, a drain at the downstream edge of the cutoff trench, and a foundation blanket drain. The chimney filter and cutoff drain satisfy the functions of a filter diaphragm around the conduit. The blanket drain serves as an outlet for the collected seepage flow. The design shown is typical for embankment dams that have distinctly different materials in the core zone and the exterior shells of the dam. The foundation blanket drain may also function to collect seepage in bedrock or permeable foundation horizons, and function to convey collected seepage to the downstream toe. Not all high hazard embankment

dams require the same configuration of foundation drainage features shown in figure 89, but the design shown is a typical one.

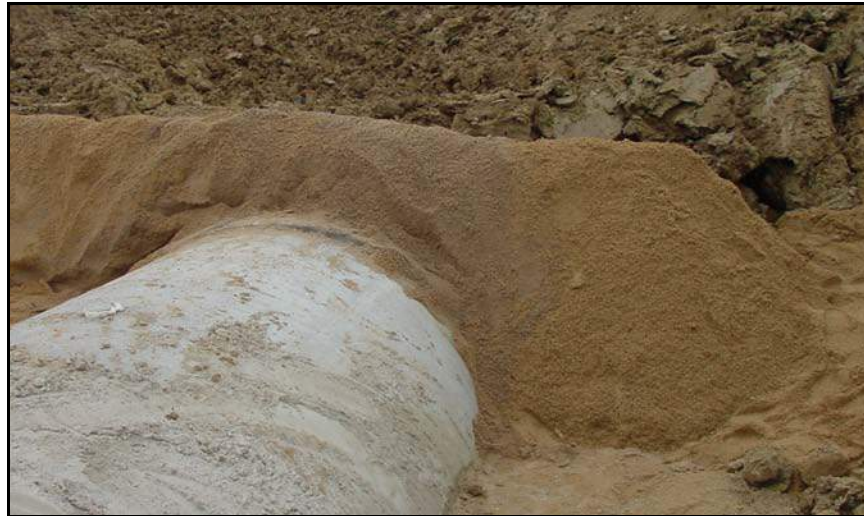
Figure 90.—Construction of a filter diaphragm within an embankment dam.

A filter diaphragm (figures 90 and 91) is a designed zone of filter material constructed around a conduit in which a chimney filter is not being used (usually in

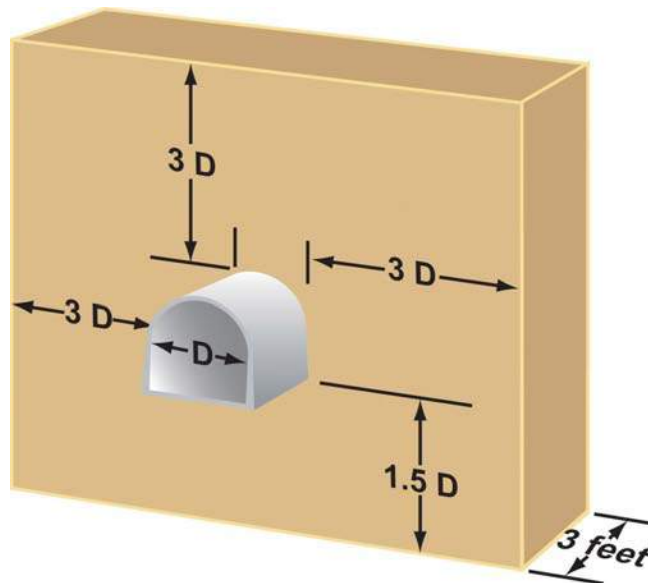
Figure 91.—Typical configuration for filter diaphragm used in the design of an embankment dam.

- *Configuration.*—The filter diaphragm is a rectangular or trapezoidally shaped zone of filter sand that is about 3 feet wide in a direction perpendicular to the conduit; see figure 91.
- *Location.*—Locating the filter diaphragm along a conduit depends on several site conditions. If the embankment is zoned, the filter is often located at the juncture of the impervious core zone and downstream shell zone. In a homogeneous embankment dam, the location of the filter diaphragm is usually based on the following requirements:
 1. Downstream of the cutoff trench.
 2. Downstream of the centerline of the embankment dam when no cutoff trench is used.

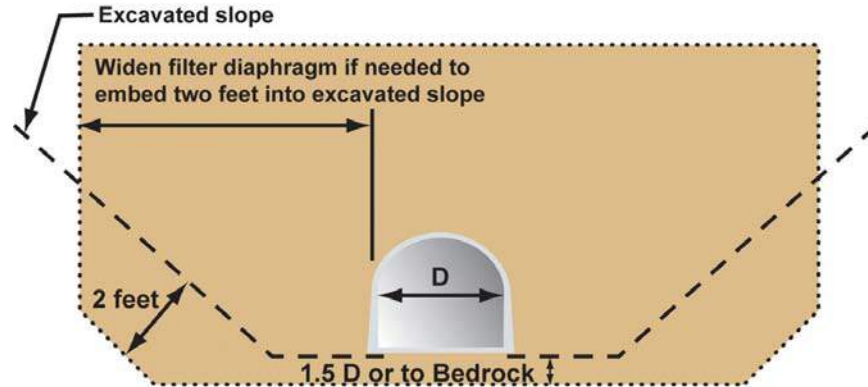
Figure 92.—Typical configuration for filter diaphragm used in design of an embankment dam. The filter diaphragm should extend into the foundation soils, where an excavation is made for the conduit.

- *Vertical/horizontal limits.*—The filter diaphragm should extend below and to either side of the conduit far enough to intercept potential flow along excavation/embankment interfaces. Usually, the filter diaphragm extends into the foundation a dimension equal to at least 1.5 times the diameter of the conduit, unless bedrock is encountered at a shallower depth.
- *Lateral limits.*—The filter diaphragm usually extends laterally a distance at least equal to 3 times the diameter of the conduit or a minimum of 10 feet from the sides of the conduit. In some situations the filter diaphragm may need to be wider than these minimum suggested dimensions. For instance, if an excavation has been made for the conduit, the filter diaphragm should notch into the excavation slopes by at least 2 feet; see figure 92.

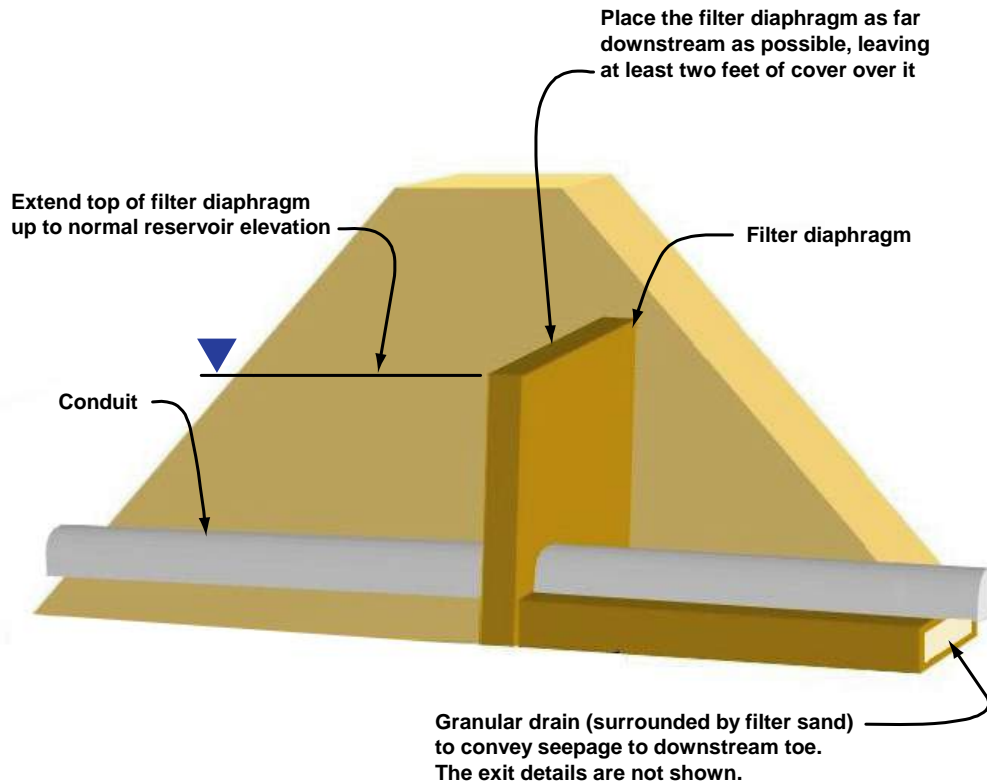
Figure 93.—Typical configuration for a filter diaphragm used in the design of an embankment dam. The figure shows the location of the filter diaphragm as far downstream as possible, leaving adequate cover over it.

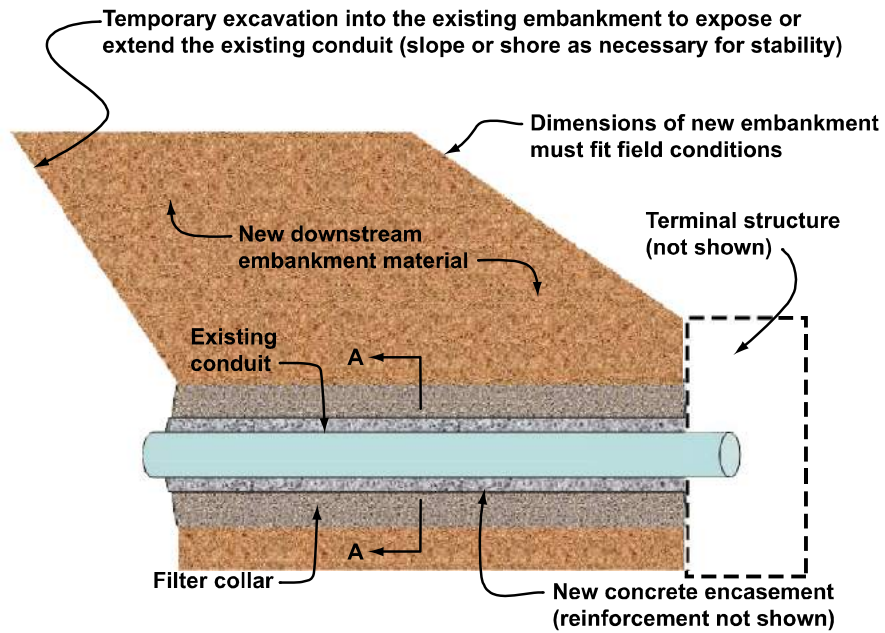
Figure 94.—Filter collar surrounding a conduit renovation.

For renovations, the filter collar wraps the downstream one-third length of the conduit, and the filter is about 18 inches thick. The thickness depends upon design requirements. The USACE's *Design and Construction of Levees* (2000, p. 8-5) and *Culverts, Conduits, and Pipes* (1998a, p. 1-3) show a typical design. Figures 94 and 95 illustrate an example of this type of filter design for a conduit renovation.

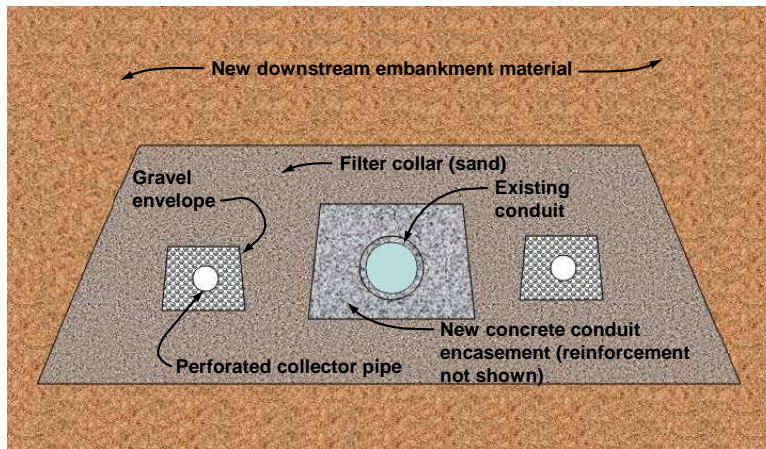
Section A-A

Figure 95.—Cross section showing a filter collar surrounding a conduit renovation. The drain pipes located on both sides of the conduit collect and convey any seepage within the filter collar to a downstream exit location.

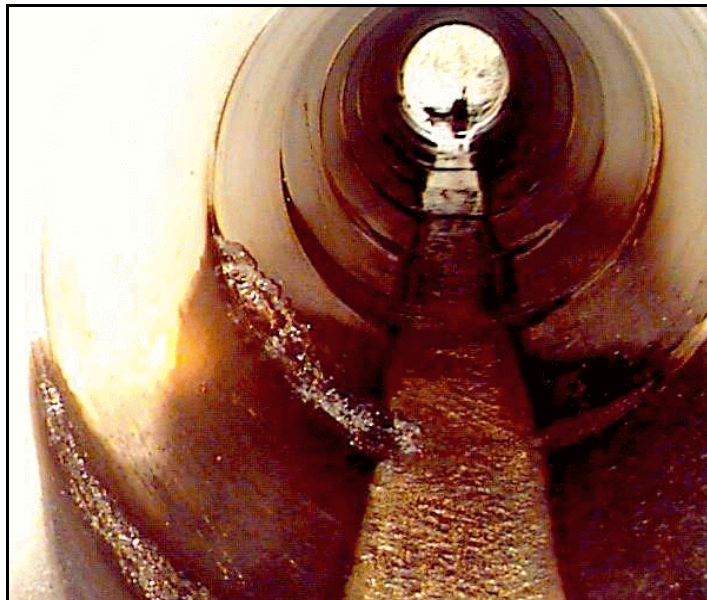
Figure 96.—Leaking joints in a 60-inch diameter RCP spillway. Several large voids were also observed in the adjacent earthfill on the upstream slope.

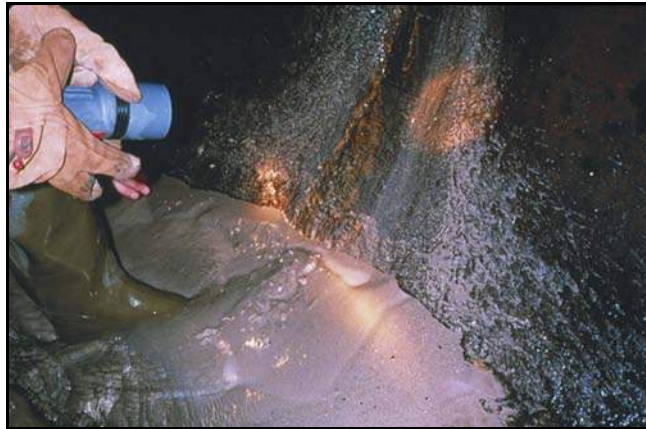
Figure 97.—Soil particles being carried into an outlet works conduit through a joint.

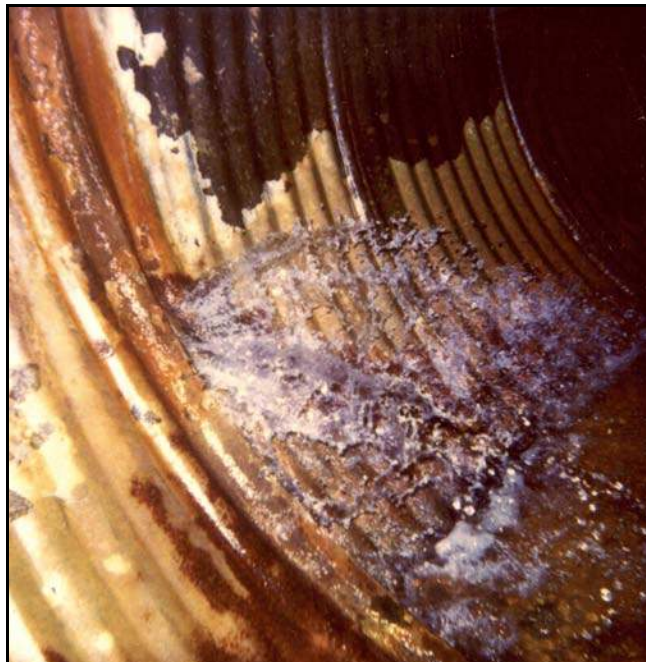
Figure 98.—Leakage from an unauthorized “field joint” constructed by the contractor about 5 feet downstream from the spillway riser structure. An inspection revealed that nearly all of the joints were exhibiting severe leakage and loss of embankment material.

For this failure mode, the conduit is surrounded over at least part of its length by soil with a low resistance to backward erosion piping. If the conduit develops a defect from deterioration, or a joint in the conduit becomes open from movement and seepage is occurring through the surrounding embankment, seepage forces may carry soil particles into the conduit. For this failure mode, the conduit is presumed to have an interior pressure lower than the seepage pressures in the surrounding soil. Figures 96, 97, and 98 show conduits with defects where water is entering the conduit. In figures 96 and 97, the defects are separated joints in a conduit. In figure 98, the defect is a poorly constructed joint in a CMP.
