Technical Manual: Conduits through Embankment Dams

Best Practices for Design, Construction, Problem
Identification and Evaluation, Inspection,
Maintenance, Renovation, and Repair

September 2005

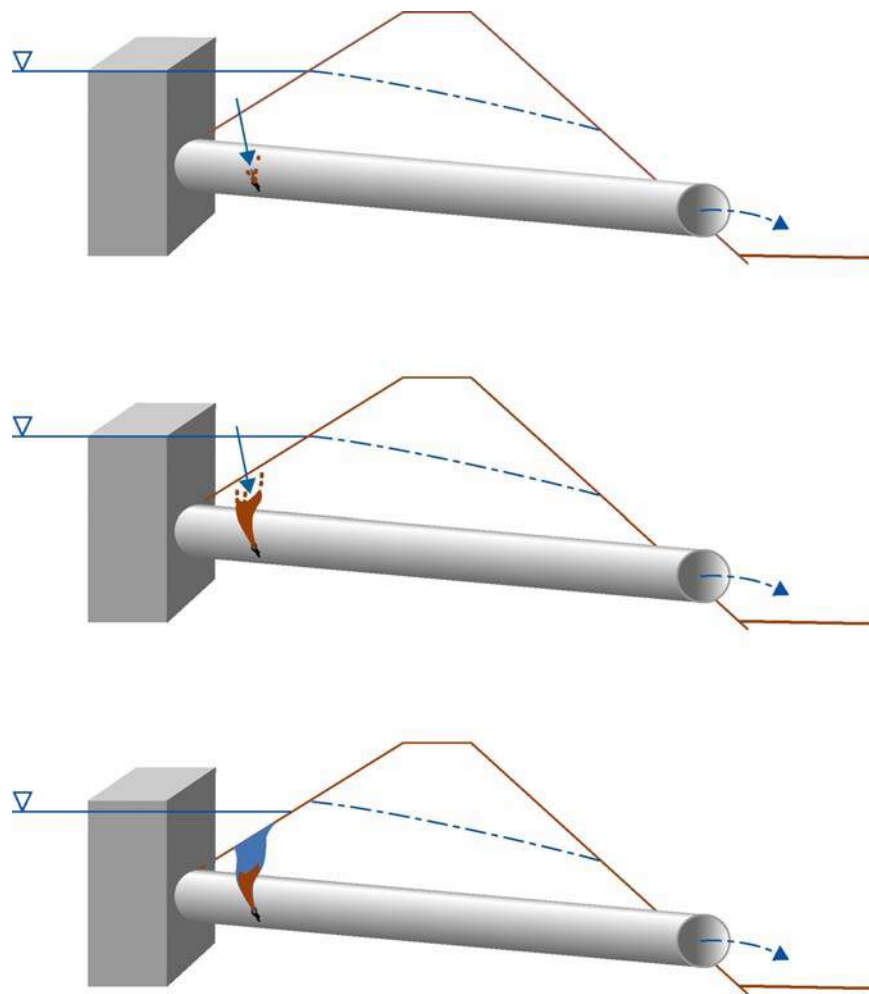
Figure 99.—Failure Mode No. 1.—Backward erosion piping or internal erosion of soils surrounding a defect in a nonpressurized conduit.

The sequence in which this failure mode could develop is illustrated in figure 99 and described in the following steps. Note that the following description specifically involves the development of backward erosion piping in a situation where the conduit is surrounded by soils susceptible to this failure mechanism. A similar set of steps could be described for a scenario involving internal erosion rather than backward erosion piping, when the surrounding soils are not susceptible to backward erosion piping. For the sake of brevity, this description of similar steps in an internal erosion scenario is not repeated.

3. Backward erosion piping of the soils in the embankment dam will cause a tunnel to develop for soils that can support a tunnel. If the soils cannot support a tunnel, a sinkhole may occur instead. A failure can occur if the defect in the conduit is large enough to allow most of the reservoir water to escape.

4. If soils between the reservoir and the defect in the conduit are not susceptible to backward erosion piping, and no preferential flow paths occur in the surrounding soils, the defect in the conduit may not result in immediate problems.

5. If a preferential flow path develops in the soils surrounding the defect in the conduit, such as a hydraulic fracture in the surrounding soils, then internal erosion will occur as water from the reservoir flows along the crack or other preferential flow path to the defect in the conduit.
6. The extent of the erosion that will occur depends on the velocity of the flow, the erosion resistance of the surrounding soil, the size of the preferential flow path, and the size of the defect in the conduit. The erosion that develops from internal erosion from a preferential flow path may have a similar appearance to that from backward erosion piping.

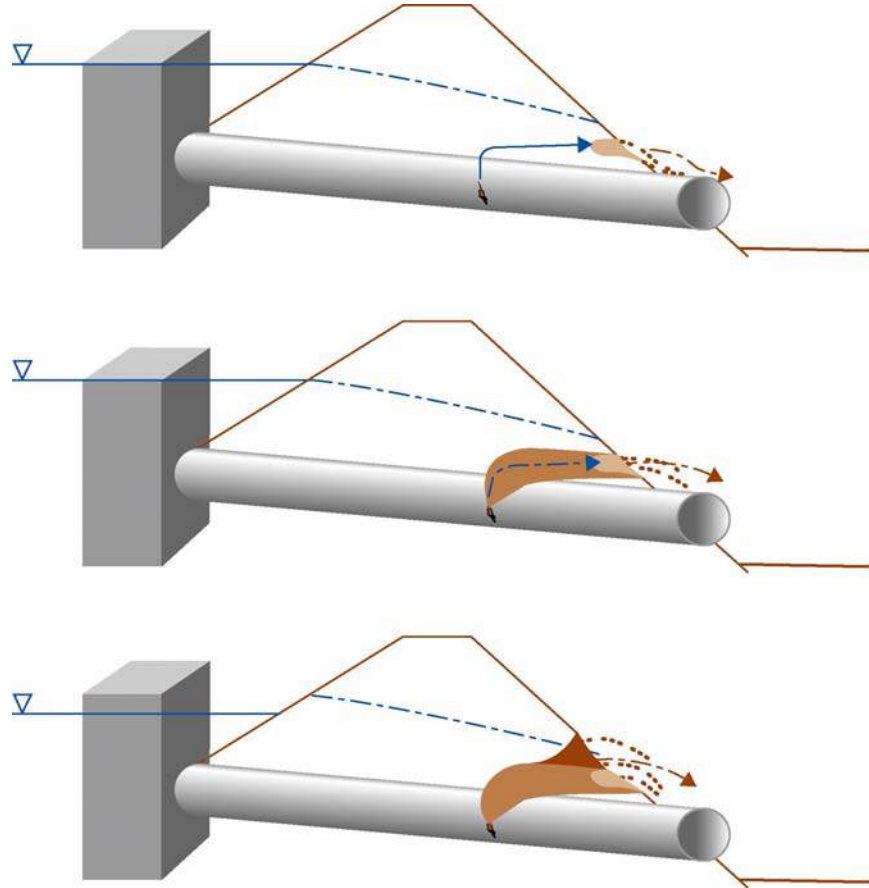
Figure 100.—Failure Mode No. 2.—Backward erosion piping or internal erosion of soils surrounding a pressurized conduit with a defect.

Conduits may collapse from deterioration, poor design and construction, and other causes, as discussed in chapter 8. If the conduit were to become blocked by debris, the internal pressure in the conduit could be much higher than the normal pressure at design flow. A conduit designed to flow without pressure may then become pressurized. Designers should consider this possibility. Separation of articulated conduits is discussed in section 4.3.1. The sequence of failure is described as follows and is illustrated in figure 100.

3. Backward erosion piping progresses backwards until a tunnel connecting the defect in the conduit and the exit face forms. If this backward erosion piping continues, it can lead to a failure of the embankment dam.

4. If the soils surrounding the conduit are resistant to backward erosion piping, the defect in the conduit is small, and the hydraulic force of water in the conduit is low, no immediate problems may occur. Soils not susceptible to backward erosion piping require a concentrated flow path for significant erosion to occur.

5. If soils surrounding the conduit develop a preferential flow path, such as a hydraulic fracture, and the internal conduit pressure is large enough, internal erosion may occur, rather than backward erosion piping. The hydraulic fracture created can erode and lead to development of a failure tunnel that is similar to that which develops in soils that are susceptible to backward erosion piping. If the erosion process continues, it can lead to a breaching failure of the embankment dam.

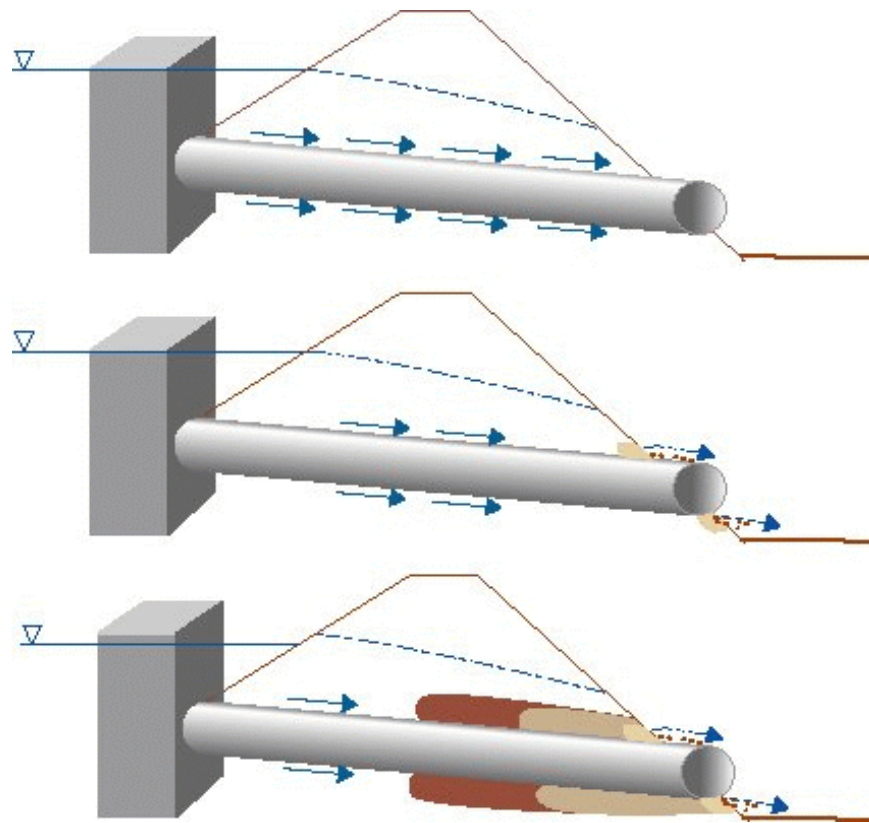
Figure 101.—Failure Mode No. 3.—Backward erosion piping or internal erosion of soils along a conduit at the interface between the conduit and surrounding soils.

For this failure mode, water flows along the interface between the conduit through an embankment dam and the surrounding soil. This failure mode is usually associated with embankment seepage through the soils surrounding the conduit. The seepage along the interface between the conduit and surrounding soil may be concentrated enough to result in backward erosion piping, if the soils are susceptible. This failure mode is very similar to Failure Mode No. 2. The only difference in these two modes of failure is the source of the water. In Failure Mode No. 2, the source of the water causing internal erosion of the soils is a defect in a conduit. In Failure Mode No. 3, the source of the water is seepage from the reservoir that concentrates at the interface between the conduits and surrounding soil. The sequence of failure is described as follows and is illustrated in figure 101.

1. Seepage forces and concentrated flow develop along the contact between a conduit and surrounding soil.
2. Backward erosion piping can occur if the seepage exits downstream through an unfiltered face or into an overly coarse zone of the embankment dam and the soils surrounding the conduit are susceptible to backward erosion piping. Continued flow can result in the formation of a tunnel connected to the reservoir that will potentially result in a breach of the embankment dam.
3. If soils surrounding the conduit are resistant to backward erosion piping, but cracks or preferential flow paths occur from poor compaction techniques or later develop from hydraulic fracture, continued flow through the preferential

flow paths will result in internal erosion. An erosion feature similar to that caused by backward erosion piping can then develop.

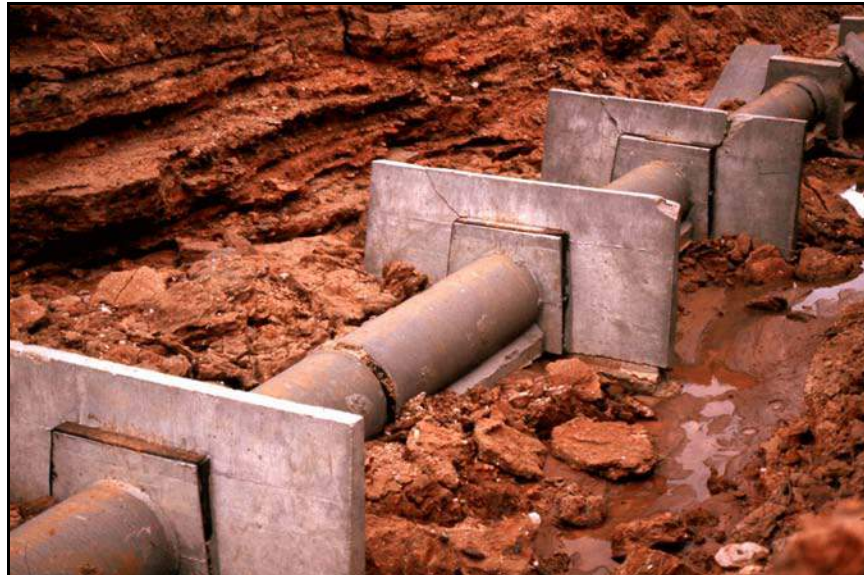
Figure 102.—Conduit with intact antiseepage collars. The collars would have interrupted flow along conduit. Internal erosion or backward piping erosion likely occurred through hydraulic fractures in surrounding earthfill, resulting in failure of this embankment dam.

Figure 102 shows a conduit with its antiseep collars intact after an internal erosion failure of the embankment dam. In this case, it appears unlikely that the flow path for the failure was a continuous uninterrupted flow along the conduit, but at least part of the flow path was in the earthfill surrounding the conduit. In most cases, it has not been possible to determine the exact flow path that water followed in internal erosion failures, because the evidence was destroyed by the failure. If hydraulic fracture and other causes of cracks in compacted backfill were ignored as the potential cause for failures, one might incorrectly assume that all failures that occur in the vicinity of conduits are attributable to flow along the conduit. In Failure Mode No. 4 (discussed in the following section), hydraulic fractures occur in the soil mass beyond the immediate vicinity of the conduit, usually associated with differential settlement in the fill caused either by the conduit or excavations made to install the conduit, or uneven bedrock profiles near the conduit.

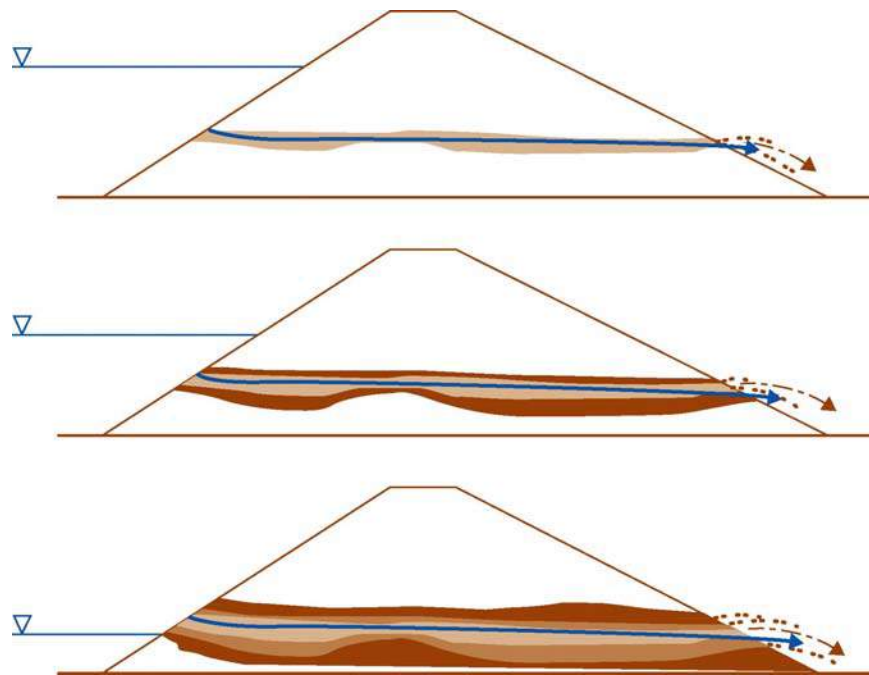
Figure 103.—Failure Mode No. 4.—Internal erosion of the earthfill above and on either side of a conduit caused by concentrated flow in a hydraulic fracture or other preferential flow path in the compacted earthfill. Hydraulic fracture cracks in the embankment dam may result from differential settlement caused by the presence of a conduit within the earthfill.

If a crack is not intercepted with a filter zone, an embankment dam failure can result when the crack enlarges from erosion. Even high plasticity clays that are not dispersive can erode over time. The sequence of failure for Failure Mode No. 4 is described as follows and is illustrated in figure 103.

2. The erosion tunnel enlarges to the point that the reservoir is emptied and the breaching process is completed.
3. A tunnel-shaped hole will exist after the failure, if the eroded tunnel is narrow enough to support the roof of the tunnel. If the tunnel collapses from erosion and widening caused by a lack of support for the roof, the failure will have the appearance of an open breach in the embankment dam.

4. As previously discussed, Failure Mode No. 4 almost always involves the mechanism of internal erosion, and very rarely can backward erosion piping be correctly attributed as the cause of such failure.

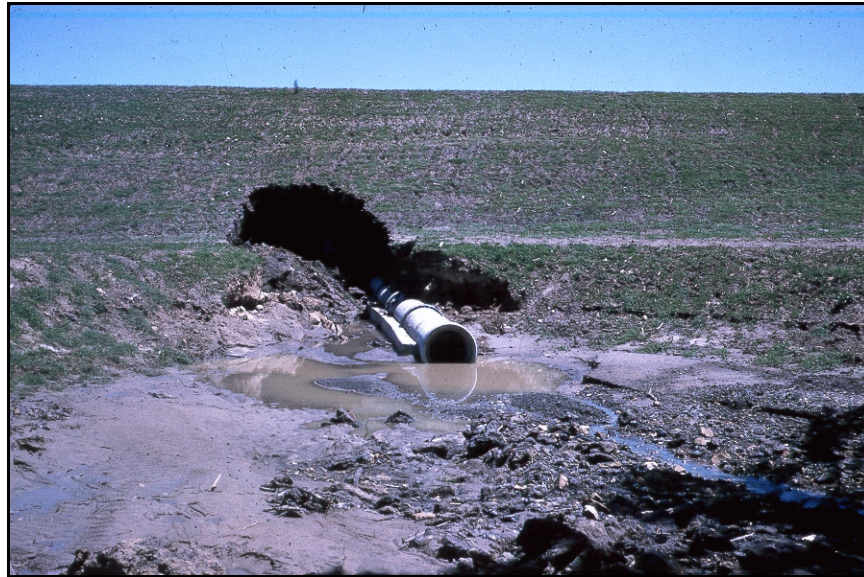
Figure 104.—Failure of an embankment dam due to internal erosion of hydraulic fracture cracks upon first filling of the reservoir.

Figure 104 shows a small embankment dam that failed by internal erosion. The conduit created differential settlement in soils above the conduit that resulted in hydraulic fracture. The embankment soils were highly dispersive clays.

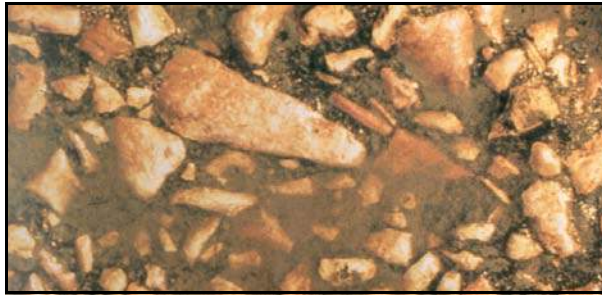
Figure 105.—Abrasion/erosion damage to concrete from flowing water containing sand and silt.

Abrasion in conduits is an erosional process and is a function of velocity and turbulence in the flow, the hardness of the abrasive material, and the quality of the surface experiencing abrasion. Abrasion is caused by water flowing through a conduit at high velocities and containing silts, sands, gravels, or stones (figure 105).

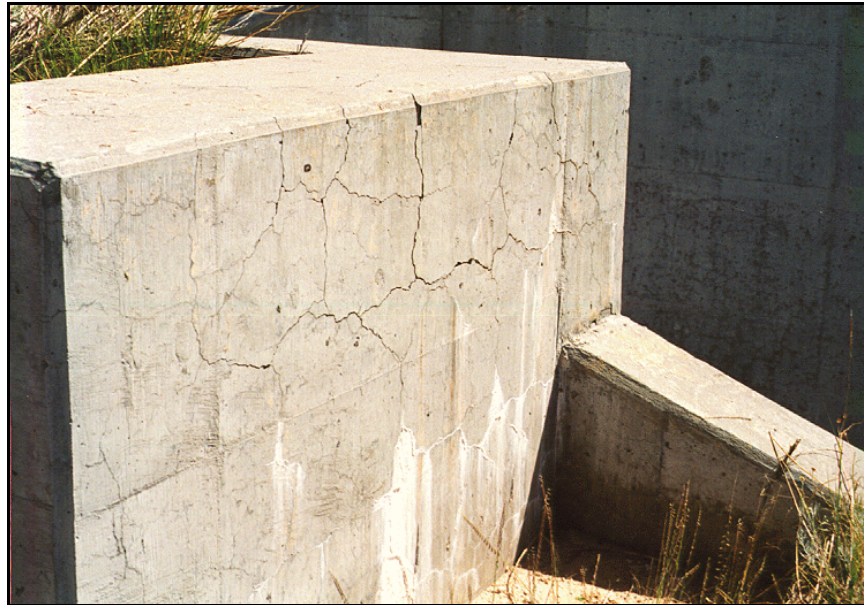
Figure 107.—Concrete deterioration from alkali-aggregate reaction.

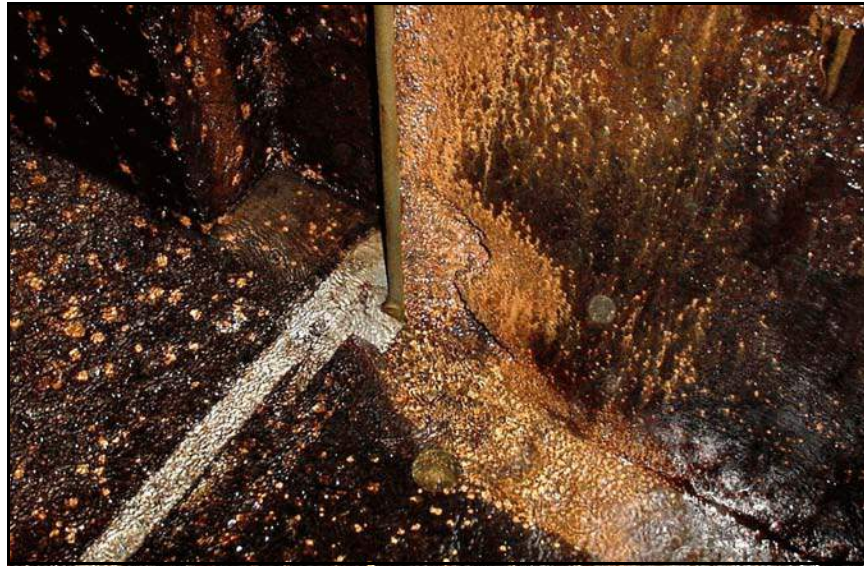
Figure 108.—Cavitation damage to the cast-iron lining of a conduit immediately downstream of a slide gate, caused by high velocity flow.

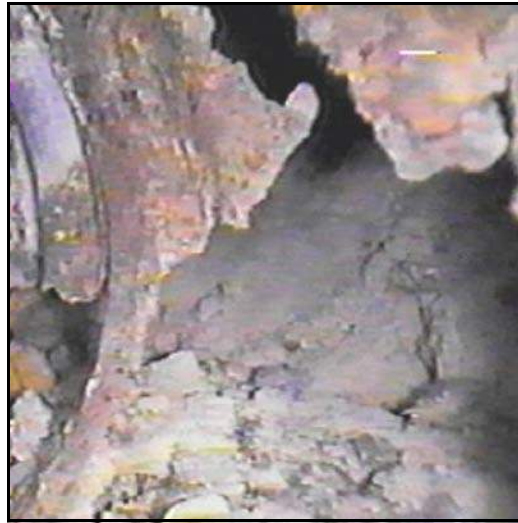
Figure 109.—Corrosion has completely destroyed this CMP spillway conduit. Backfill materials that surrounded the conduit have been eroded by flow within the conduit.

In the past, CMP has been a commonly used material for conduits through embankment dams. Thousands of embankment dams in the United States and all over the world have CMP conduits installed in them. Corrosion is a common problem with CMP conduits (figure 109). Many State highway departments have made extensive studies on the use and durability of CMP for culverts under highway embankments. However, available information on the use of CMP for conduits through embankment dams is limited. A study of 50 existing CMP conduits in watershed dams located in the Midwestern United States was done in 1989 (Koelliker and Lin, 1990). The study determined that the estimated average life of the sampled CMP conduits was 43 years, but the lifespan ranged from 24 to 72 years. This study also found that leakage and associated corrosion at pipe joints was most often the primary limiting aspect of life expectancy. Many spillway conduit systems constructed with CMP experience corrosion at the joint connection between the conduit section and the riser (the vertical pipe or inlet that connects to the outlet pipe). Spillway risers are subject to deformation and movement (tilting) caused by ice loadings or erosion, which can open the joint connection with the outlet pipe. The riser itself is also susceptible to corrosion.

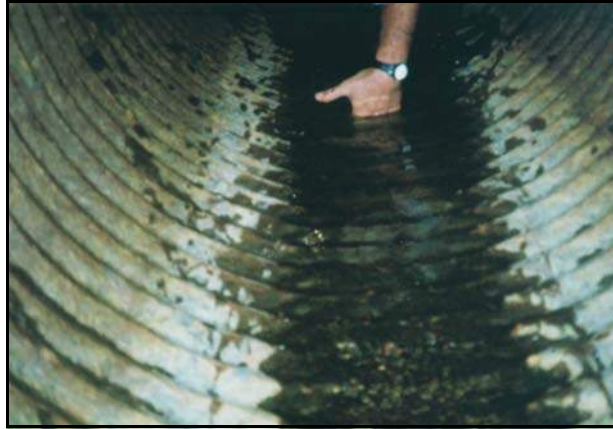
Figure 111.—CMP corrosion on the invert of an outlet works conduit.

For guidance on estimating the service life of CMP conduits, see the National Corrugated Steel Pipe Association's *CSP Durability Guide* (2000) and FHWA's, *Durability of Special Coatings for Corrugated Steel Pipe* (1991). Caution should be exercised in attempting to determine the service life of CMP used in conduits through embankment dams. Many of these CMPs may have used no corrosion protection, and many of the coatings and linings available today were not available when the embankment dams were originally constructed. Prior to 1950, galvanized steel was the only metallic coating available for CMP. If a CMP has experienced denting during installation, this could result in corrosion in areas where the protective coating has been damaged. Figures 110 through 113 show the results of corrosion affecting CMP outlet works conduits.

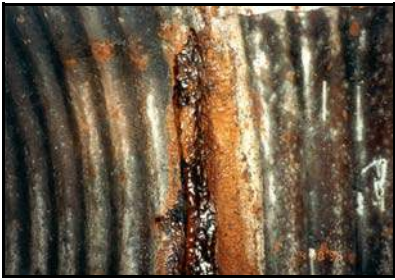
Figure 112.—CMP corrosion within an outlet works conduit caused by a leaking pipe joint.

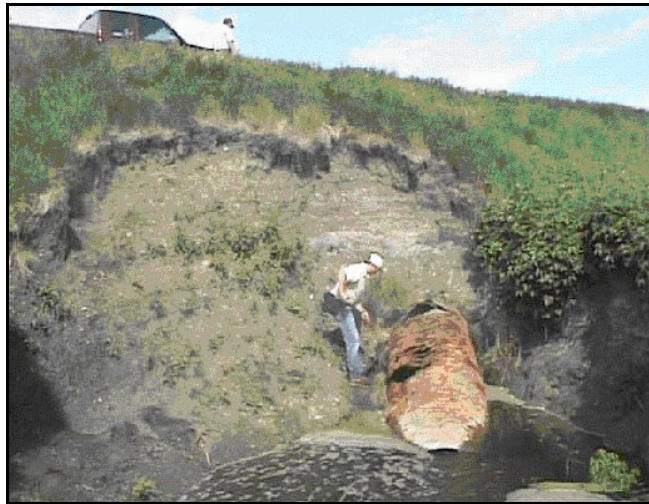
Figure 113.—An outlet works conduit that has experienced corrosion and failure.

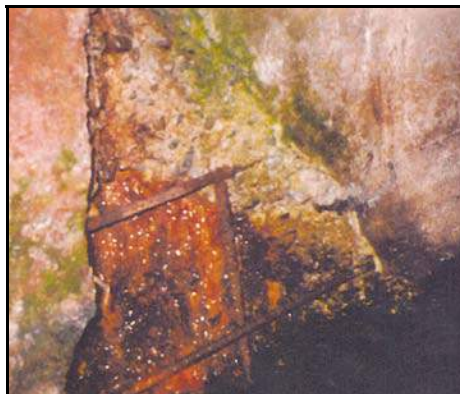
Figure 114.—Spalled concrete and exposed reinforcement in an outlet works conduit.

Corrosion of reinforcement in concrete conduits can also occur when it becomes exposed. Reinforcement can become exposed by cracking or spalling of the concrete (figure 114), inadequate cover, or porous concrete. When reinforcement is exposed to corrosive elements, the iron oxides formed expand (requiring more space within the concrete than the original reinforcement), resulting in tensile stresses within the surrounding concrete. These tensile stresses cause cracking and delamination of the concrete. Rust stains on the conduit surface may be an indicator of reinforcement corrosion.

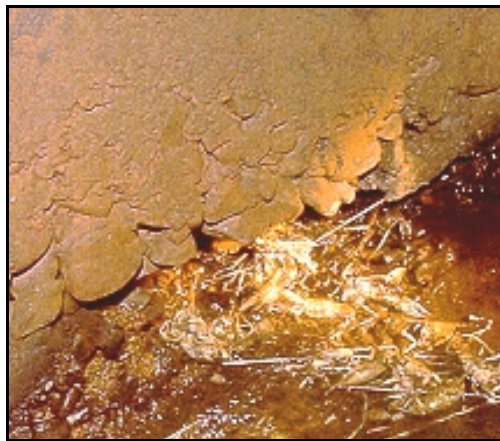
Figure 115.—A rock pocket at the bottom of a conduit side wall.

Figure 115 shows an example of poor construction practice (improper consolidation of concrete). For an example of how poor design and construction practice can lead to the failure of a concrete conduit, see the Olufson Dam case history in appendix B.

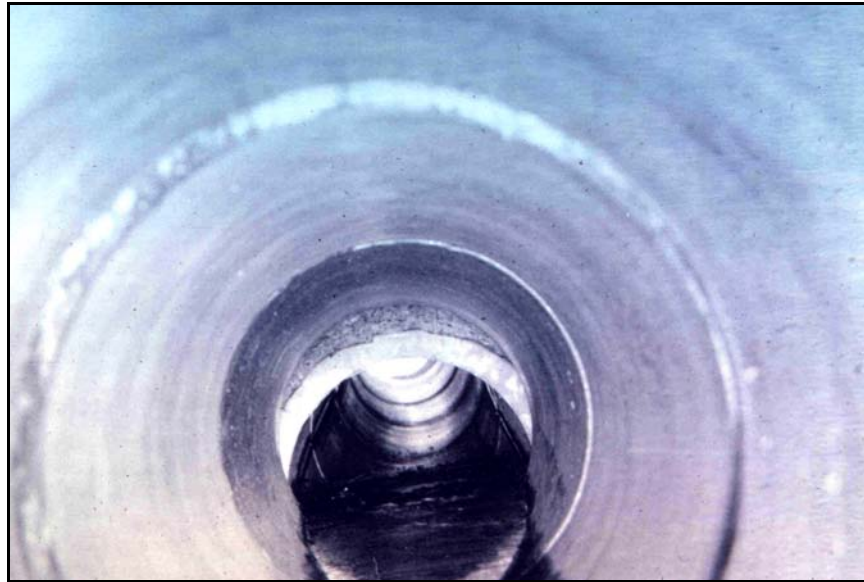
Figure 117.—This conduit was severely damaged after the foundation settled more than 2 feet.

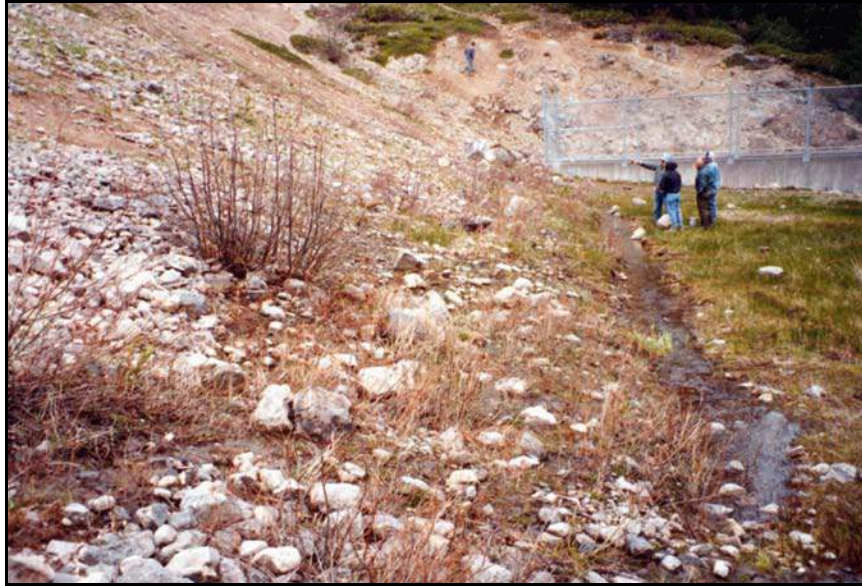
Figure 118.—Visual inspection for seepage on the downstream face of an embankment dam.

Dam safety organizations and embankment dam owners may employ a variety of inspections during the life of a conduit (figure 118). These inspections may include the following types (Reclamation, 1988, p. I-2):

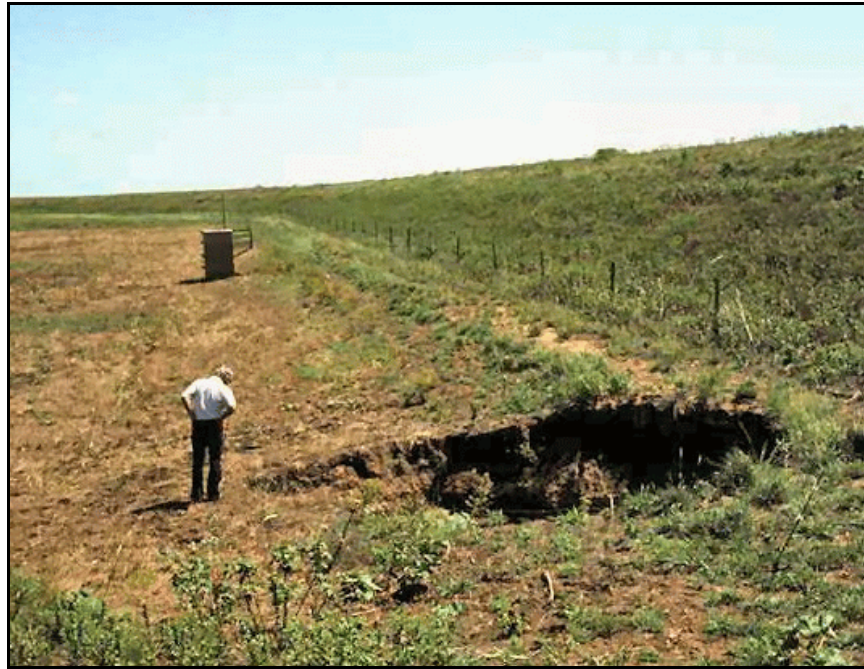
Figure 119.—Sinkhole in the crest of an embankment dam.

- Look for signs of infiltration of soil into the conduit. Depressions, sinkholes (figures 119 and 120), or cavities that exit onto the surface of the embankment dam along the centerline conduit alignment are usually an indication that internal erosion or backward erosion piping is occurring. These features often appear as holes that line up with one another. Such features should be marked with reference points and monitored to determine whether they are expanding with time. Sinkholes should be probed to determine the extent of the void, which may be dome shaped and enlarge with depth. The seepage and flow conditions on the downstream slope and through the conduit, should be examined for evidence of association with the sinkhole. Sinkholes are a cause for immediate concern and further investigation. Beware that some animals may take over these areas, and they may not be recognizable as sinkholes or cavities.

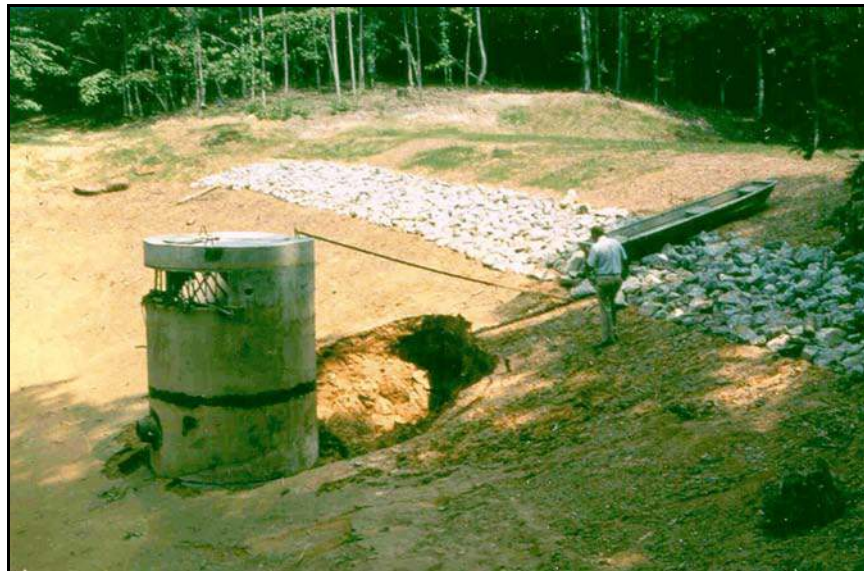
Figure 120.—Sinkhole around a spillway riser. Photo courtesy of Schnabel Engineering.

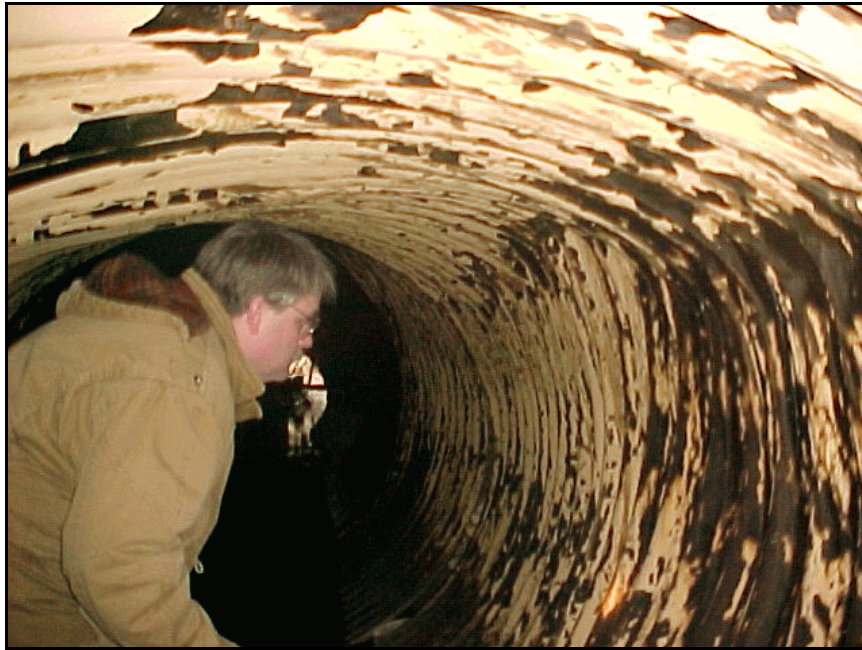
Figure 121.—Inspection of a CMP conduit looking for signs of deterioration.

Typical problems within the interior of conduits include deterioration, obstructions, joint offsets and separations, defective joints, cracking, and mechanical equipment misoperation (figures 121 and 122).

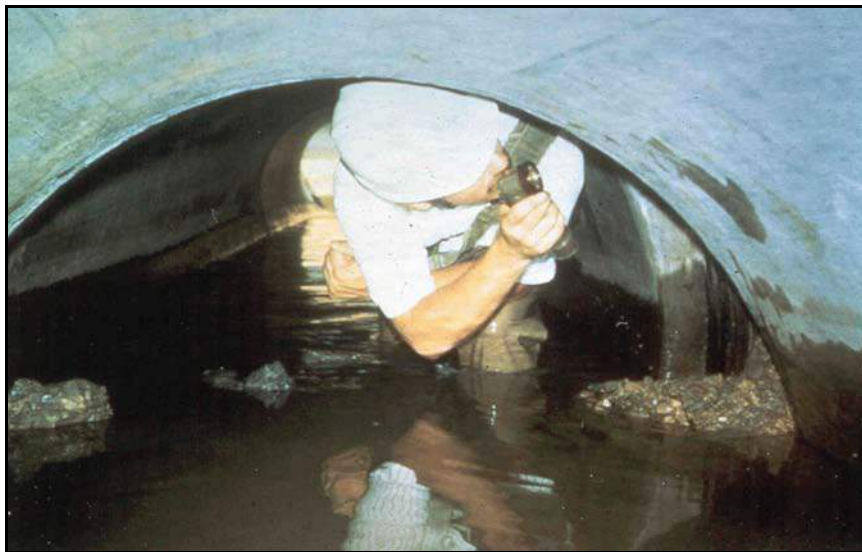
Figure 122.—Inspection being performed in difficult conditions. The joints of this 48-in concrete pipe separated when foundation movement occurred during construction of the embankment dam. For details, see the case history for Little Chippewa Creek Dam in app. B. Photo courtesy of Ohio Dam Safety Division.

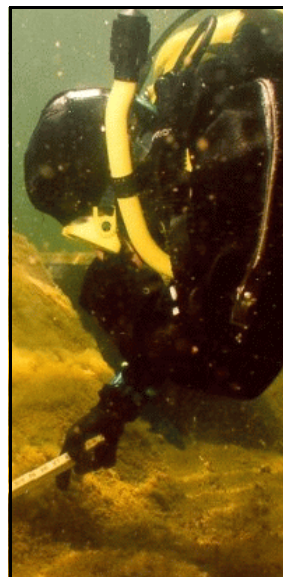
Figure 123.—Diver performing an underwater inspection.

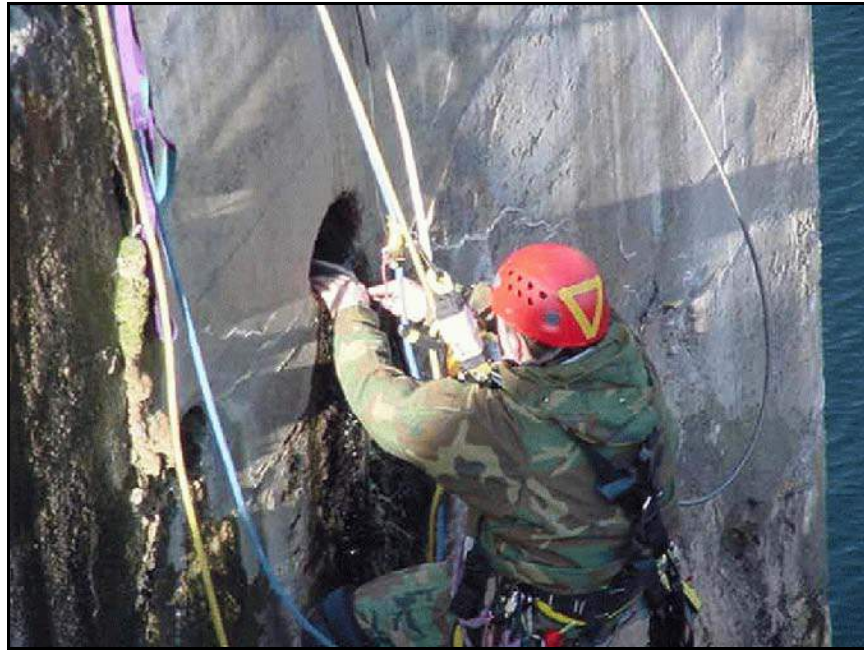
Figure 124.—Climber performing an inspection on a terminal structure wall.

Although not often required for conduits, a climbing team may be utilized to perform inspection of the inaccessible portions of intake towers and the walls of terminal structures (figure 124).

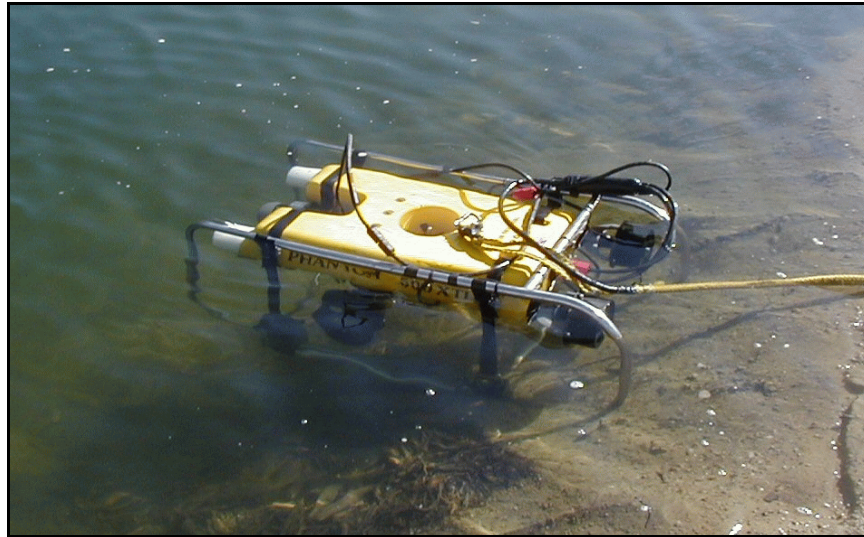
Figure 125.—An observation-class ROV entering the water to begin an inspection.

An ROV consists of a video unit, a power source for propulsion, vehicle controllers (referred to as “joysticks”), and a display monitor. The ROV can provide real-time viewing. Most ROVs are either observation or working class vehicles. An observation class vehicle is small and compact and is used for visual inspection where nonintervention applications are required. Typically, observation class ROVs include a high resolution color video camera capable of zoom and manual or auto focus. Figure 125 shows an observation-class ROV entering the water. Precision color scanning sonar is an added option, but can be expensive. Some observation class ROVs may have a single function manipulator. Working class ROVs are typically capable of search, survey, inspection, and light intervention to depths of

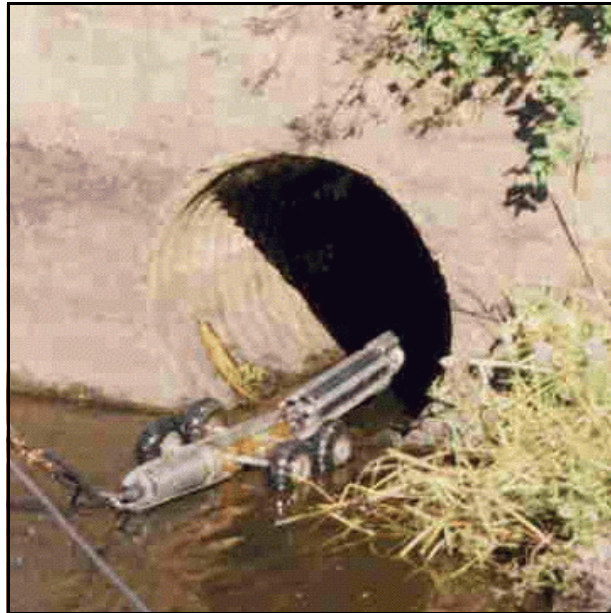
Figure 128.—A CCTV inspection camera-crawler entering the downstream discharge portal of an outlet works conduit.

CCTV is a very useful method for examining small or inaccessible conduits (figures 126, 127, and 128). CCTV inspection provides significant improvements over other methods of inspection, such as man-entry inspection where an inspector crawls through the conduit (36 inches or larger) and documents the conditions, manual inspection where a sled with a camera is pushed through the conduit using long push rods, and mechanical inspection where a camera tethered to a wire rope is pulled through the conduit. CCTV inspection has the advantages of being able to examine conduits regardless of size limitations, has complete mobility, and provides real time video images.

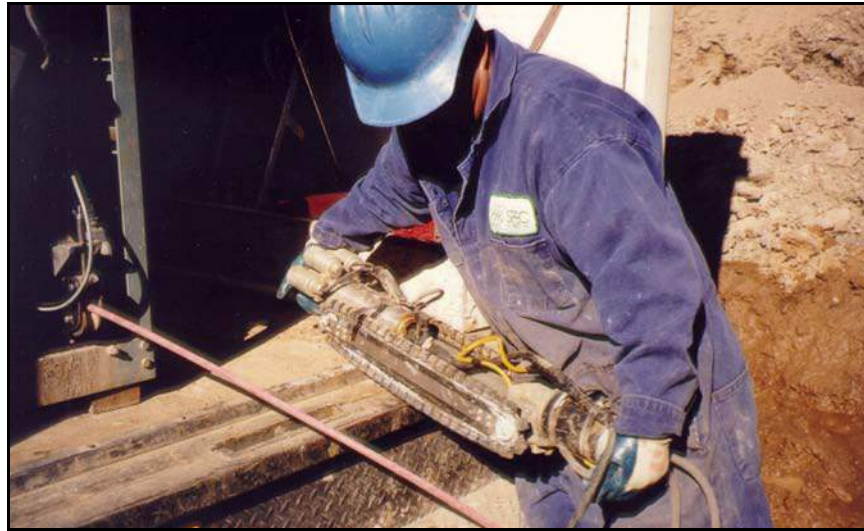
Figure 130.—Most CCTV inspection equipment is portable and can be carried to conduit access locations.

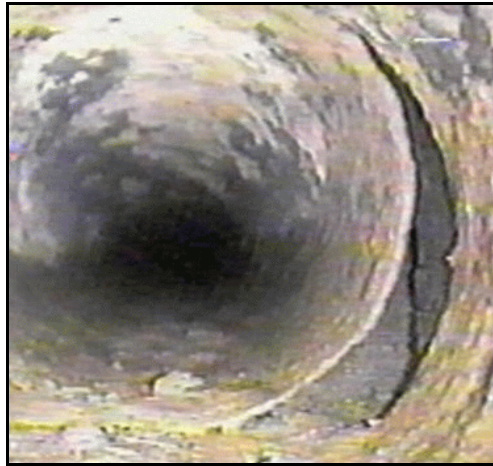
Figure 132.—A joint has separated in the steel pipe of this outlet works.

An important part of any CCTV inspection is the technical evaluation of the conditions observed during the inspection. A qualified professional engineer experienced in the design and construction of conduits should perform this evaluation. Interpretation of the results of the CCTV inspection should not be left to inexperienced personnel. The correct determination of conditions within the conduit is crucial in understanding potential failure modes involved. Many years may pass before the opportunity to perform another CCTV inspection is available. The engineer should prepare a report of findings (ROF), which documents all problem areas observed and recommends future actions. The ROF should also include pictures captured off the videotape or DVD showing areas of concern, a drawing or sketch showing the limits of the CCTV inspection, additional informational drawings if needed, and a detailed summary or log of observations that corresponds with time and linear footage on the videotape. Figure 132 shows a picture captured from videotape.

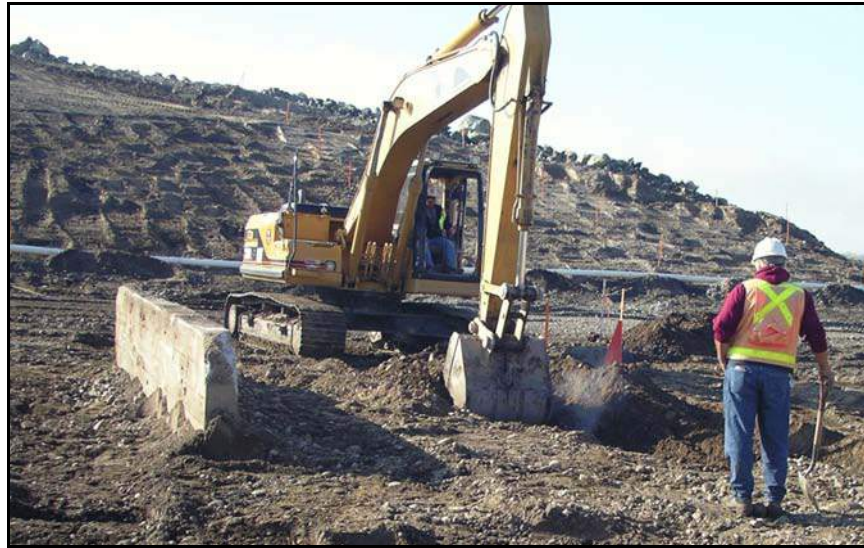
Figure 135.—An outlet works conduit is being excavated during a forensic investigation. The top of an antiseep collar is exposed on the left side of the figure.

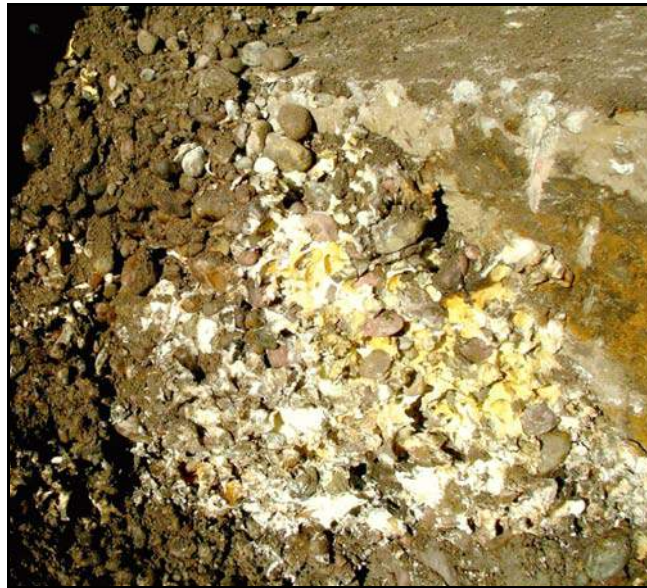
Figure 136.—Close coordination between the forensic team and contractor allowed for careful study of how polyurethane grout injected into the deteriorated joints of a conduit flows through surrounding backfill. In this case, the forensic investigation showed the injection of grout was relatively successful in sealing the joints of the conduit.

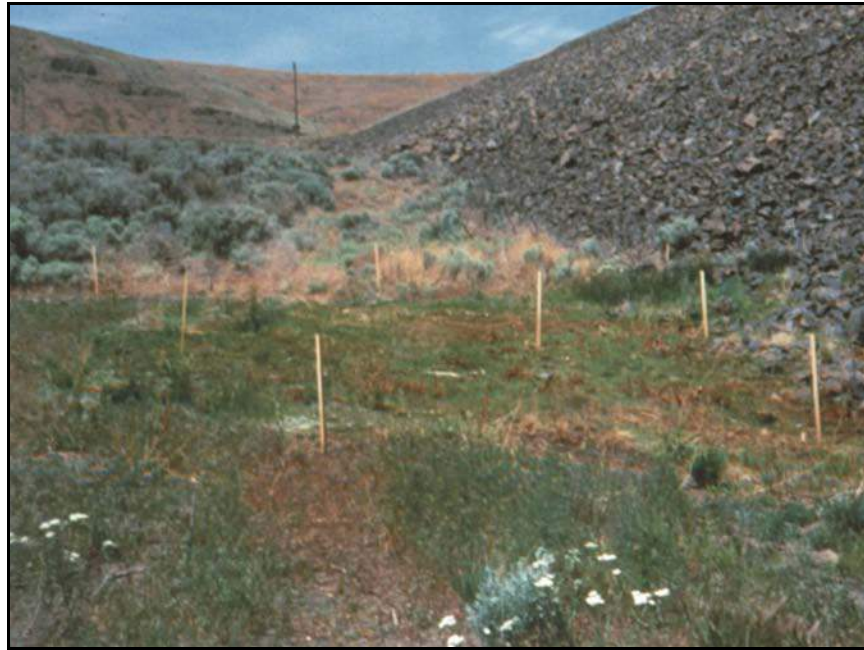
Figure 137.—The perimeter of a wet area at the downstream toe of an embankment dam located with wooden stakes.

For saturated areas on the downstream slope of an embankment dam, the perimeter of the hole or wet area should be surveyed to determine the extent of the area. As a minimum, the perimeter of the hole or wet area can be staked out with metal fence posts or wooden stakes (figure 137) and the length, width and location of the wet area recorded and photographed for future reference. For saturated areas on the embankment dam face, the degree of wetness should also be estimated and recorded, such as “boggy,” or “surface moist but firm underfoot.” Any flow of water from the wet area or into a sinkhole should be measured, if possible, and/or estimated and recorded. See section 11.3 for guidance on actions involving sinkholes.

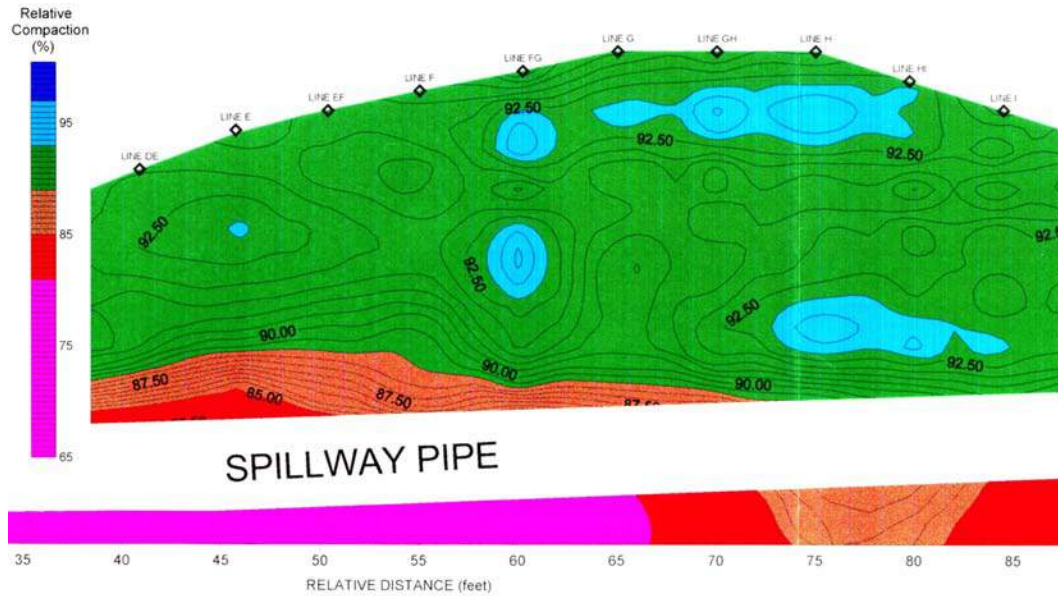
Figure 139.—Seismic tomography profile along failed CMP spillway conduit in an embankment dam.

The parameters recorded can provide important information about different features that may damage the embankment dam's structure, such as fractures, low density regions, saturated zones, and high stress regions. The results may be presented as cross-section images (figures 139 and 140) of compression (P- [primary]) wave velocity, or of seismic wave attenuation. These properties may be correlated to other engineering parameters of interest, such as possible fractured zones, and potential void areas. For an embankment dam in Maryland (Schaub, 1996, p. 3), the tomographic investigation interpretations revealed that the relative compaction of the earthfill around a CMP spillway conduit ranged from 65 percent to nearly 100 percent. The areas with the lowest interpreted densities were found to be under, along, and above the conduit.

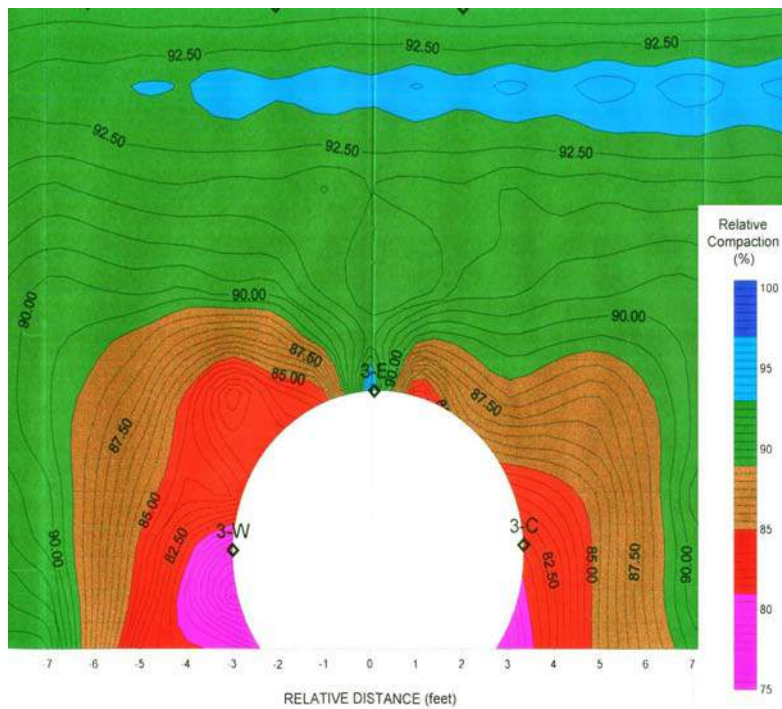
Figure 140.—Typical section from seismic tomography used to identify voids along the outside of a CMP spillway conduit in an embankment dam.

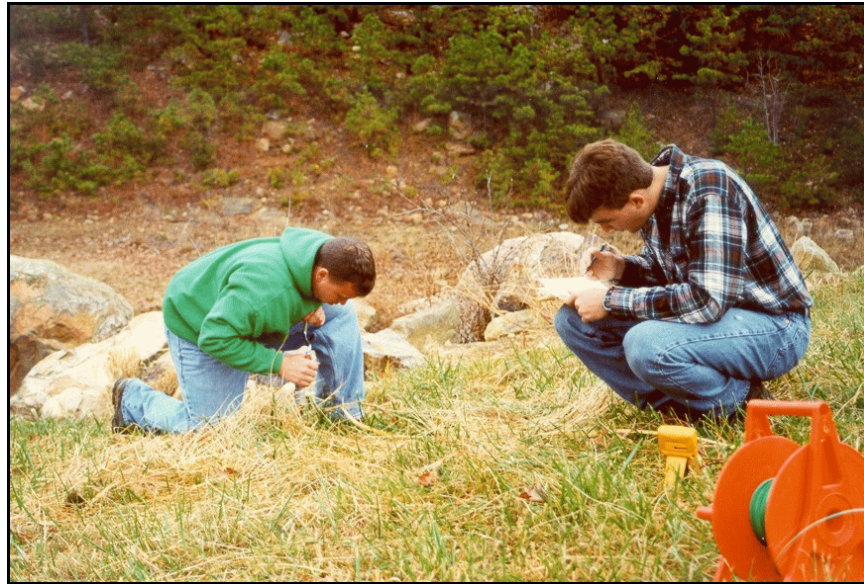
Figure 141.—Collecting self potential (SP) data on the crest of an embankment dam in Virginia to trace the source of observed seepage. The 75-ft high embankment dam had a sinkhole, a sand boil, and several seepage points on the downstream face. This information was used in complement with electrical resistivity imaging data. Photo courtesy Schnabel Engineering.

Self potential (sometimes referred to as streaming potential or SP) (figure 141), measures the electrical potentials (or voltages) that exist in the ground or within an embankment dam. Flowing water naturally generates these potentials as a consequence of the separation of ions in the seepage water itself. SP is considered to be the only geophysical method capable of direct detection of seepage (Corwin, 2002). Other geophysical methods, such as resistivity, infer the existence of seepage based on other measured parameters.

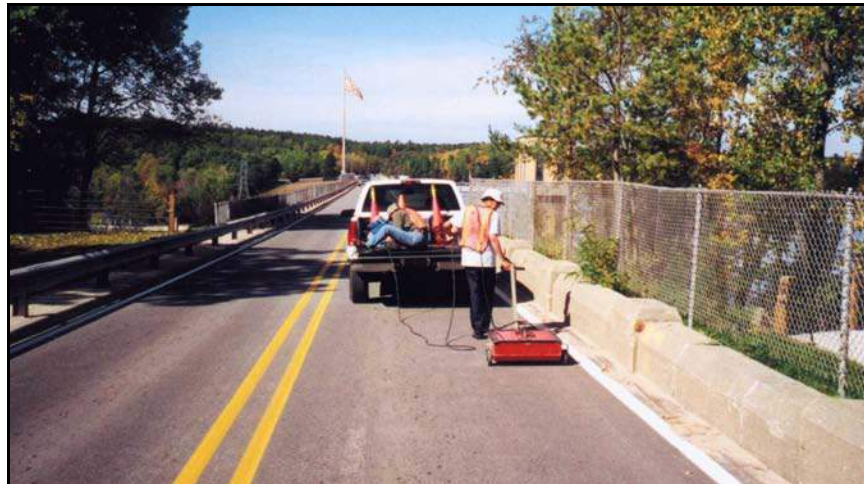
Figure 142.—Conducting a ground-penetrating radar survey across dam crest to locate voids beneath roadway and spillway. Photo courtesy Schnabel Engineering.

Ground-penetrating radar (GPR) uses high frequency electromagnetic energy to penetrate below the ground surface (figure 142). An antenna is used to transmit a short duration pulse, which travels through the air and the subsurface until it is reflected back by a change in the dielectrical properties of the material being imaged. The resulting reflections are displayed in sounding or section format, with sections being the far more common display mode. If the GPR profiles are conducted on a close spacing, the resulting data can be treated in a data volume manner, allowing arbitrary slices through a three-dimensional data mass. This three-dimensional technique can be labor intensive to acquire and process.

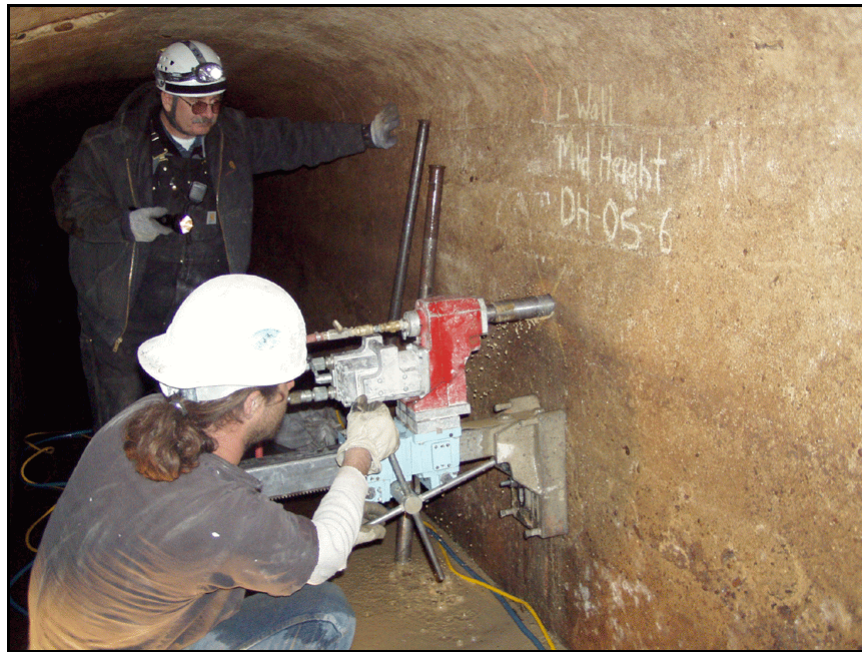
Figure 143.—A core hole is being drilled to reveal voids behind the concrete in this conduit.

Known void areas are extremely useful in “calibrating” a GPR survey at a particular site. Lacking known void areas, core drilling or other direct inspection methods are highly desirable to aid in the GPR data interpretation. GPR data profiles can be difficult to interpret properly, if no site “ground truth” is available. Figure 143 shows a core hole being drilled to reveal voids behind the concrete, and figure 144 shows an example of GPR profiles along a conduit invert.
