Technical Manual: Conduits through Embankment Dams

Best Practices for Design, Construction, Problem
Identification and Evaluation, Inspection,
Maintenance, Renovation, and Repair

September 2005

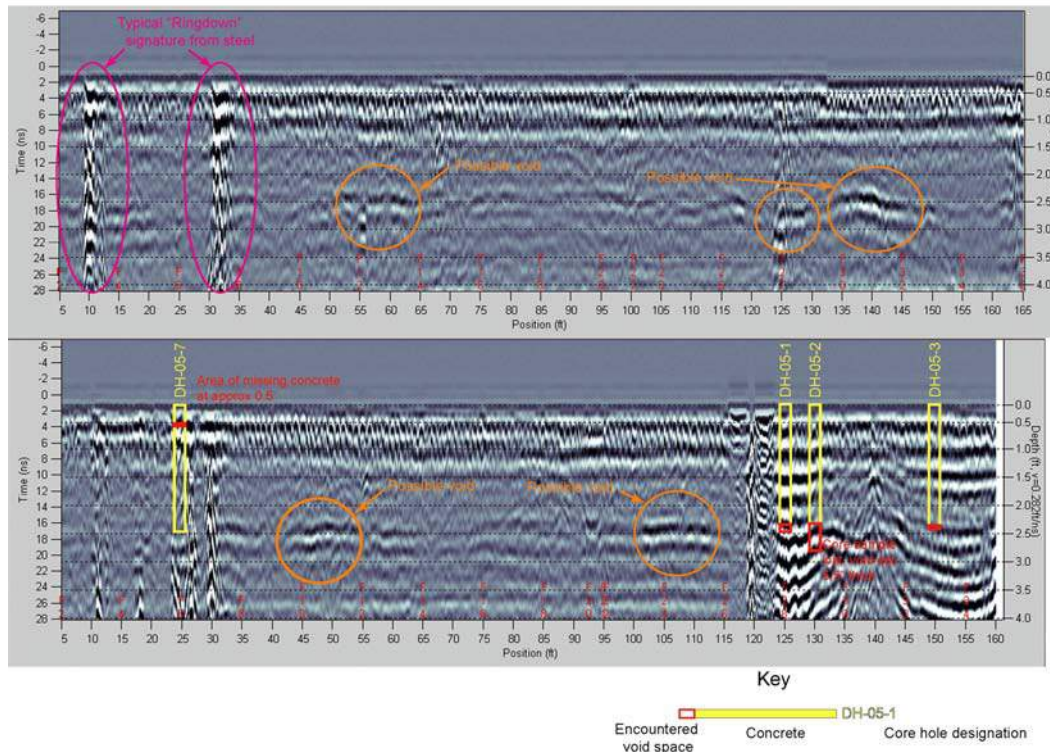
Figure 144.—GPR profiles along a conduit invert. The large amplitude white-black reflection patterns are associated with concrete underlain by voids in drill holes (DH) DH-05-01 through -03.

Known void areas are extremely useful in “calibrating” a GPR survey at a particular site. Lacking known void areas, core drilling or other direct inspection methods are highly desirable to aid in the GPR data interpretation. GPR data profiles can be difficult to interpret properly, if no site “ground truth” is available. Figure 143 shows a core hole being drilled to reveal voids behind the concrete, and figure 144 shows an example of GPR profiles along a conduit invert.

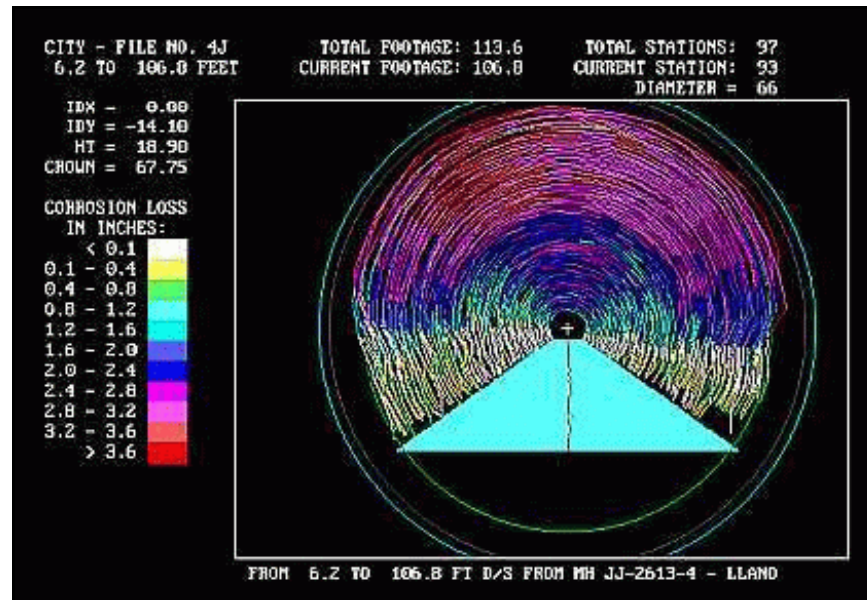
Figure 145.—A rotating sonar transducer mounted on a sled can be pulled through a conduit to measure and record changes in dimensions along the conduit. This can be very useful when determining the size for a proposed slipliner. Here, the measured corrosion loss of the crown of a steel pipe is shown at many locations on one image. The bottom of the conduit is submerged. The sonar device can work in water or air, but requires different settings for each. Thus, both above water and underwater sonar measurements cannot be made at the same time, although a mechanical device on the sonar sled can simultaneously provide information for the bottom of the pipe. Figure courtesy Sonex Corporation.

for generated sonar pulses to return to the transducer (through air or water) are a function of the distance that the pulse travels, it is possible to precisely measure the distance to the conduit surface. When processed by a computer, thousands of these measurements can be used to generate a map (figure 145) of the condition (deflection, joint size, depth of deterioration, etc.) of the conduit. The precision of the system is such that measurements of fractions of an inch can be made. The sonic velocity can vary with temperature and humidity, and calibration is required prior to commencing with the inspection. The accuracy of the measurements depends upon the calibration. The sonar can also be used in navigating the transporting unit within the conduit.

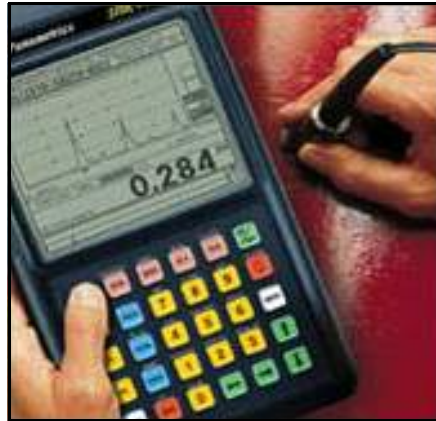
Figure 146.—Ultrasonic thickness gauge for measuring metal thickness.

The thickness of an existing metal or steel pipe can be measured using an ultrasonic thickness survey. The survey is conducted by using a pulse-echo ultrasonic thickness gauge (figure 146). An ultrasonic gauge determines the thickness of metal or steel pipe by accurately measuring the time required for a short ultrasonic pulse generated by a transducer to travel through the thickness of the pipe, reflect from the back or inside surface, and be returned to the transducer. Different types of materials have different acoustic velocities. The advantages of performing an ultrasonic survey are:

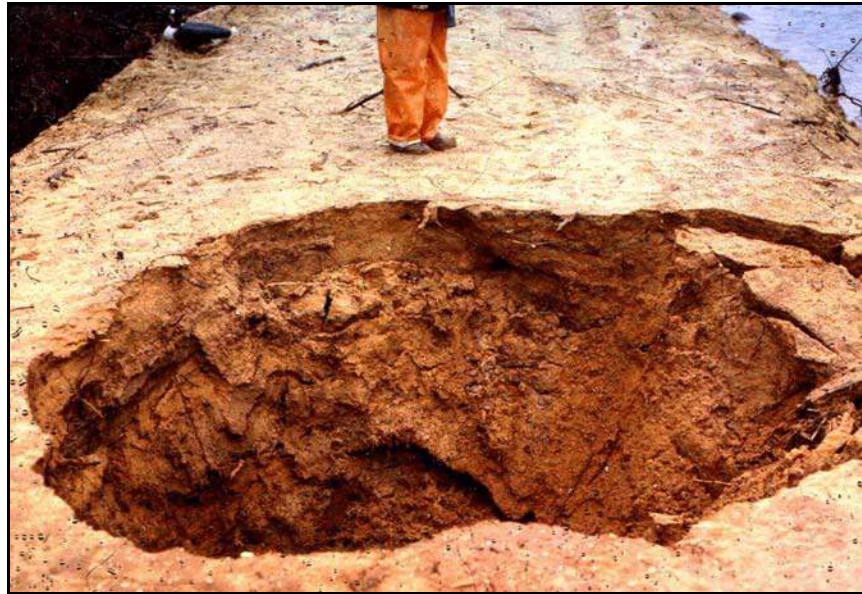
Figure 147.—Sinkhole over a spillway conduit.

Sinkholes or subsidence of the embankment surface in the immediate area of the conduit are usually the result of erosion of the embankment material. They usually indicate a very serious problem that needs immediate attention. Figure 147 shows an example of a sinkhole that occurred over an spillway conduit.

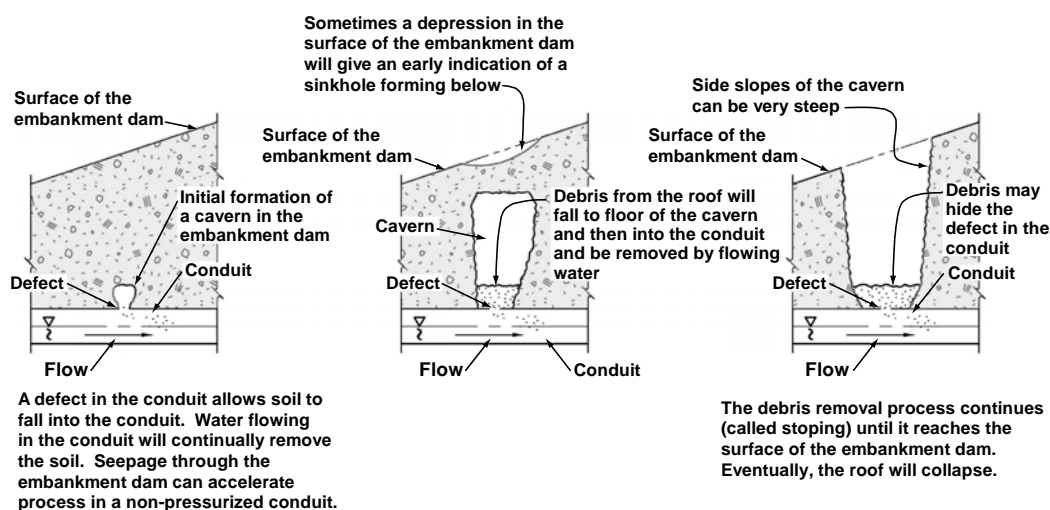
Figure 148.—Typical sequence of the formation of a sinkhole.

Most often, a sinkhole that was caused by erosion of embankment material into a conduit will be located immediately above the alignment of the conduit, and the following discussions apply to this situation. Figure 148 illustrates a typical sequence of the formation of a sinkhole located above a conduit. Figure 149 shows an example of a sinkhole where the continued removal of soil would have caused the roof of the cavern to migrate to the surface of the embankment dam. Sinkholes that are not associated with a conduit may have different considerations and are not further discussed here.

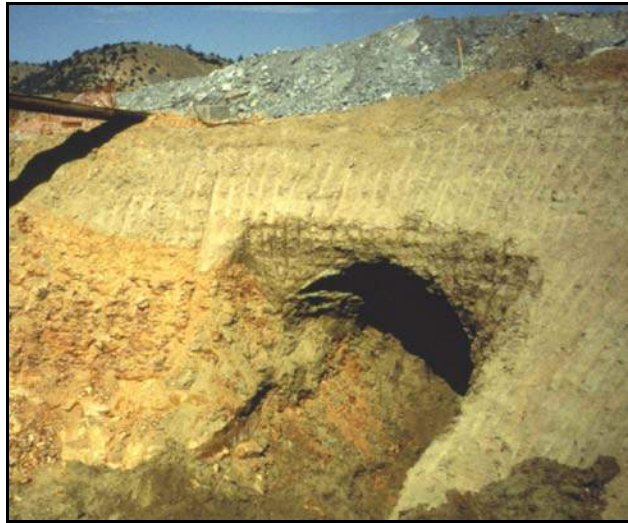
Figure 149.—Incipient sinkhole in an embankment dam. Eventually, the continued removal of the soil at the bottom of the cavern would have caused the roof to migrate to the surface of the embankment dam.

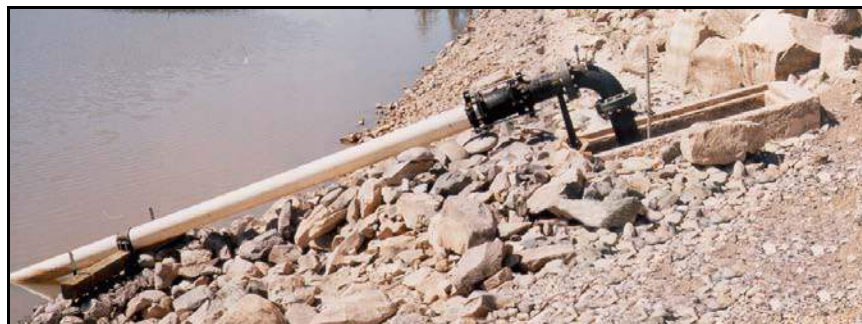
Figure 150.—Siphon used to lower the reservoir water surface through the upper entrance of an outlet works intake structure.

A siphon is a closed conduit system formed in the shape of an inverted U. A siphon (figure 150) can be used to partially drain a small reservoir. A single or a series of siphons can be constructed. Typically, siphons are placed up and over the embankment dam and extended to the toe of the dam. The downstream portion of the siphon can be charged with water and then released to create the siphonic action to start the siphoning of water. The downstream end of the siphon should be equipped with a gate or valve to facilitate creating the siphonic action. Multiple methods should be considered for priming siphons, such as a vacuum pump, water pump, or hand pump. Provisions for breaking the siphon (siphon breaker vent) should be provided at the crest of the embankment dam, should the need arise. At the discharge end of the siphon, the area should be properly protected to ensure that the discharging water does not cause erosional damage. A siphon over an embankment dam is illustrated in figure 151. The siphon in figure 151 is shown extending over the dam crest to avoid excavation into the embankment dam. If the siphon must be excavated through the embankment dam crest, the guidance provided in chapter 5 should be utilized.

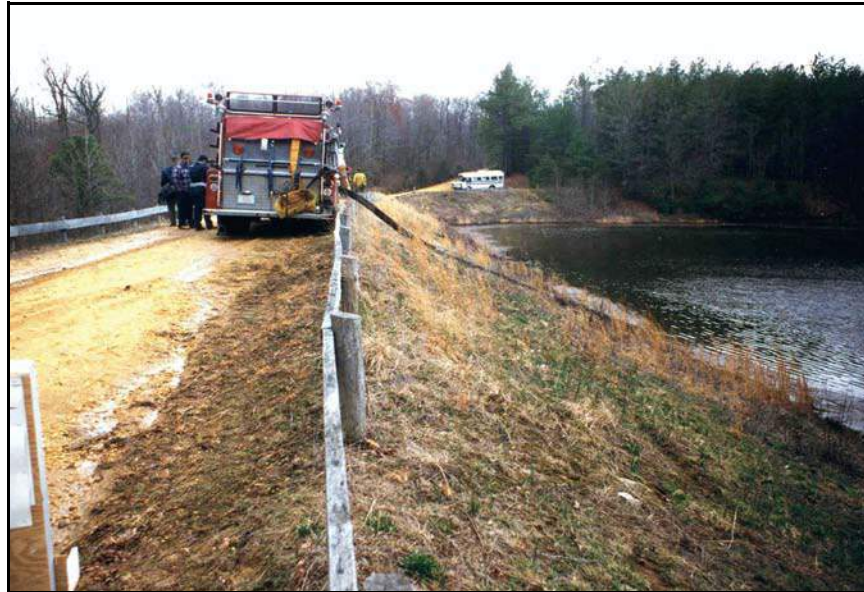
Figure 152.—All available resources may need to be utilized to drain the reservoir in an emergency. Here, the local fire department assists in draining a lake during a thunderstorm after the 45-year old CMP spillway collapsed.

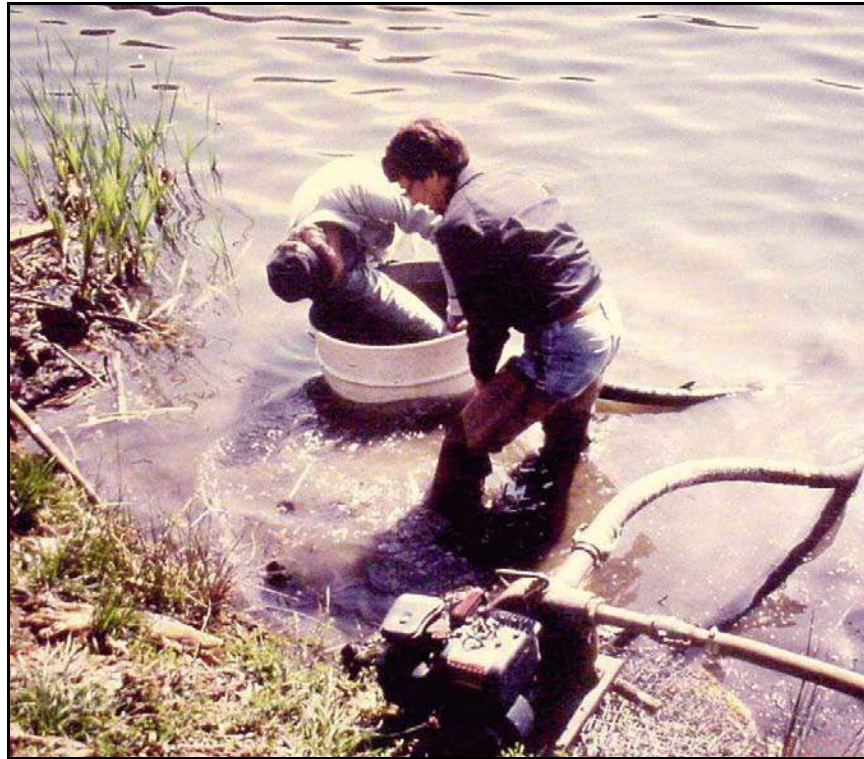
Figure 153.—The upper portion of a small metal pipe riser structure was removed with an acetylene torch. The riser was isolated from the pool by surrounding it with a large drum pressed into the soil. A pump was used to remove the water between the drum and the riser so that the work was completed in the dry.

If the riser can be temporarily isolated from the reservoir with a portable cofferdam, a torch can be used to remove the upper portion of the riser. This procedure was used to lower the pool of an embankment dam in Maryland by about 1.5 feet (figure 153). Care must be taken when removing the inlet structure to ensure that the materials being removed do not fall into and plug the spillway conduit, and debris does not enter the conduit (figure 154).

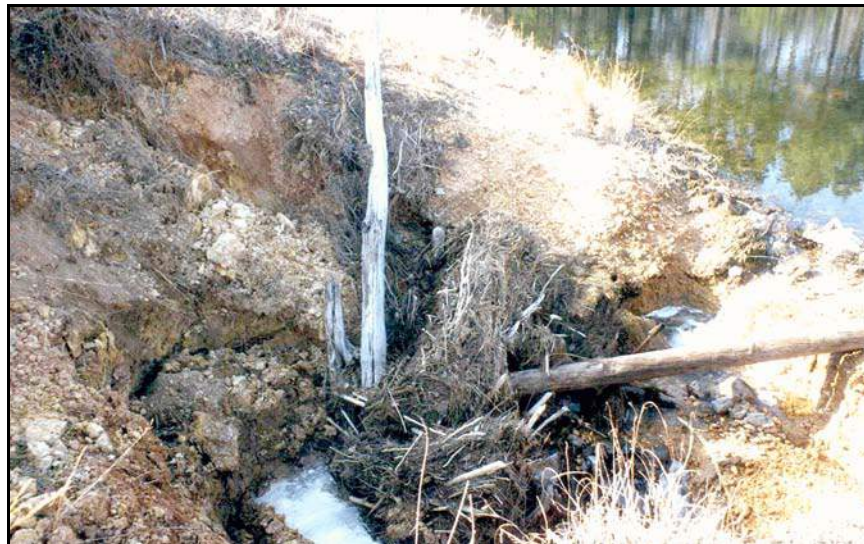
Figure 154.—Care must be taken to ensure that debris does not clog spillway after removal of the riser.

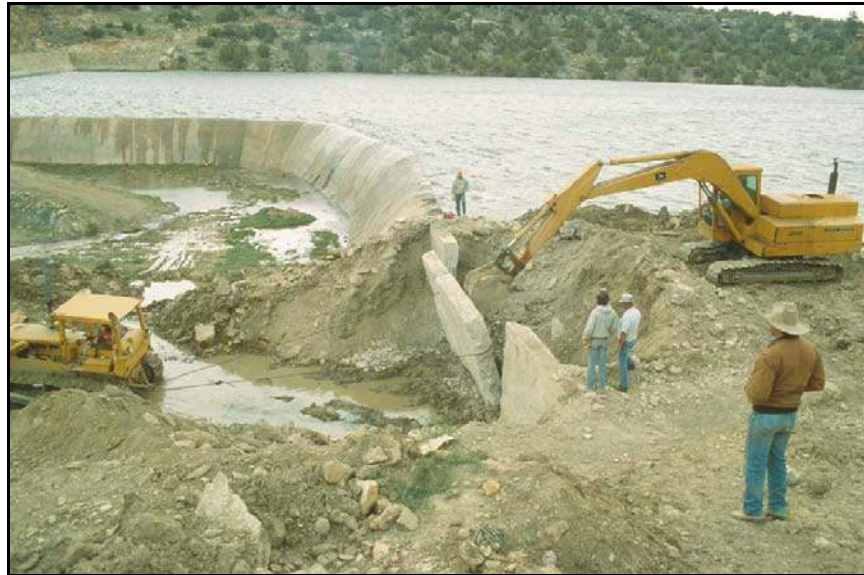
Figure 155.—Spillway being partially breached to lower the reservoir.

The concrete control structure/weir of an existing spillway can be partially or fully removed to facilitate the lowering of the reservoir in the event of an emergency. The concrete control structure is typically used in earth cut spillways as a grade fill. If blasting is employed to remove the concrete, caution should be taken to ensure that the blasting does not cause additional damage to the embankment dam or foundation. Controlled blasting techniques with minimum particle velocities can be used effectively to remove the concrete structure. Figure 155 shows a concrete control structure being partially breached to allow for lowering of the reservoir.

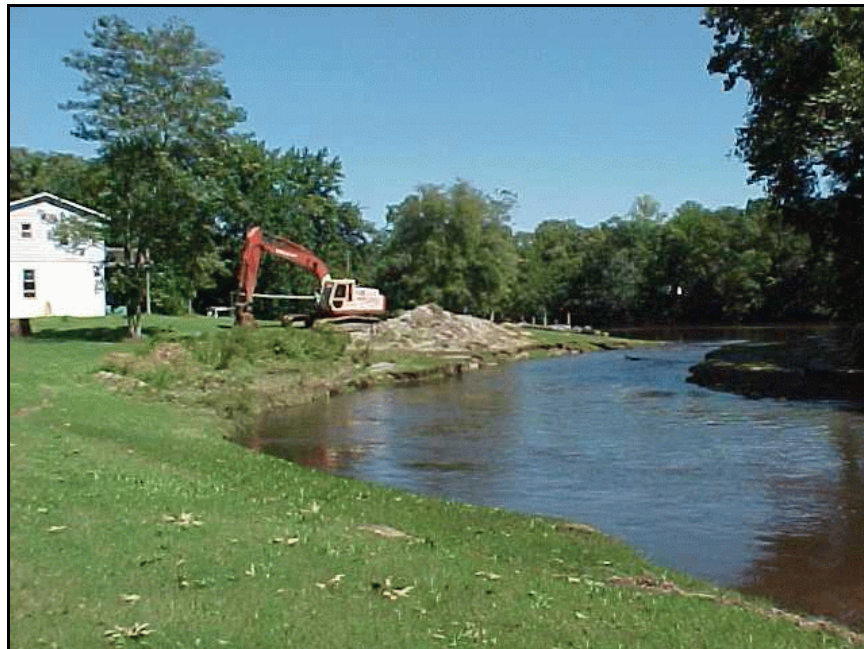
Figure 156.—The owner of this embankment dam excavated a channel around the dam to prevent its overtopping during a hurricane.

Similarly to excavating a channel through an existing earthcut spillway, a trench can be excavated through the abutment of the embankment dam (figure 156) to provide emergency release of the reservoir, if required. The trench should be properly located to ensure that uncontrolled releases of the reservoir through the channel do not encroach upon the embankment dam and cause an unanticipated breaching of the embankment dam. Care should also be employed to ensure that the excavated channel does not cause larger-than-anticipated flooding downstream of the embankment dam. Construction and cautions similar to those mentioned in the previous section for the excavation of a trench through an existing earthcut spillway should be employed.

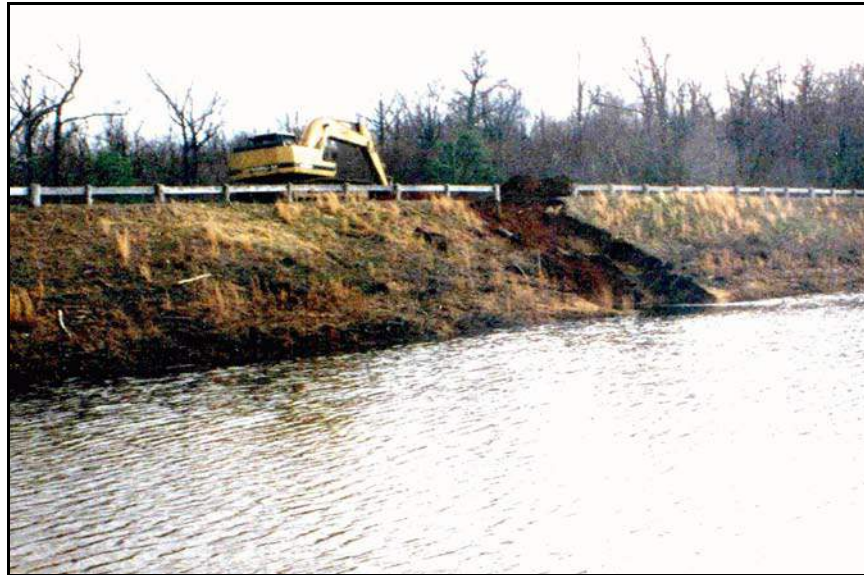
Figure 157.—A controlled breach of an embankment dam begins after the 45-year old CMP spillway conduit collapsed and the lake level began to rise.

The breaching of the embankment dam should be done in stages and in a controlled manner to ensure that a catastrophic failure of the embankment dam does not occur, causing unanticipated and unwanted downstream property damage or loss of life (figure 157). First, a discharge channel should be excavated down the embankment downstream face or abutment area to convey the discharging water safely to the downstream channel. This channel should be excavated down to or into erosive-resistant materials, if possible. If not, the excavated channel should be protected by lining the channel with erosion-resistant materials, such as rock riprap, concrete rubble (if temporary), sandbagging, plastic sheeting, or geotextiles. The embankment dam can then be breached in a slow and staged operation. The embankment dam is first excavated down to a point that will allow a predetermined maximum amount of water to flow through the breach. The initial flow of water through the breach should be as minimal as possible and allowed to stabilize and diminish before removing another small portion of the embankment dam. The excavation of the embankment material should be kept at a minimal amount to limit the quantity of water discharging through the breach section at any time. This process can then be repeated until the desired breach dimensions have been obtained. If possible, a cofferdam should be upstream of the area to be breached, which serves to prevent a catastrophic failure, if the breached section begins to erode in an uncontrolled manner. See the Balman Reservoir Dam and Empire Dam case histories in appendix B for examples of controlled dam breaches to draw down reservoirs.

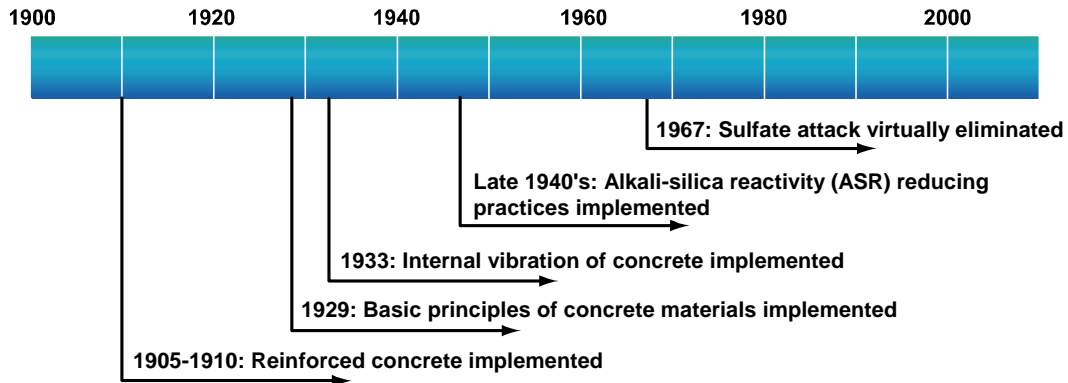
Figure 158.—An example of a historical timeline that can assist the designer in evaluating the condition of a conduit.

The understanding of a historical timeline can often assist the designer with identifying conduits that may remain relatively free of long term deterioration and those that may require actions for renovation, replacement, or repair. Typically, timelines cannot specifically identify exact dates or structures when changes in methods or materials may have occurred because most of the available information is based upon a collective understanding that evolved over a period of time. Available timelines in many cases may be agency specific. An example of a historical timeline developed by Reclamation is illustrated in figure 158. This timeline was developed based on significant events that have occurred in regards to their experience with concrete technology. Using a timeline such as this, if the designer knows the approximate date of construction for a particular conduit, a preliminary assessment of its likely condition can be made.

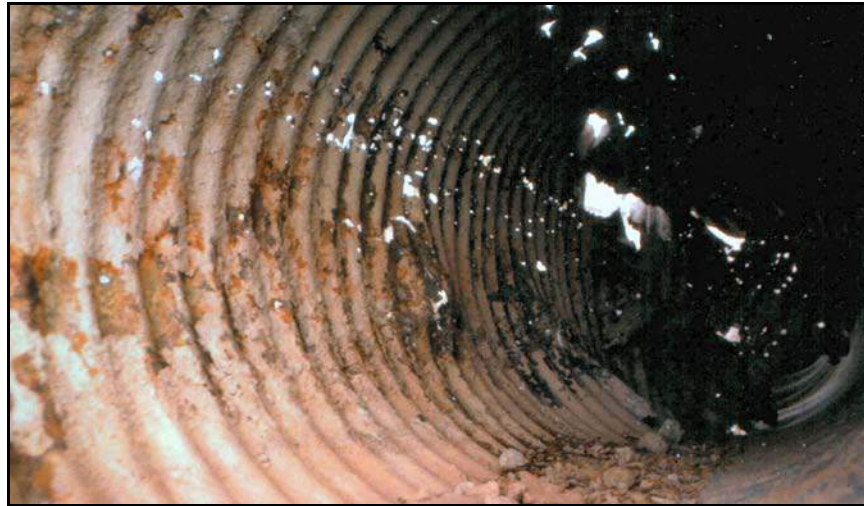
Figure 159.—The holes in this CMP conduit were clearly visible after removal. The conduit was considered to be so severely corroded that sliplining was not an option and it was removed and replaced. Photo courtesy of Maryland Dam Safety Division.

- *Deterioration process.*—If deterioration of the existing conduit is caused by a corrosive process, then the useful life expectancy of the existing conduit should be evaluated based on the knowledge that deterioration will continue. Generally, the slipliner should be designed to accommodate all internal and external loadings without any support provided from the deteriorating conduit. If the existing conduit is expected to provide support for the new slipliner, and the life expectancy of the existing conduit is less than the life of the project, then removal and replacement should be considered (figure 159).

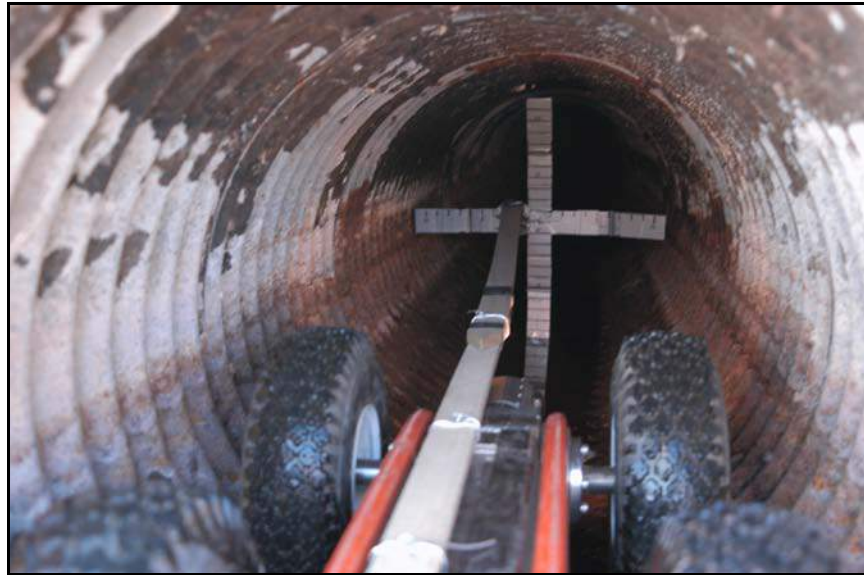
Figure 160.—Crossbar template attached to a CCTV camera-crawler to check for irregularities in the CMP conduit.

protrusions, or irregularities in the existing conduit will control the selection of the slipliner diameter. The pulling or pushing of a template (figures 160 and 161), inflatable pipeline sphere, or soft (typically open cell polyurethane foam) pig (figure 162) through the existing conduit is recommended. This will also ensure that sliplining can be done without difficulty.

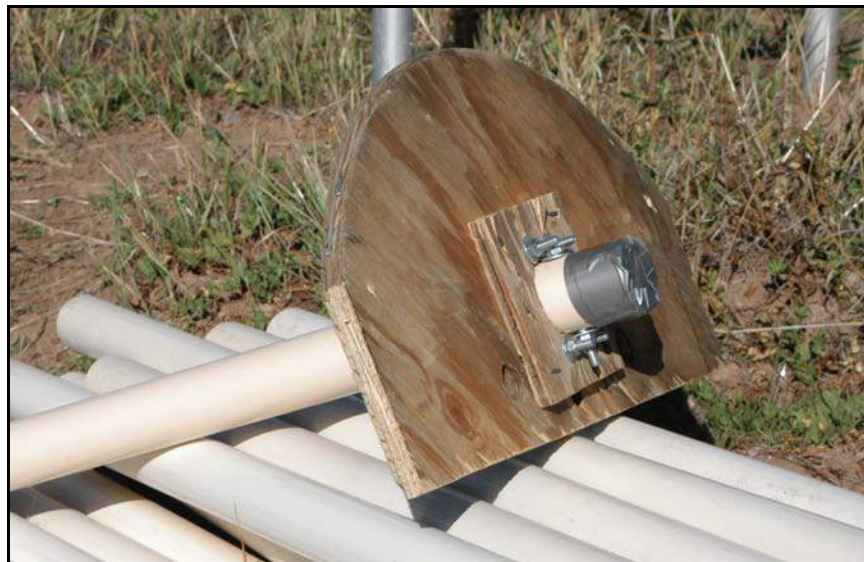
Figure 161.—A horseshoe shaped template used for checking irregularities in a conduit. The template is attached to the CCTV camera-crawler.

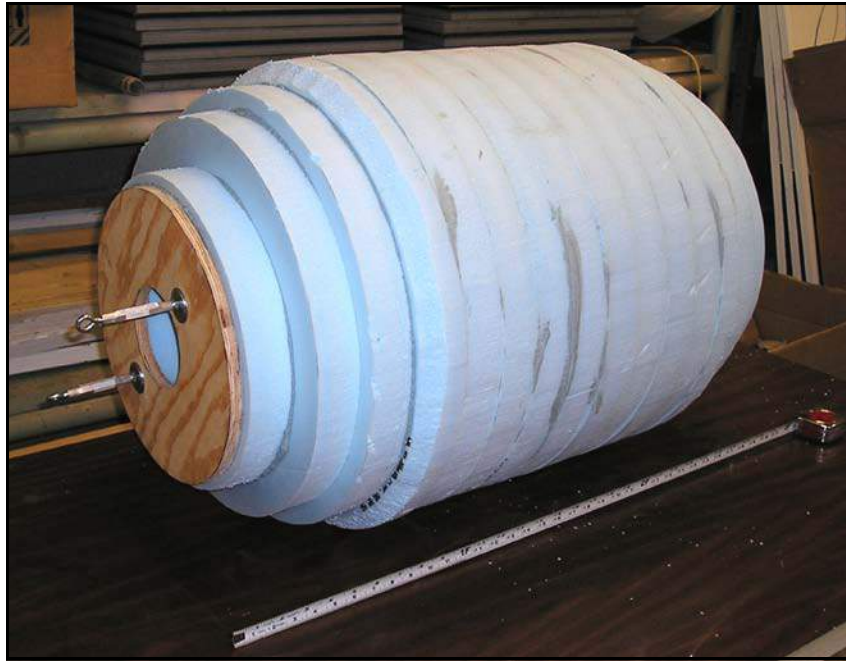
Figure 162.—A styrofoam pig used for checking irregularities in a conduit.

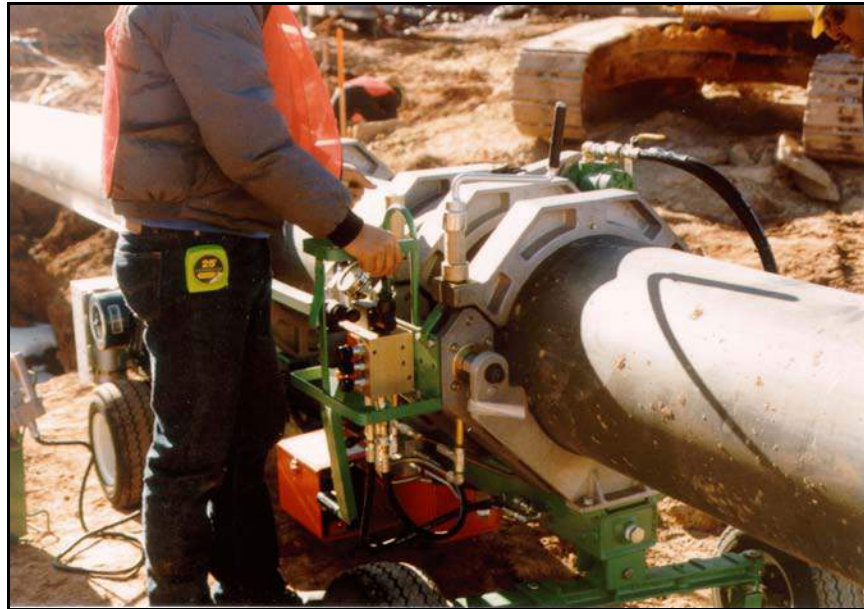
Figure 163.—HDPE pipe joint being fusion welded.

Joints.—The most common method used to join HDPE pipe is heat fusion (ASTM D 2657). This method is also known as butt fusion. The butt fusion technique is a widely used and industry-accepted heat fusion method for joining sections of smooth solid walled HDPE pipe. This method produces a joint that is watertight and is as strong or stronger than the HDPE pipe material itself, if performed correctly. A special machine (figure 163) is used to trim the ends of the pipes (facing or squaring off), align the ends of the pipe, heat both ends of the pipes to about 400 to 450 °F, and force the ends together under pressure. The melt bead size required for the thickness and diameter of the HDPE pipe determines how much pressure and time is needed for fusion of the joint. About 1 hour should be allowed for the joint to adequately cool after completion of the fusion process (figure 164). Trial fusions should be considered at the beginning of the day, so the fusion procedure and equipment settings can be verified for the actual jobsite conditions. Manufacturer's recommended procedures should always be observed for heat fusion.

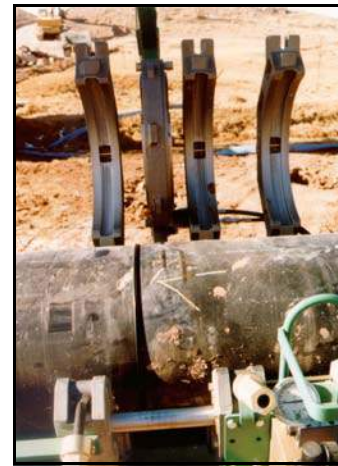
Figure 164.—Finished fusion welded joint.

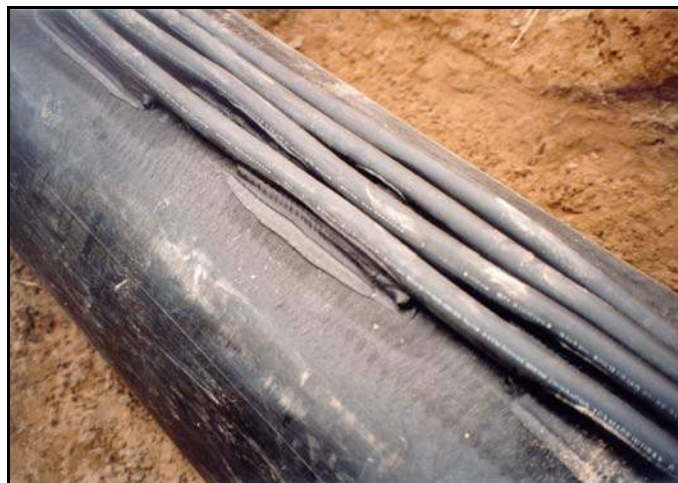
Figure 168.—HDPE grout pipe attached to HDPE slipliner.

and air vent pipes to the slipliner (figure 168). Extrusion welding cannot be used to repair damaged HDPE pipe.

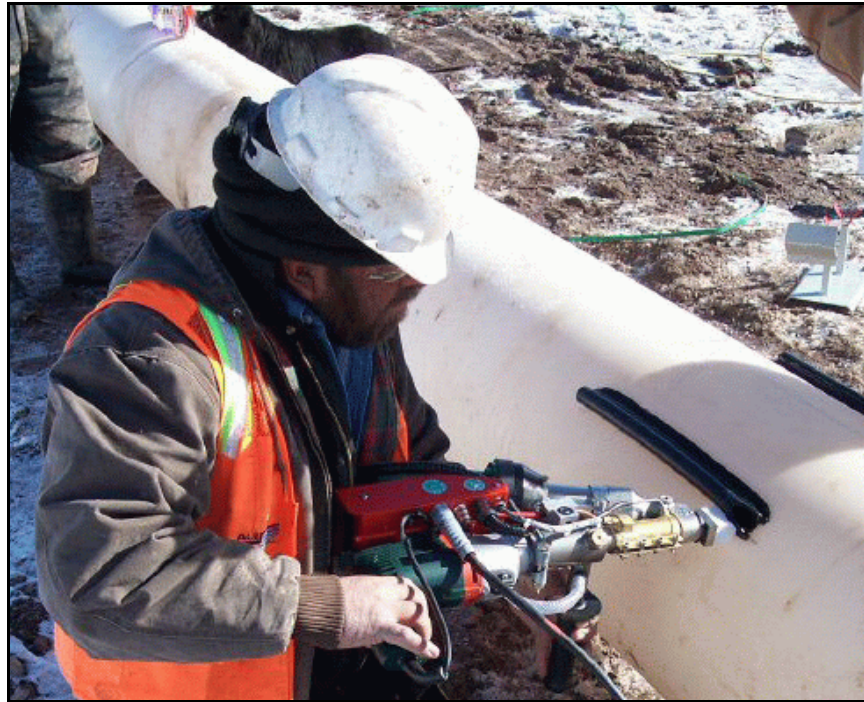
Figure 169.—Spacers being attached to an HDPE slipliner using an extrusion gun.

Steps should be taken to address this floating potential, such as using spacers or blocking between the existing conduit and the slipliner. Figure 169 shows an example of spacers being attached to the HDPE slipliner by extrusion welding. Some manufacturers have recommended that the HDPE pipe be filled with water to reduce flotation of the pipe during grouting. However, this does not always prevent flotation, because water is not as dense as the surrounding grout, and blocking is still necessary. Other manufacturers strongly advise against filling the HDPE pipe with water and instead recommend properly installed blocking and staged grouting.

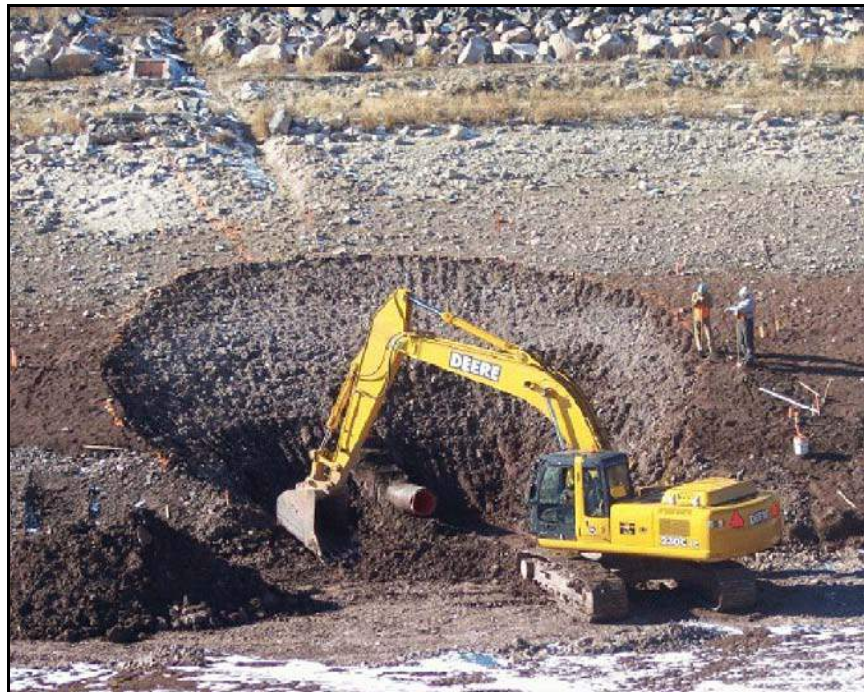
Figure 170.—The intake structure has been removed as part of a conduit renovation.

Entrance and terminal structures.—The sliplining of an existing conduit may require partial or full removal and replacement of certain structures to improve release capabilities or to facilitate construction. Figure 170 shows an intake structure

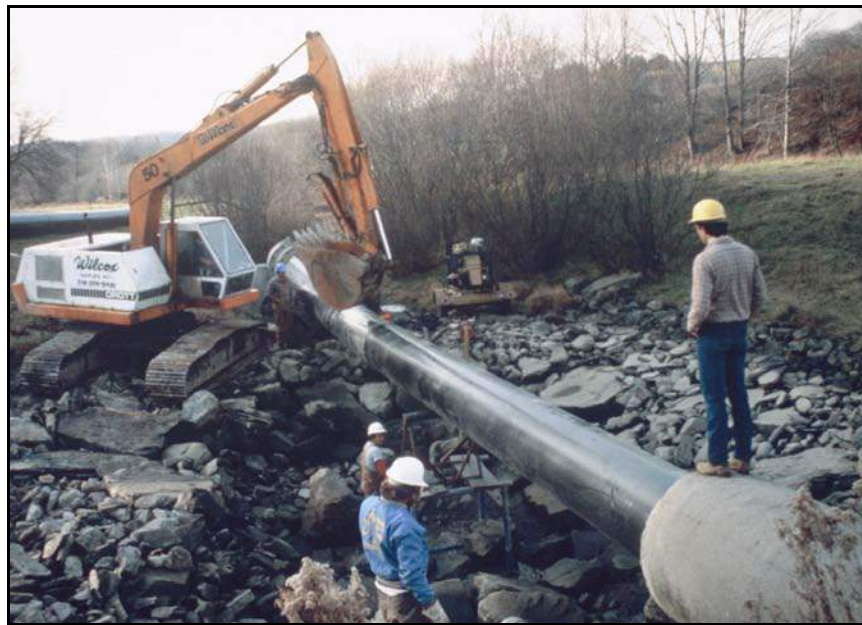
Figure 171.—Insertion of an HDPE slipliner into an existing concrete conduit. A backhoe is being used to assist with slipliner insertion.

- *Access and insertion.*—HDPE pipe is light in weight relative to more traditional pipe materials, and as such is easier to insert into existing conduits. Pulling, pushing, or a combination of both are the typical methods for slipliner insertion. Backhoes, bulldozers, and winches have been used to assist with the slipliner insertion (figure 171).

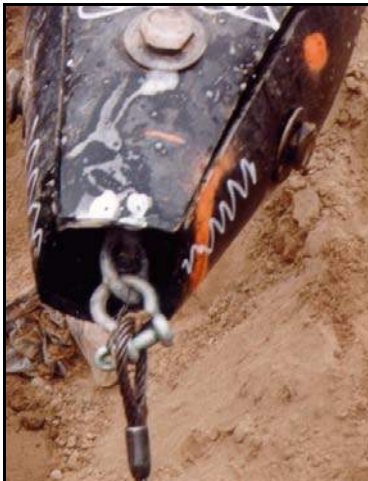
Figure 172.—Nose of HDPE slipliner modified for pulling into an existing conduit.

The nose cone pulling head (also known as the banana nose or soft nose) is a simple and cost effective configuration to use where the pulling stress on the HDPE slipliner is less than 700 lb/in². The nose cone pulling head is made from a few extra feet of HDPE pipe that has been fused onto the slipliner. Evenly spaced wedges are cut into the leading edge of the pulling head. A couple of alternatives exist for the nose cone configuration: (1) the wedges are collapsed towards the center to form a cone and fastened together with bolts. A pulling cable is attached to secondary bolts that extend across the collapsed nose (figure 172) and (2) holes are drilled through the wedges and cables or narrow plates are attached to the wedges. The cables or plates are attached to a pull ring (figure 173).

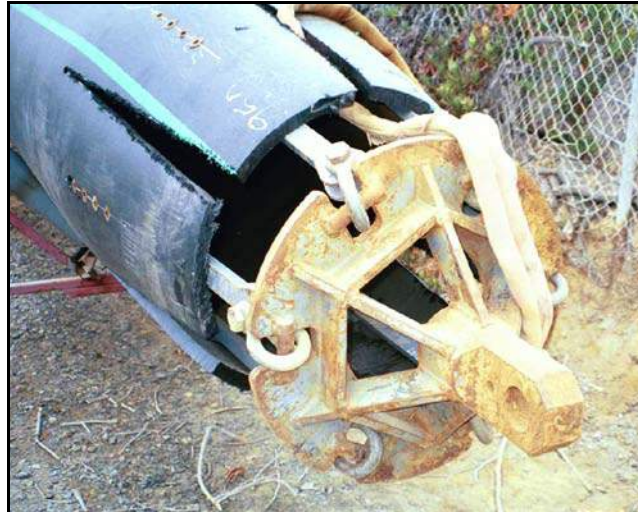
Figure 173.—A nose cone configuration utilizing a pull ring.

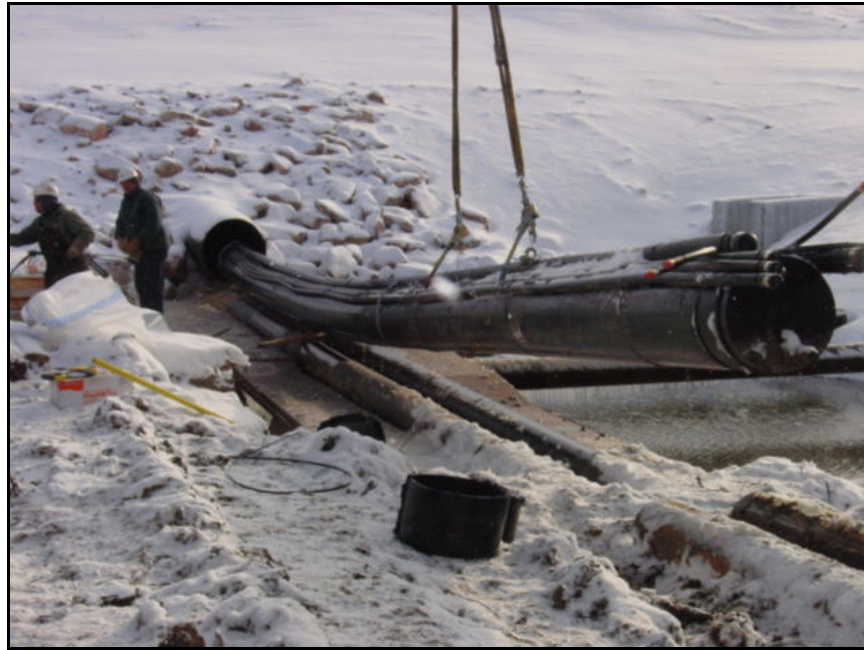
Figure 174.—Insertion of an HDPE slipliner into an existing CMP outlet works conduit.

Blocks of wood or other material (called blocking or bridging) should be attached to the top of the HDPE slipliner, so that the slipliner will not contact the top of the existing conduit. Once the slipliner insertion (figure 174) begins, it should continue without any stoppage until completion. The pulling method will result in some stretching of the HDPE slipliner (1 percent of the total length). The slipliner will also experience differential temperatures before and

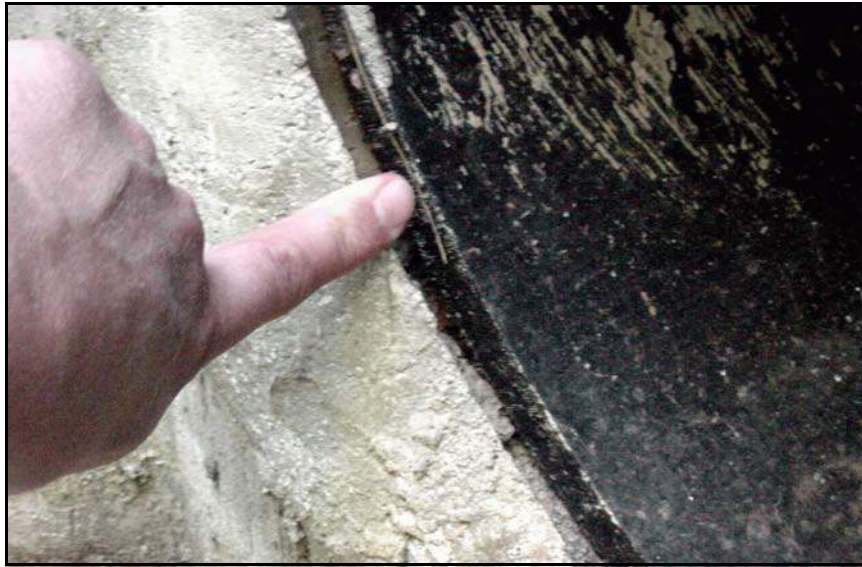
Figure 175.—This gap shows that the designer did not adequately consider the potential for thermal expansion/contraction during installation of this HDPE slipliner. To avoid this problem, the HDPE slipliner should have been designed to extend beyond the end of the existing conduit.

after insertion, which will affect the length of the slipliner (1 in./100 ft/10 °F). Allowances for these changes in HDPE slipliner length need to be considered during insertion (figure 175). A 24-hour relaxation period is recommended to allow the slipliner to recover its length.

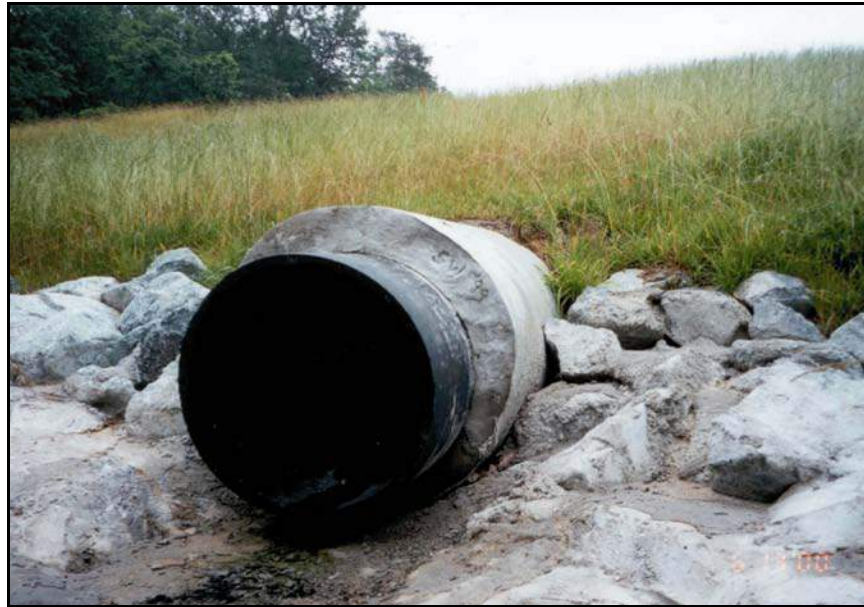
Figure 176.—Completed HDPE slipliner in existing CMP spillway conduit. Photo courtesy of Maryland Dam Safety Division.

Postinspection and acceptance.—The completed HDPE slipliner (figure 176) should be visually inspected by trained personnel to evaluate the conditions within the renovated conduit. If the sliplined conduit is too small for man-entry inspection, CCTV inspection methods should be used. Some designers may want to consider the use of white or gray HDPE pipe to reduce glare using CCTV equipment, figure 177 shows an example of this type of pipe. See section 9.5.2 for guidance on inspection of conduits. No localized dimpling or distortion of the HDPE slipliner wall or infiltration of groundwater or grout should be present.

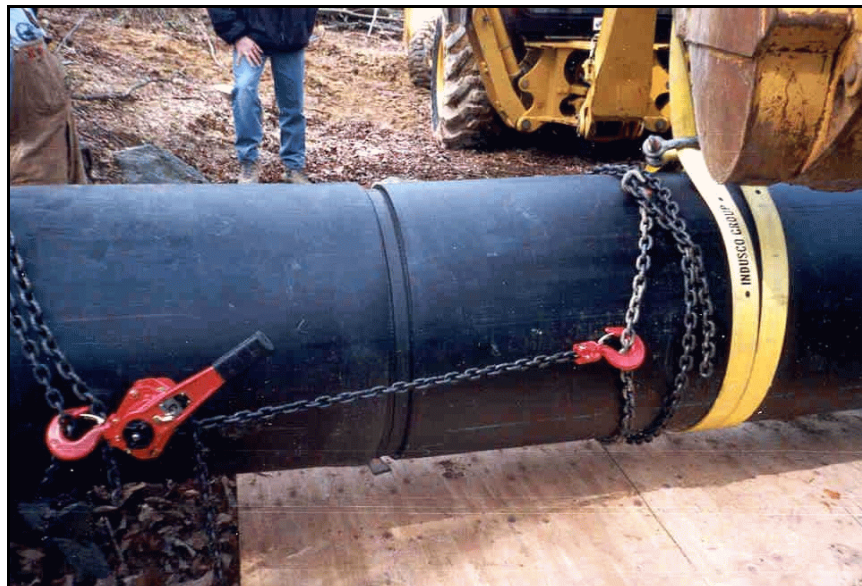
Figure 179.—Sections of proprietary Snap-Tite® pipe can be easily handled with small equipment.

HDPE joint fusion machines require specialized contractors, and mobilizing them to a construction site can add to the cost of a sliplining project, especially for smaller embankment dams. For some nonpressurized projects in low hazard embankment dams, an alternative product, such as “Snap-Tite®” may be used. This proprietary product consists of gasketed joint grooves machined onto lengths of standard HDPE pipe. This alternative is not appropriate for use with pressurized conduits, due the possibility of leakage through the gasketed joints. This type of pipe is lightweight, and sections of the pipe can be easily handled by three or four workers and a backhoe (figure 179). After the first section of the pipe is inserted into the existing conduit, the next section is aligned with the first section and the joint is lubricated and pulled together with “come-along hoists” and chains wrapped around the liner. As in the usual method of installing HDPE slipliner, the first section of the pipe is tapered to allow the leading edge to ride over irregularities in the existing conduit. The joined sections of pipe can be pulled or pushed into the existing conduit. Pulling from the upstream end is preferred, because in some cases, excessive force used to push the liner from the downstream end has damaged some joints. The blocking and grouting procedure would be the same as that for fused HDPE pipe. For further design and installation details, see the manufacture’s data.

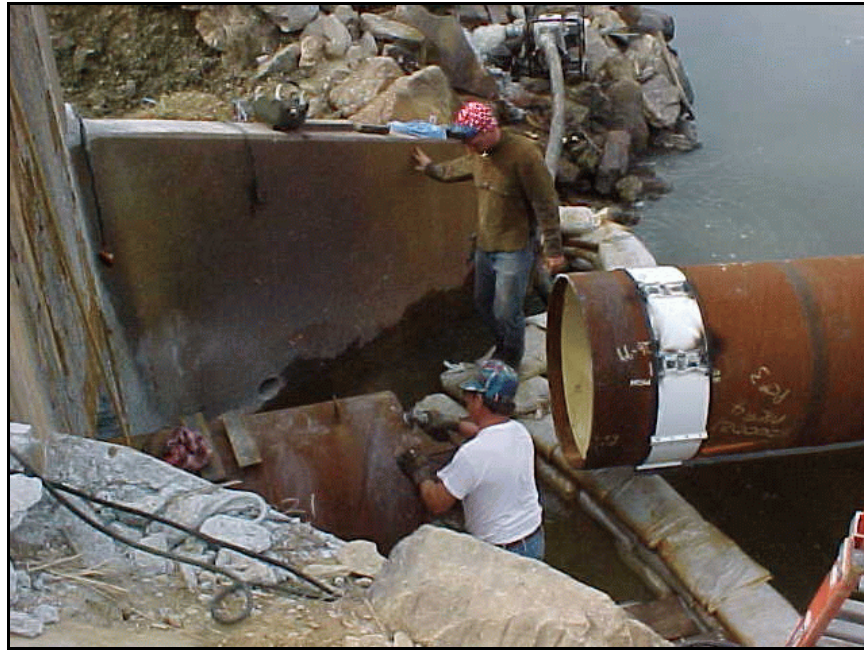
Figure 180.—The Lake Linganore Dam outlet works consists of a 48-in diameter RCP conduit with a sluice gate located at the downstream end, which places the conduit under full reservoir head at all times. Concern about the integrity of the RCP joints led to installation of a steel slipliner when the inoperable sluice gate was replaced.

Steel pipe slipliners (figure 180) are generally applicable, if the existing conduit is straight and does not have bends or significant invert slope changes. Steel pipe slipliners can be installed in conduits with bends or slope changes, if adequate clearance will allow for the insertion of the fabricated pipe sections.

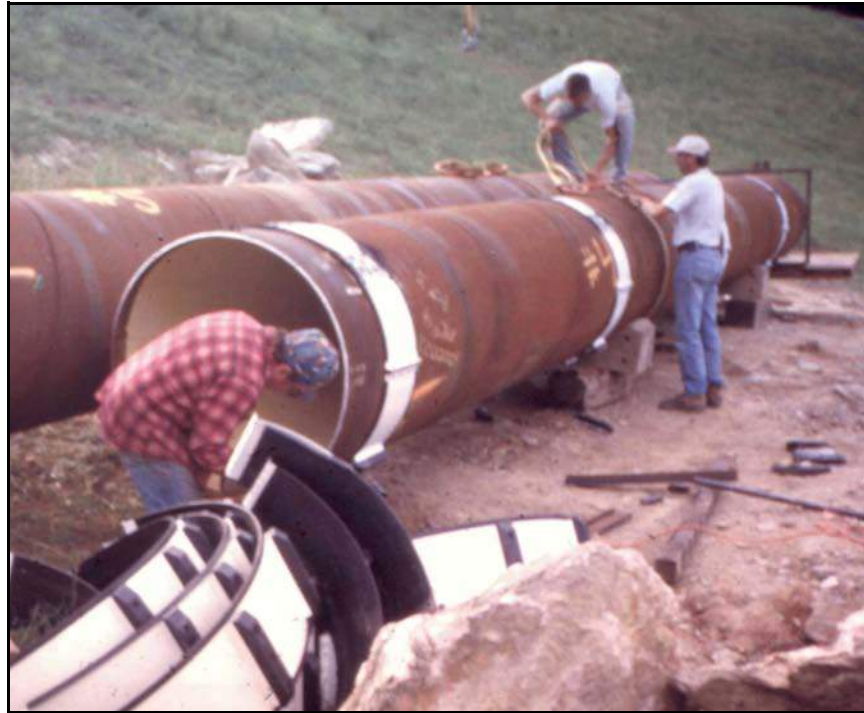
Figure 181.—Spacers being installed on a steel pipe slipliner.

Installation.—The steel pipe slipliner should be supported and braced to prevent distortion during installation and grouting. Spacers are required to maintain separation between the existing conduit and the steel slipliner during grouting. Figure 181 shows spacers being installed on a steel pipe slipliner. Guidance on installation includes the following. Additional guidance on steel pipe installation is available in AWWA M11 (2004c).

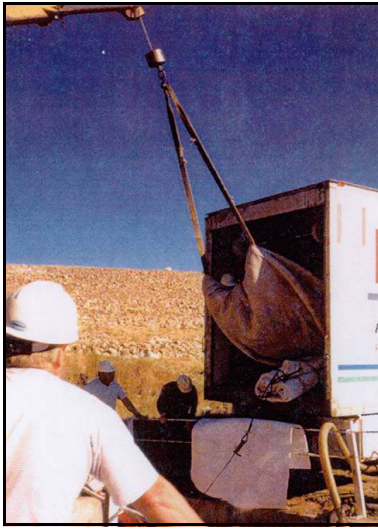
Figure 182.—Unloading the CIPP liner prior to installation.

- *Access and insertion.*—Two methods of installation are available for insertion of the CIPP liner:
 1. *Inversion method.*—The inversion method (figures 182 through 184) consists of utilizing air or water (hydrostatic head) to push the CIPP liner inside-

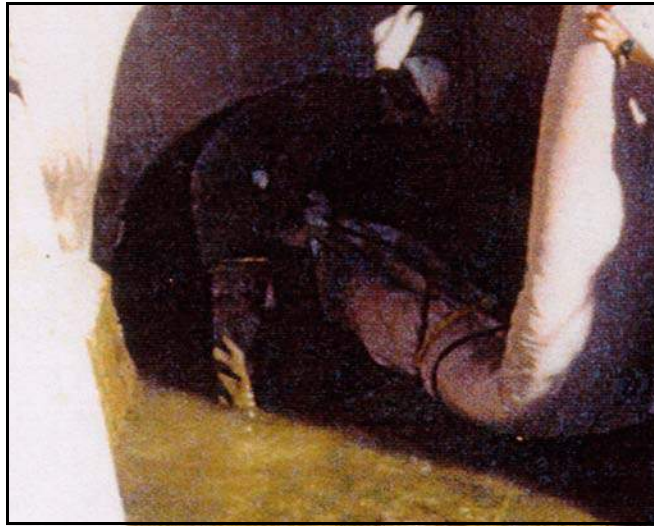
Figure 183.—CIPP liner being positioned for installation.

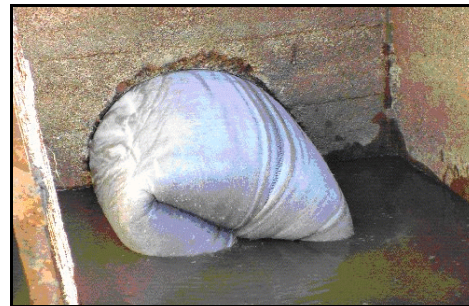
Figure 184.—The hydrostatic inversion method is being used for CIPP liner installation into an existing conduit.

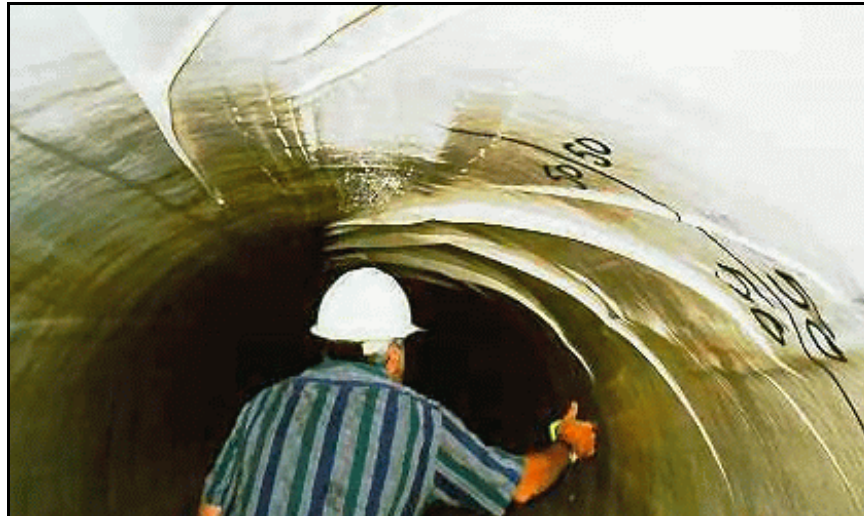
Figure 185.—The calibration hose of this pulled-in-place CIPP developed “fins.” These fins were considered to have an insignificant effect on hydraulic capacity for this particular conduit application and were not removed.

— Trained personnel should visually inspect the completed CIPP installation. No dry spots, lifts, delamination, pinholes, or infiltration of groundwater should be present and the CIPP liner should be in a fully expanded condition. Wrinkles (figure 185) that could reduce the hydraulic capacity of the CIPP liner should not be allowed. If the CIPP-lined conduit is too small for man-entry inspection, CCTV inspection methods should be used. See section 9.5.2 for guidance on inspection of conduits.
