Technical Manual: Conduits through Embankment Dams

Best Practices for Design, Construction, Problem
Identification and Evaluation, Inspection,
Maintenance, Renovation, and Repair

September 2005

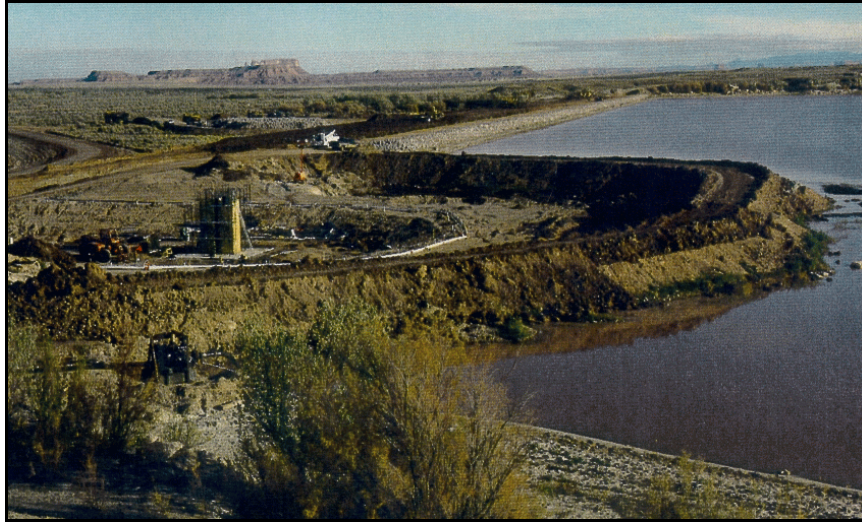
Figure 187.—Cofferdam constructed around the construction area for a new outlet works.

A cofferdam (figure 187) may be needed to act as a temporary barrier to protect the construction area from flooding (Reclamation, 1987a, pp. 499-500). If construction for the removal and replacement of the existing conduit can be performed during the low water season, the use of a cofferdam may be minimal. However, where the reservoir inflow characteristics are such that construction cannot be done during a low water season, the cofferdam must be designed for safety and for optimal height to accommodate the full range of expected inflows during the construction period. Often the flood selected for sizing diversion requirements is based on the projected length of the construction period. For instance, if the projected length of the construction period is 1 year, the cofferdam would need to be able to accommodate a flood with a return interval of 5 years. If the projected length of the construction period is 2 years, a 10-year diversion flood would be used.

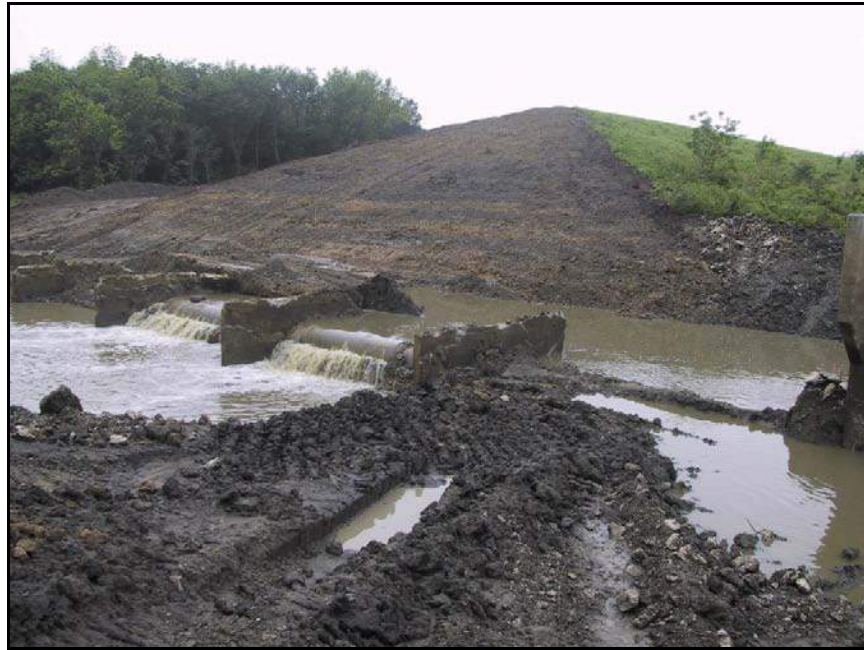
Figure 188.—During the removal of this outlet works conduit a flood occurred. No stream diversion or cofferdam was used at this site.

At some sites, a diversion channel in lieu of a cofferdam may be more practical. Diversions or cofferdams may not be justified for smaller embankment dam projects with limited working room for the removal and replacement of conduits. For these projects, certain hydrologic events during construction may impede progress and cause delays resulting in added costs for clean up of debris caused by flooding. For this situation, construction should be scheduled during periods when the lowest rainfall is probable to avoid these problems. Figure 188 shows an embankment dam site where rainfall during construction has partially flooded the exposed excavation and conduit removal. This flooding resulted in a delay and cleanup before construction could resume.

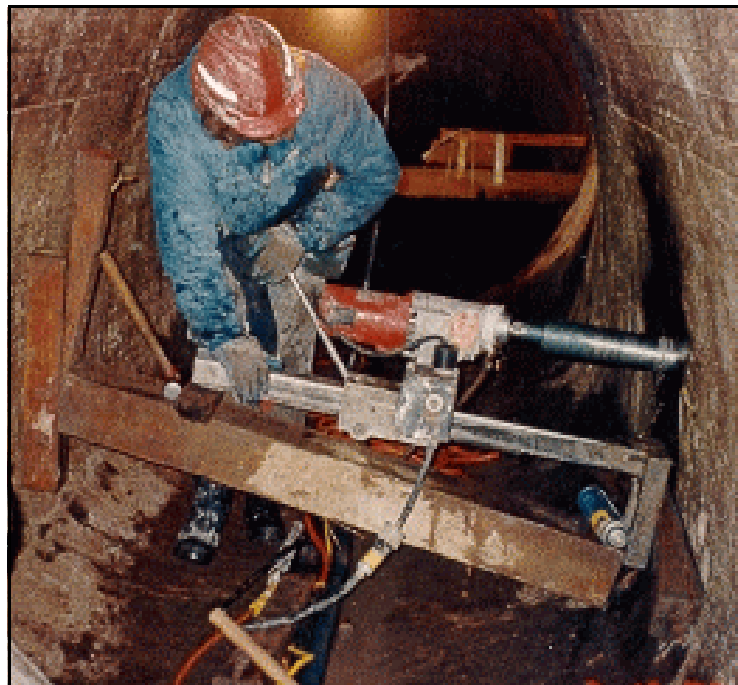
Figure 191.—Drilling a grout hole from the interior of a conduit.

Any cracks or other defects should be plugged prior to grouting operations. Unless conditions indicate otherwise, grout holes should be drilled and grouted in an appropriate pattern beginning at the downstream end of the conduit at the pipe invert progressing up and around the pipe and from the downstream to the upstream end of the conduit. Figure 191 shows the drilling of a grout hole from the interior of an existing conduit.

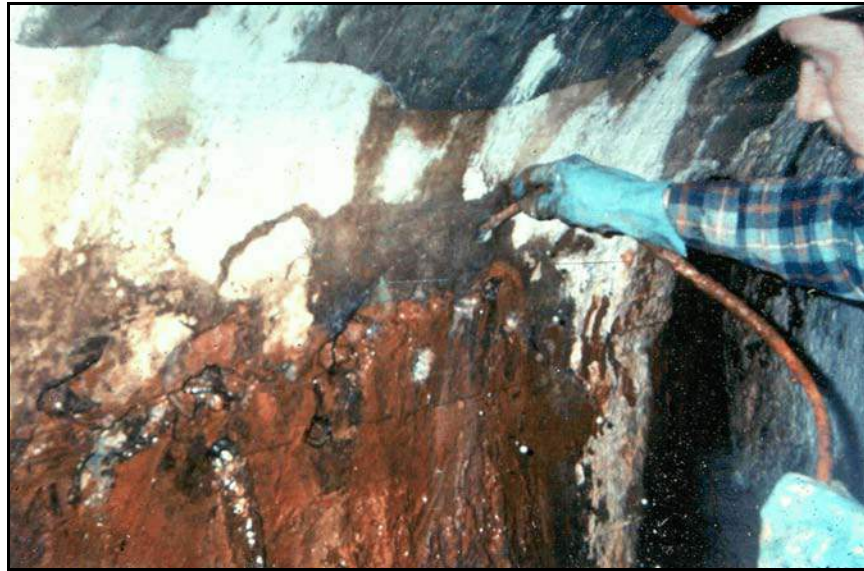
Figure 192.—Injection of urethane grout to stop leakage.

- *Cementitious*.—For guidance on cementitious grout, see section 14.2.2.
- *Chemical*.—For guidance on chemical grout, see section 14.2.2. Figure 192 shows grouting operations within a conduit. Chemical grouts have also been used for grouting voids using drill holes from the surface of the embankment dam. For additional guidance on chemical grouts, see USACE's *Chemical Grouting* (1995a).

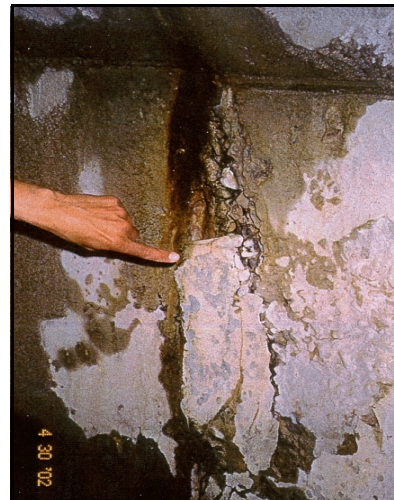
Figure 193.—Determine the cause of the damage to determine the proper repair method.

- *Determine the cause(s) of damage.*—The cause of damage or deterioration (e.g., abrasion, cavitation, poor design and construction, etc.) to the original concrete must be assessed (figure 193), or else the repair of concrete may also become subject to the same damage or deterioration. A determination must be made as to whether the damage is the result of a one-time or a recurring event. The damage could also be the result of multiple causes, such as improper design, low quality materials, or poor construction technique.
- *Evaluate the extent of the damage.*—The extent and severity of the damage and the effects on the serviceability of the existing conduit must

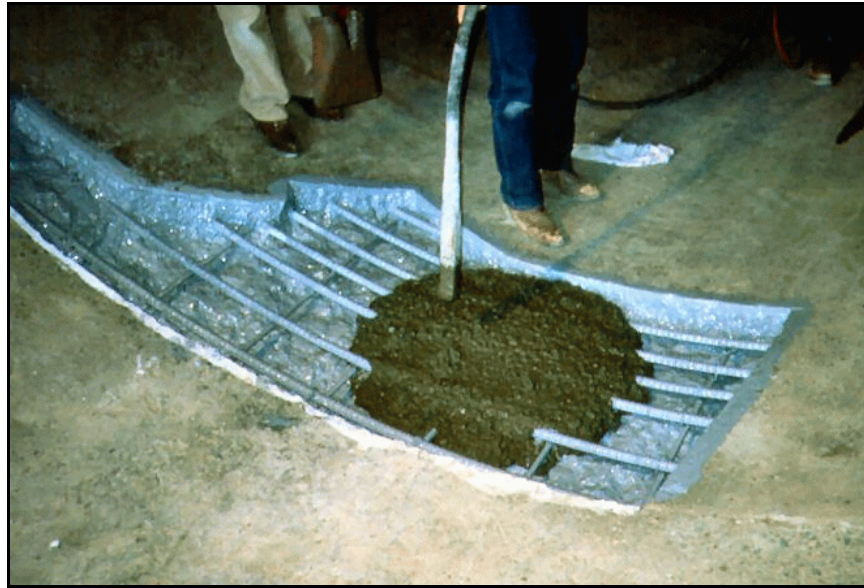
Figure 195.—A repair being made using epoxy-bonded replacement concrete. The use of epoxy resin ensures a strong, durable bond between the old concrete and the replacement concrete.

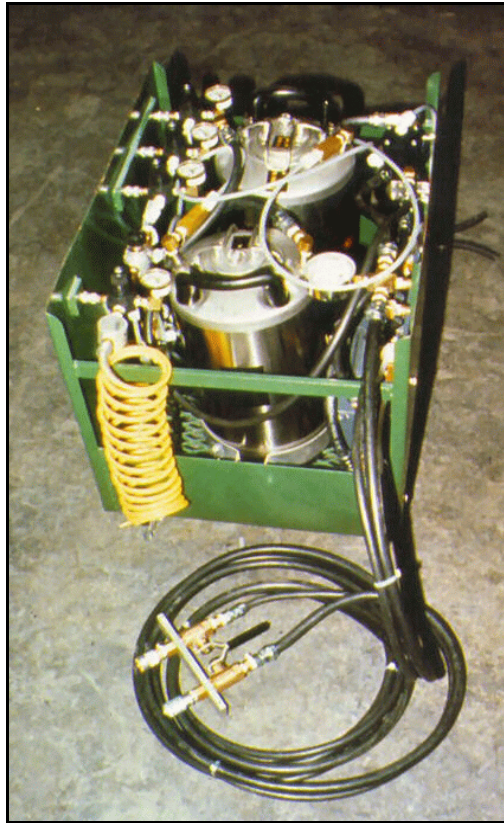
Figure 196.—An example of resin injection equipment used for small repair projects. Components are pumped independently and mixed at the nozzle for injection.

Chemical grouts are classified as hydrophobic or hydrophilic depending on how reactive they are when mixed with water. Hydrophilic grouts can incorporate a large amount of water into the cured products, and may shrink substantially if allowed to dry out completely. Therefore, hydrophilic grouts should be used in locations which are not kept wet at all times. Hydrophilic grouts cure with lower strengths than epoxy types of grout and are not considered to produce a structural bond in the area being grouted. Hydrophilic grouts form a closed-cell flexible foam barrier to stop the seepage of water through the joint. These grouts are usually injected when the ambient air temperatures in the existing conduit is above 32 °F. Figure 196 shows an example of resin injection equipment used for small repair projects.

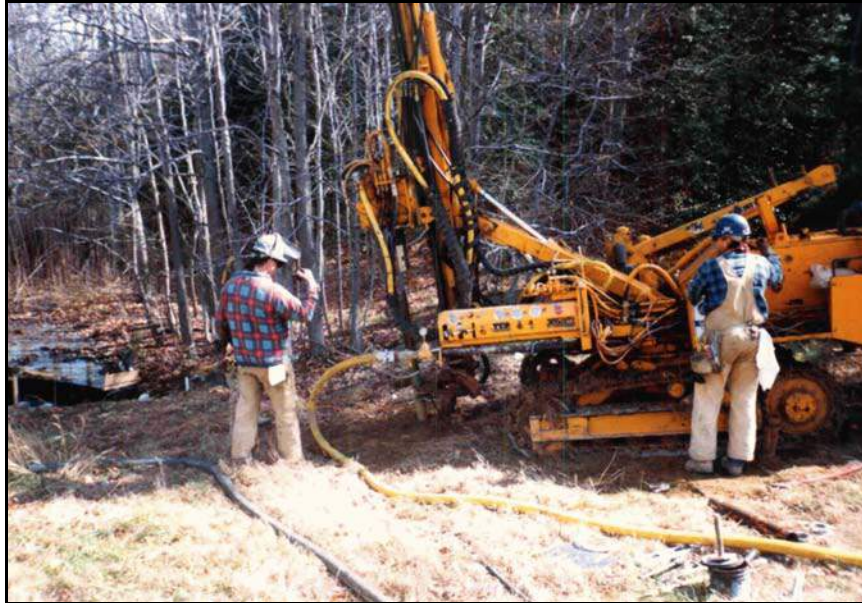
Figure 197.—Abandonment of a conduit by injection of cement grout through holes drilled from the surface of the embankment dam to depths of up to 60 feet.

- *Through holes drilled from the surface of the embankment dam.*— When the upstream and downstream ends of the existing conduit are inaccessible, it may be possible to fill the conduit with grout or concrete through holes drilled from the surface of the embankment dam (figure 197). In order to be successful, the precise location of the existing conduit must be determined, and the driller must be experienced and proceed with caution. For an example of this type of conduit abandonment, see the Clair Peake Dam case history in appendix B.

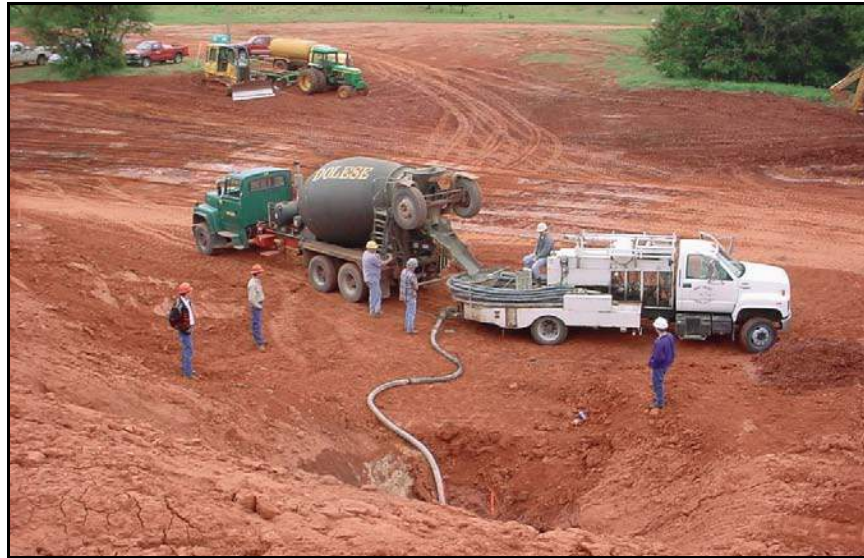
Figure 199.—Grout is delivered to the site and is pumped into the conduit being abandoned.

- *Procedure.*—The pressure at the crown of the conduit as measured at the vent pipe should not exceed 5 lb/in². Grouting is stopped when the air return pipe in the crown flows full with grout. Cap the grout and air return pipes. Remove the bulkhead upon completion of grouting operations. For grouting or backfilling of long existing conduits, the use of sections is recommended. Long grout or backfill placements could result in sufficient expansion and/or contraction to induce cracking of the existing conduit (concrete). The use of sections is also conducive to ensuring an acceptable seal. Figures 199 and 200 show grouting operations involved with the abandonment of an outlet works conduit.

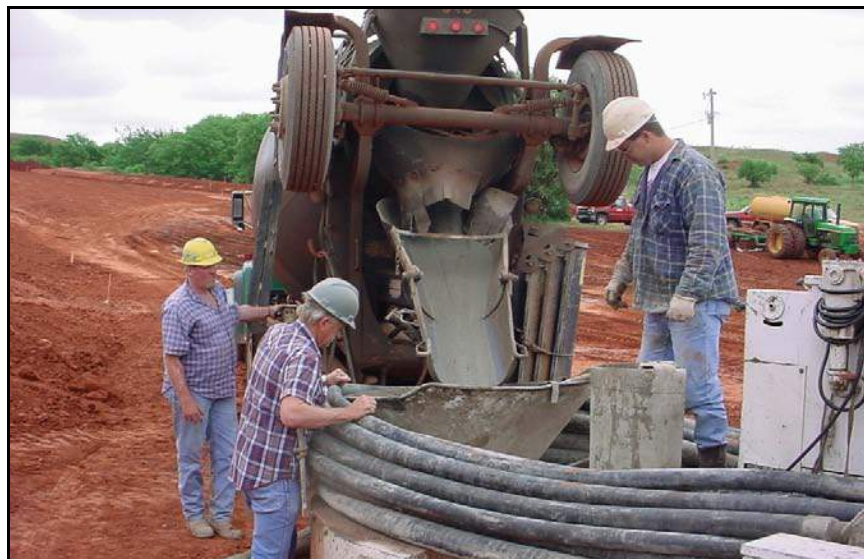
Figure 200.—Grout being delivered to the pumping truck.

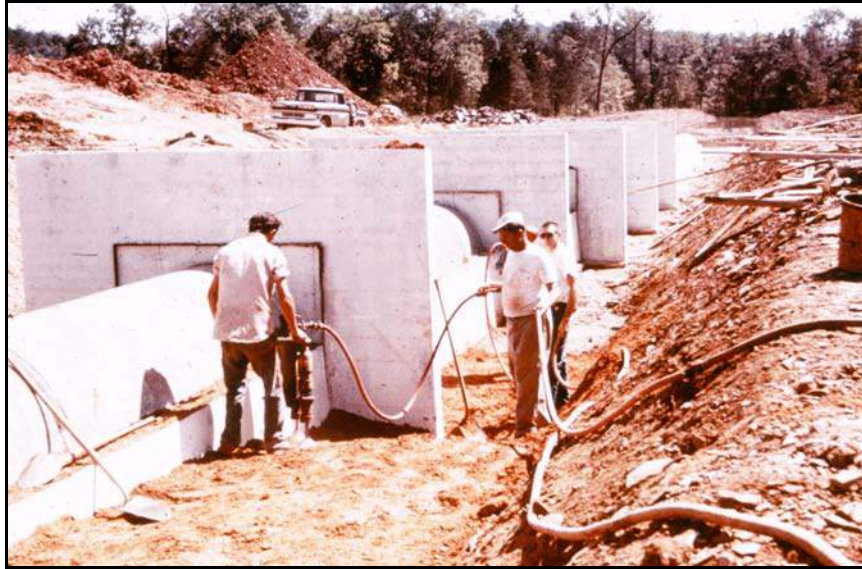
Figure A-1.—Hand tamping embankment material next to an antiseep collar.

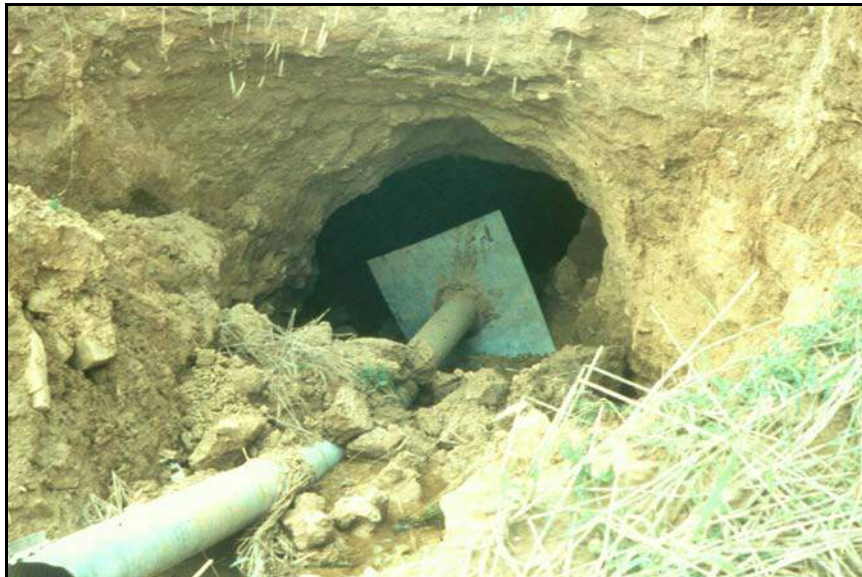
Figure A-2.—Internal erosion failure along a conduit with antiseep collars.

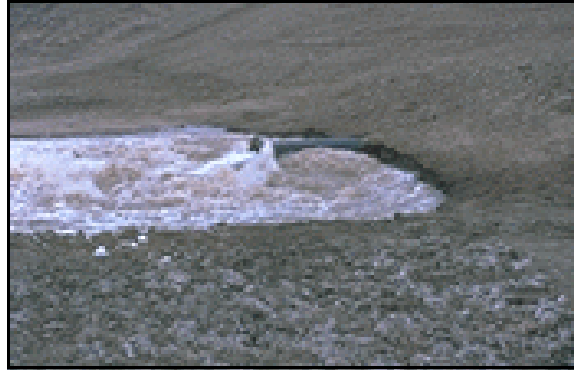
Figure B-1.—Outflow of water at downstream end of outlet conduit during failure. Note flow from conduit itself and from the area adjacent to the conduit.

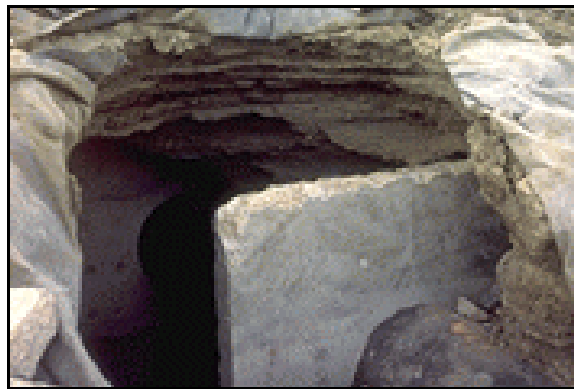
Figure B-2.—A view of upstream end of outlet conduit following failure. Note formation of caverns immediately adjacent to seepage cutoff collars. These caverns extend to the downstream embankment toe.

The reservoir completely drained through the outlet conduit and caverns in the earthfill adjacent to the conduit, concluding on March 27, 36 hours after initiation of the incident. Complete embankment dam collapse did not occur. Following drainage of the reservoir, inspections indicated that the embankment material had been completely eroded from around the outside of the conduit (figure B-2). The open tunnels immediately adjacent to the outlet conduit extended from the upstream embankment toe completely through the embankment dam to the downstream toe.

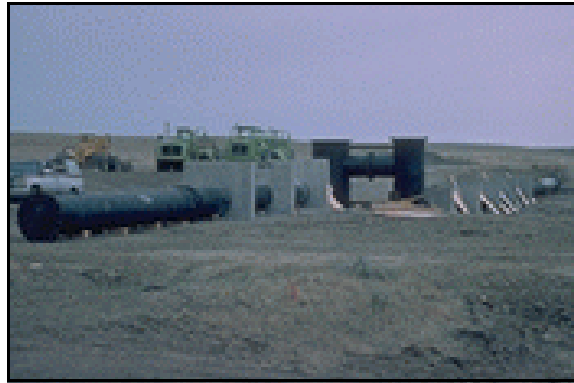
Figure B-3.—Initial construction of embankment dam and outlet conduit (upstream is to left). Note presence of antiseep collars surrounding conduit.

The cause of the failure was likely the combination of the dispersive clay embankment material, hydraulic fracture, antiseep collars (figure B-3) around the conduit that required the use of hand tampers (figure B-4), “flowable” backfill for conduit support in lieu of a continuous concrete conduit support, and lack of a filter and drain around the outlet conduit in the downstream portion of the embankment dam. Cold air flowed through the conduit during the winter preceding the failure. This caused lenses of frozen material in the conduit’s backfill. These lenses may have provided a path for concentrated leakage when they were thawed by the initial flow of water in the conduit during the runoff.

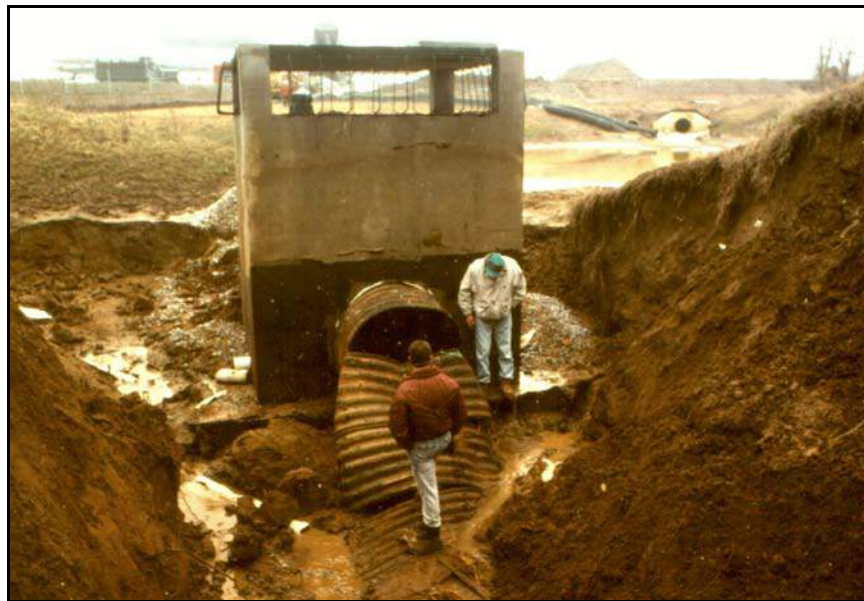
Figure B-5.—The upstream section of the 54-inch diameter CMP spillway conduit completely collapsed when the water level reached the elevation of the weirs on the inlet structure. Site personnel reported a “vortex” in the pool adjacent to the structure shortly before collapse.

In March 1993, a newly constructed embankment dam near Annapolis, Maryland, rapidly filled with water during a storm and failed, causing extensive environmental damage, but no loss of life or damage to downstream roadways. Figure B-5 shows the upstream section of the 54-inch diameter CMP spillway conduit, having completely collapsed when the water level reached the elevation of the weirs on the inlet structure.

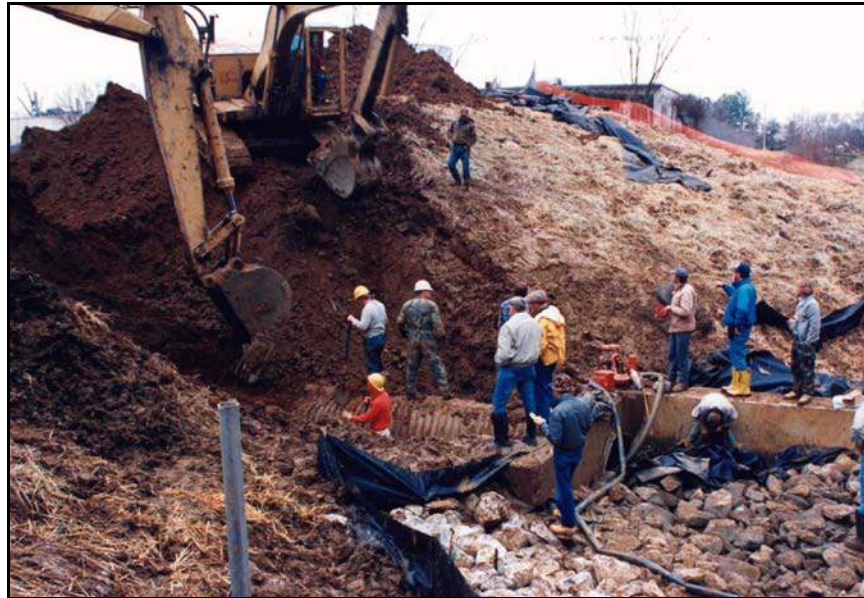
Figure B-7.—The spillway conduit and portions of the embankment soils were carefully removed and documented during a forensic investigation about 2 weeks after the failure.

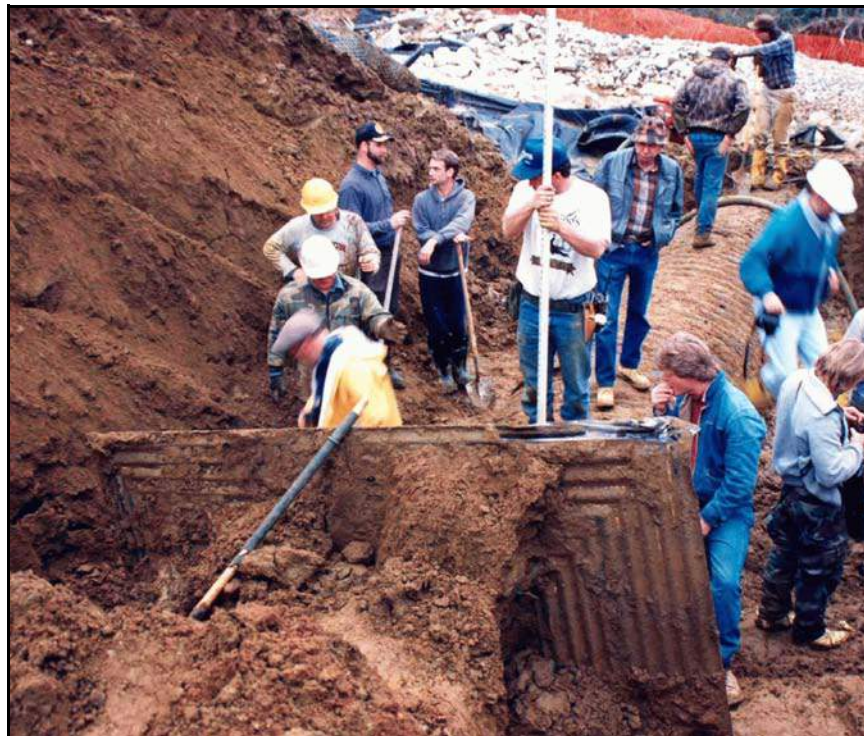
Figure B-8.—Starting at the downstream end of the conduit, two large excavators removed the majority of the earthfill under the watchful eyes of State and local officials, geotechnical engineers, surveyors, lawyers and the pipe manufacture.

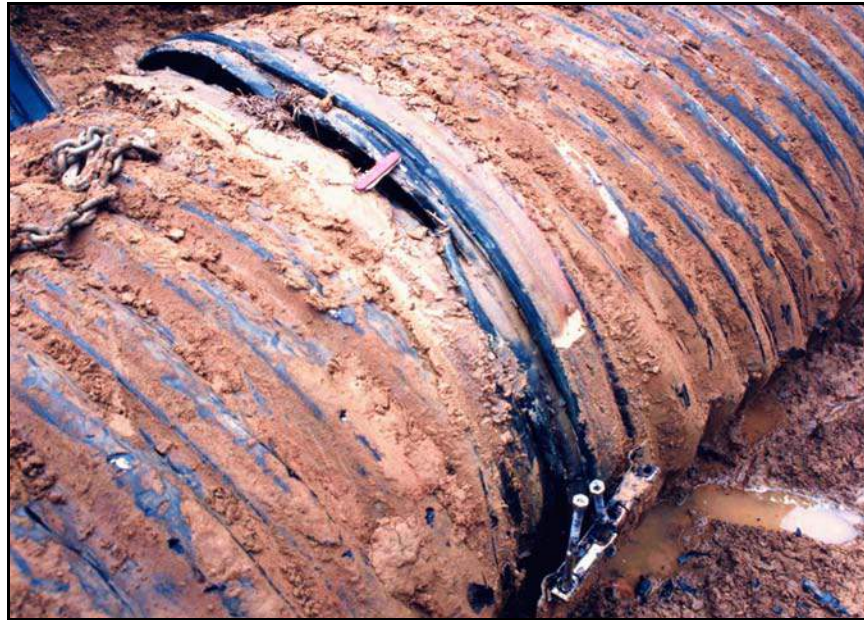
Figure B-9.—When the “hugger band” at the most downstream conduit joint was removed, the o-ring gasket was found to have been displaced. In addition, debris from the pool was found under the band, indicating that water may have flowed unrestricted along the outside of the conduit from the pool and into the joint.

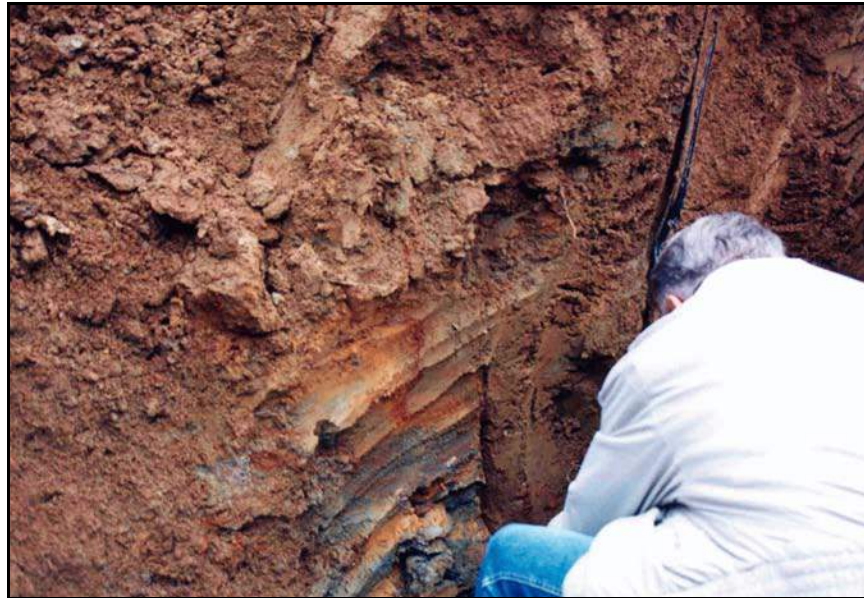
Figure B-10.—The presence of undisturbed foundation soils confirmed that the conduit was placed in a trench with nearly vertical sides, making it difficult to obtain good compaction of the fill soils under and along the CMP and around the antiseep collars.

The forensic investigation confirmed that the CMP was installed in a trench with near vertical sides. In addition, it appeared that the trench may have been overexcavated and backfilled with poorly compacted fill material, which was quickly eroded away by flow along the outside of the conduit and/or into open joints. Loss of soil support would have caused additional conduit deformation, further opening the joints, resulting in an ever-increasing cycle of leakage and loss of earthfill by internal erosion. Figure B-10 shows the presence of undisturbed foundation soils

that confirmed that the conduit was placed in a trench with nearly vertical sides, making it difficult to obtain good compaction of the fill soils under and along the CMP and around the antiseep collars.

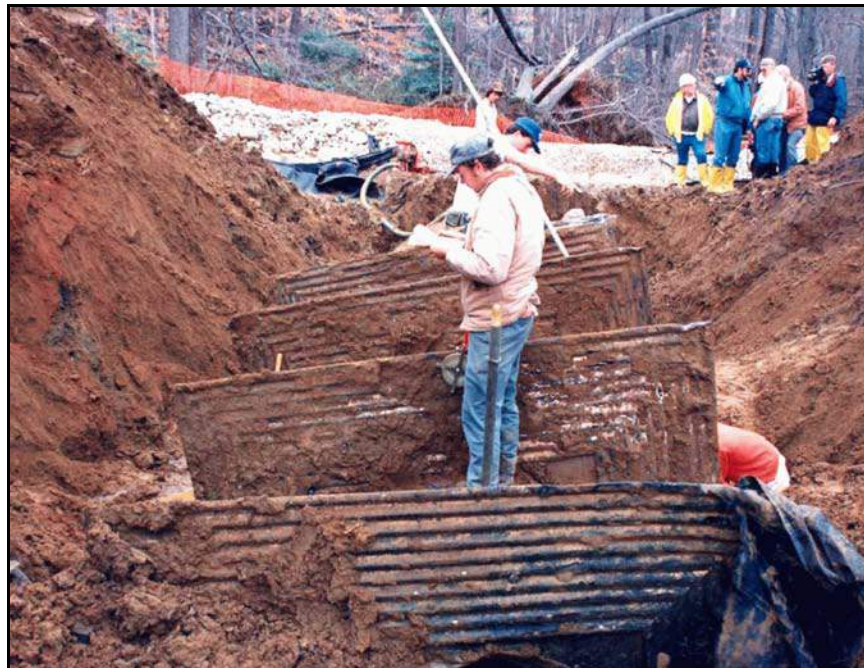
Figure B-11.—Seepage along the sides of the CMP resulted in loss of soil support, causing conduit and joint deformation.

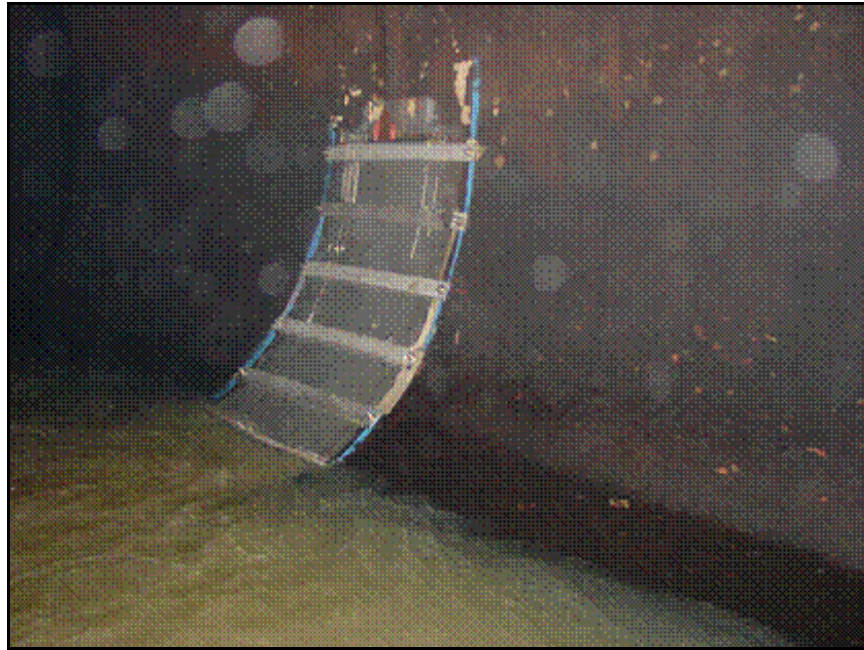
Figure B-14.—Metal plate bolted across the joint.

had been satisfactorily sealed with grout and that periodic grouting with chemical grout would keep the conduit watertight. However, since joint 6-7 broke loose suddenly and flowed sand at a significant rate, the conduit could no longer be considered safe for static loading and definitely could not be considered safe for earthquake loadings. Therefore, a team was formed to determine what should or could be done to ensure the continued safety of the conduit. The team solicited advice from personnel throughout the USACE. The consensus felt that the obvious solution was to line the conduit with a steel liner. However, the team recognized that this would be very expensive and would require bypassing outflow. Also, going through the design process, review process, and budgeting process would take several years. Therefore, the team elected to experiment with an interim measure that may or may not be the final solution. The team felt that if a plate were bolted across the joint with gasket material beneath it to prevent sand from exiting from the joint, then this would solve the problem. However, no one had any experience in doing this, and there was no assurance that the plate would stay in place. Therefore, the USACE elected to experiment with two joints during the time that the structure was unwatered for the 5-year formal inspection. A metal plate was bolted across joints 5-6 and 6-7 during a shutdown of the outlet works (figure B-14).

- *Cement mortar.*—Cement mortar was used to smooth the surface across the joint. This mortar was from 1.8 inches thick to 1 inch thick (had this much differential settlement at one joint).
- *Steel plate.*—Twenty-two feet of stainless steel plate was installed along the bottom of the joint. At a distance of about 10.5 feet from the centerline of the conduit, a 1.25-inch diameter hole was drilled in the side of the conduit to the existing waterstop (about 21 inches).

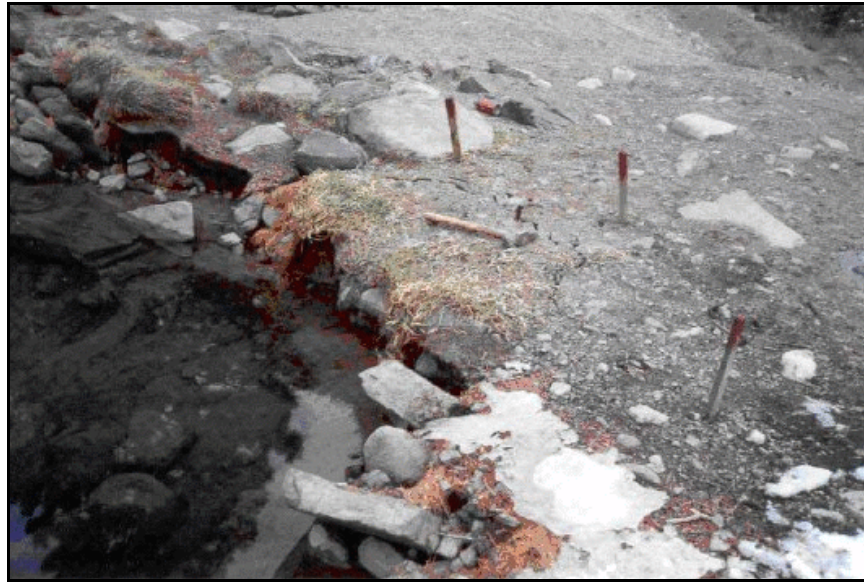
Figure B-16.—Cracking at the embankment dam crest above the sinkhole on the upstream slope of the embankment dam. Note the simple staking of the area to monitor movement of the crack.

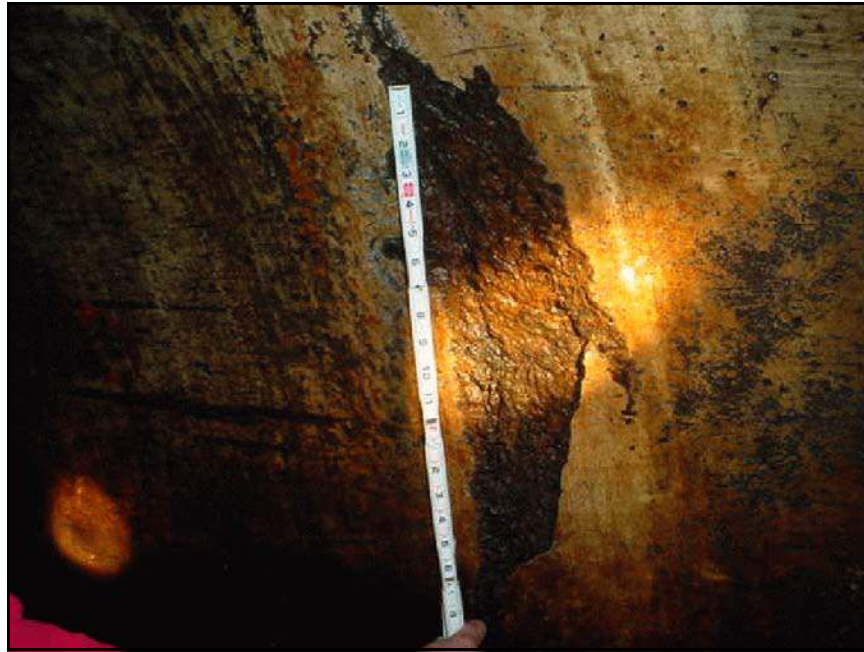
Figure B-20.—Large spall at the construction joint located at station 12+13.

Spalling had occurred at joints and other localized spots. Minor cracking, spalling, surface abrasion, and calcitic efflorescence were observed and mapped. Figures B-20 through B-23 are typical of these features. No major leakage was evident; however, minor seepage of water was observed in two locations but with no material being carried.

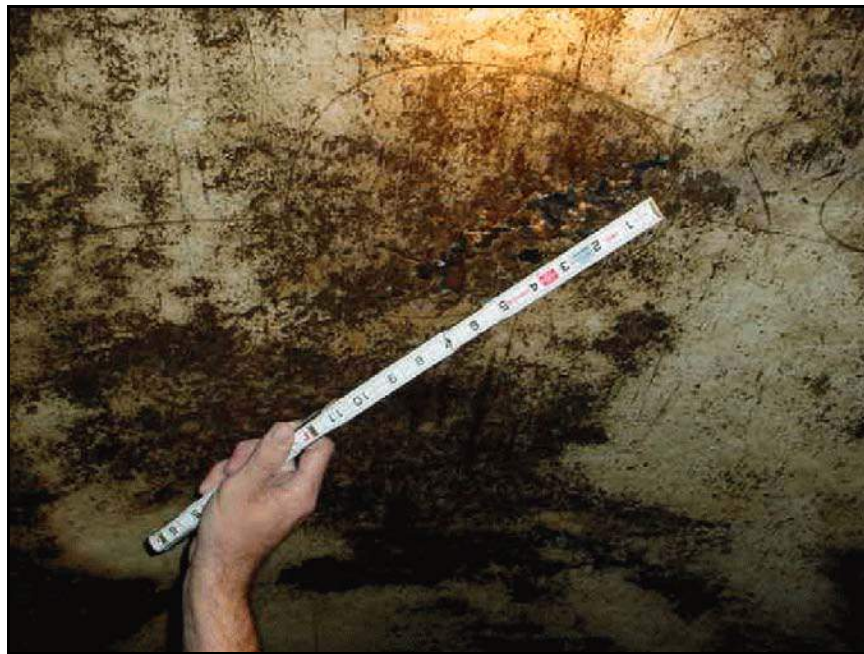
Figure B-21.—Exposed aggregate located at station 11+28.

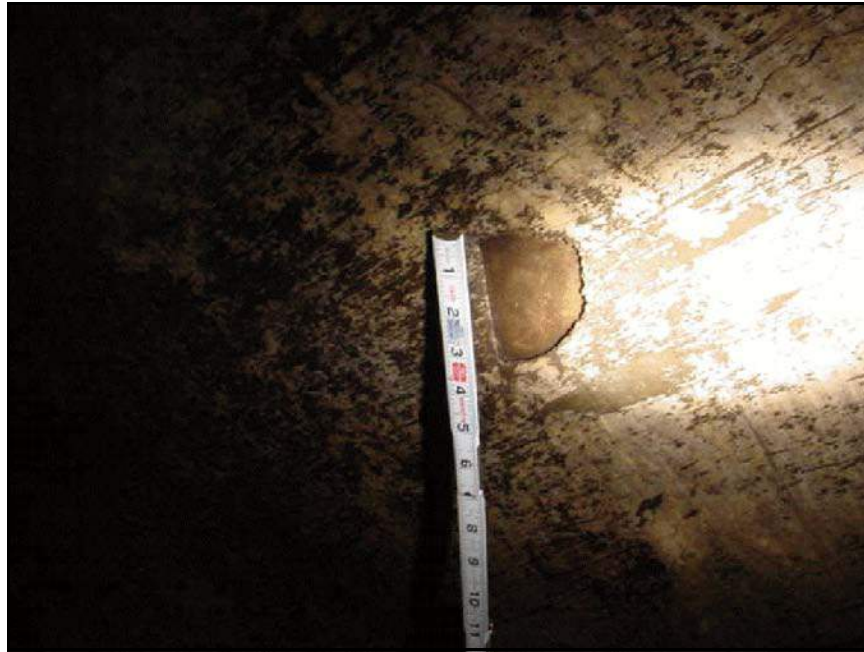
Figure B-22.—Popout located at station 10+79.

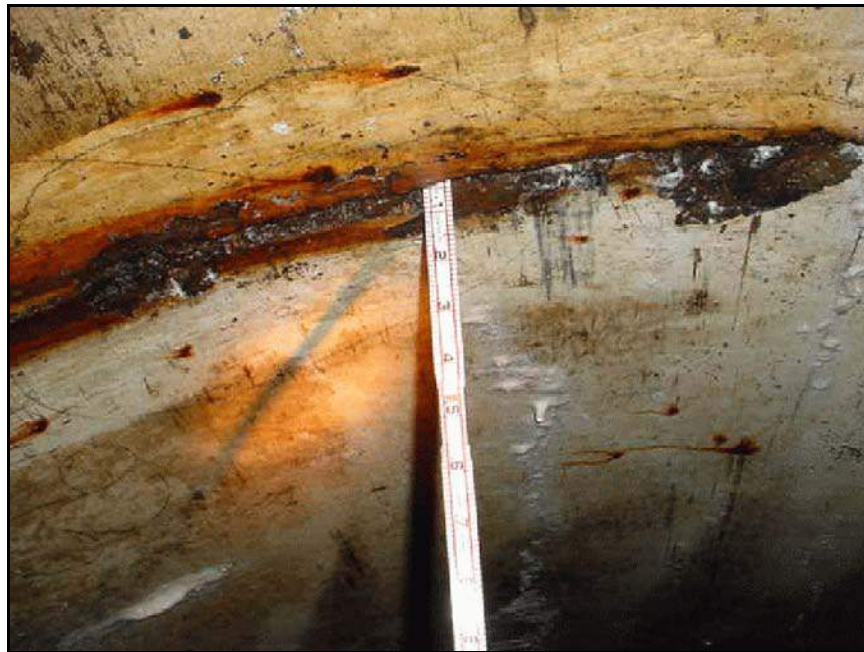
Figure B-23.—Spall at the construction joint located at station 4+93.

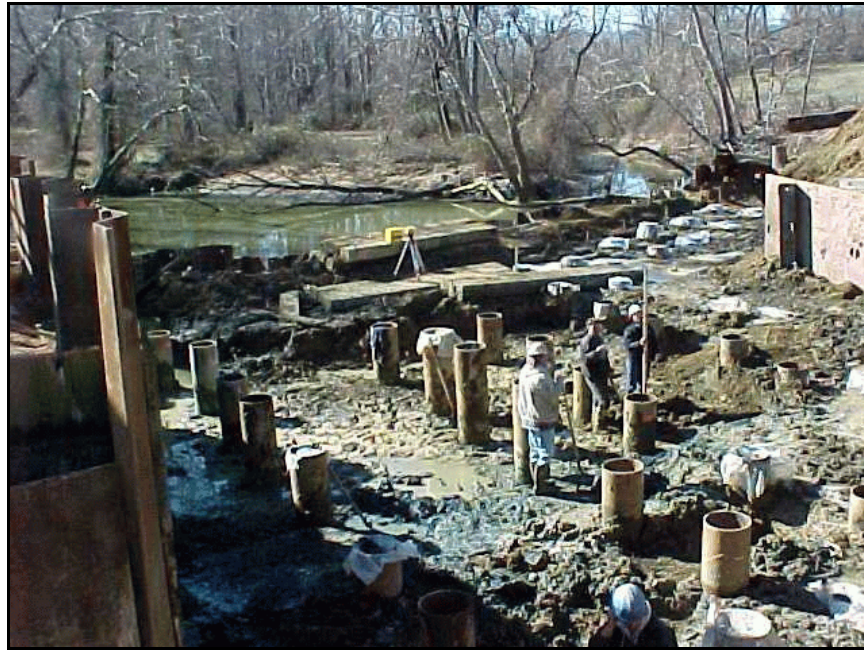
Figure B-24.—Because of soft foundation soils, numerous 60-foot long pipe piles were installed in winter 2001 to support a new reinforced cast-in-place concrete spillway structure.

Geotechnical investigations of the embankment dam and foundation revealed that the underlying soils are very soft, and a decision was made to replace the spillway with a reinforced cast-in-place box culvert supported on 60-foot long steel piles. Seepage control along the culvert was to be provided by a bentonite slurry wall near the center of the embankment dam and by a filter drain at the downstream end.

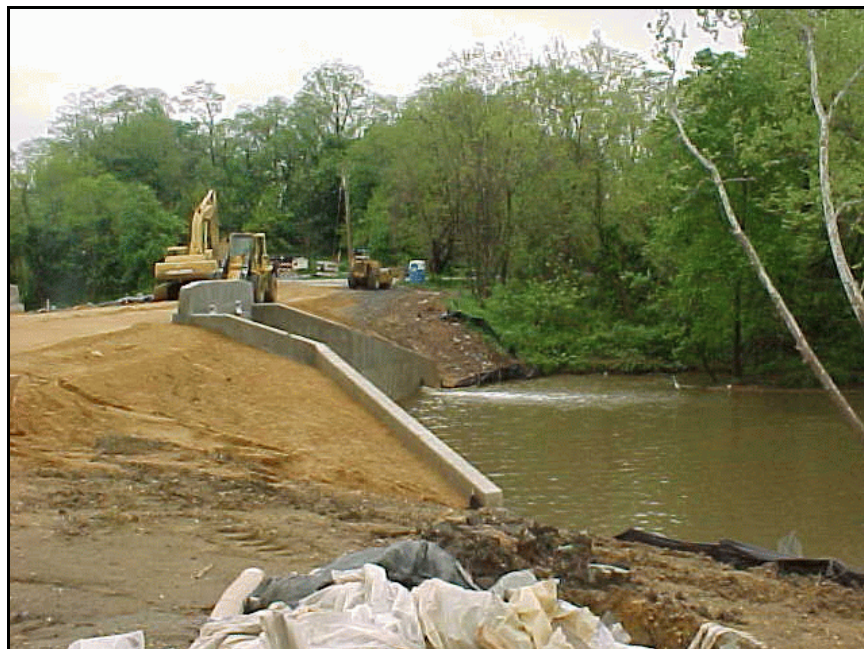
Figure B-25.—This the downstream end of the spillway at the end of construction in 2002.

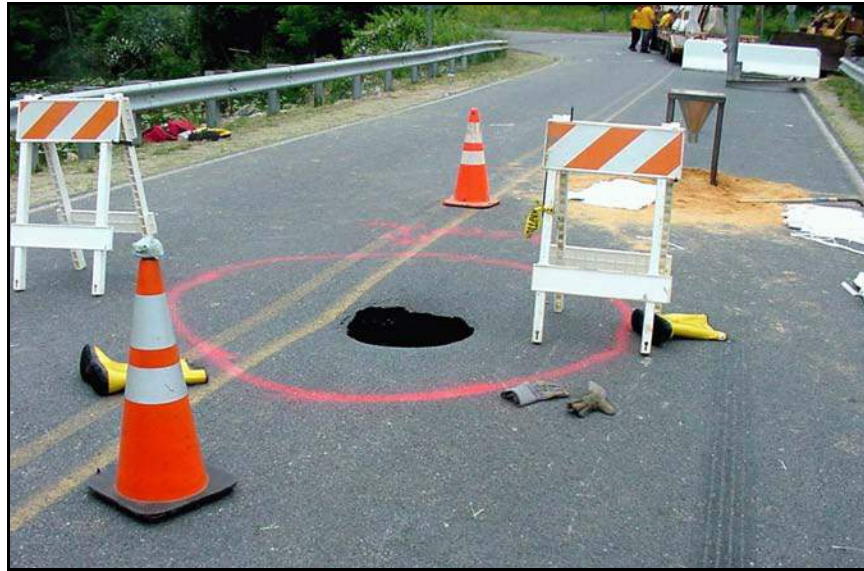
Figure B-26.—Less than 2 years later, an engineer inspecting the bridge over the spillway reported that seepage flow was visible from under the downstream end of the spillway. The seepage flow was clear, and no migration of soils was evident. A few months later, the roadway on the dam crest collapsed, and large quantities of sediment were observed in the pool below the dam.

However, within a few months, a sinkhole was noted in the pavement on the embankment dam crest (figure B-26). The seepage flow had significantly increased, and soil particles were observed moving downstream. The condition rapidly worsened, and the size of the sinkhole increased (figure B-27). Particles of the bentonite slurry cutoff wall were observed to be washing downstream from an area that appeared to be boiling (figure B-28). Attempts to create a sandbag weir around the boil to reduce leakage under the spillway conduit were unsuccessful, and the lake was drained.

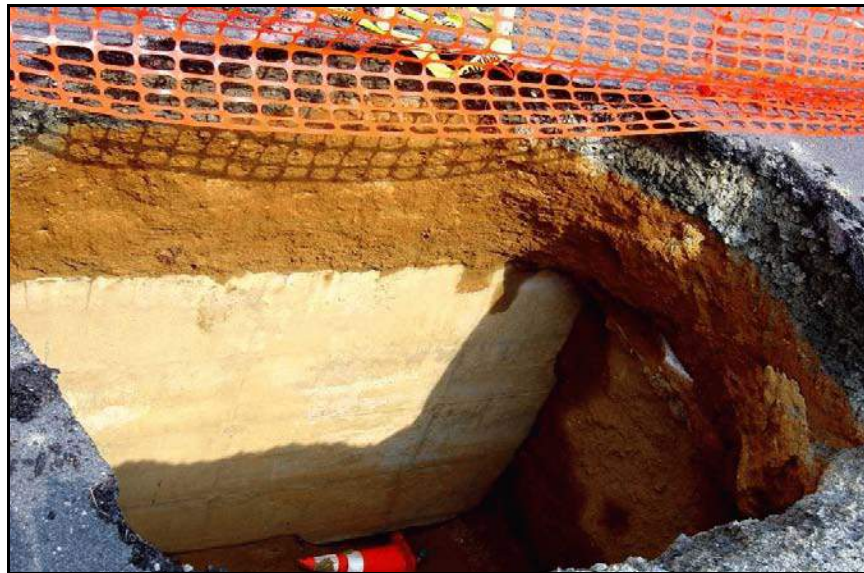
Figure B-27.—The road was closed immediately, and lake level was lowered. However, the sinkhole rapidly enlarged.

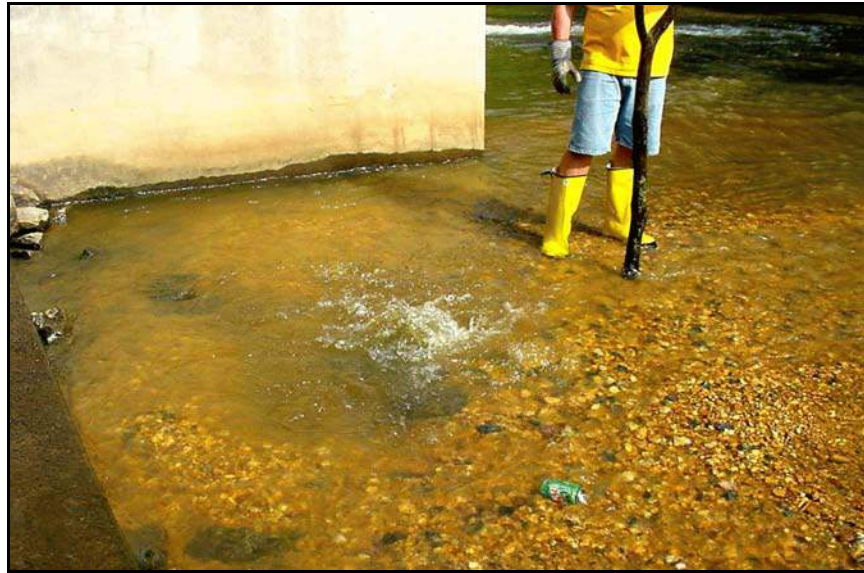
Figure B-28.—Seepage flow at the downstream end of the spillway appeared to be boiling. Attempts to create a sandbag weir around the boil to reduce leakage under the spillway were unsuccessful.

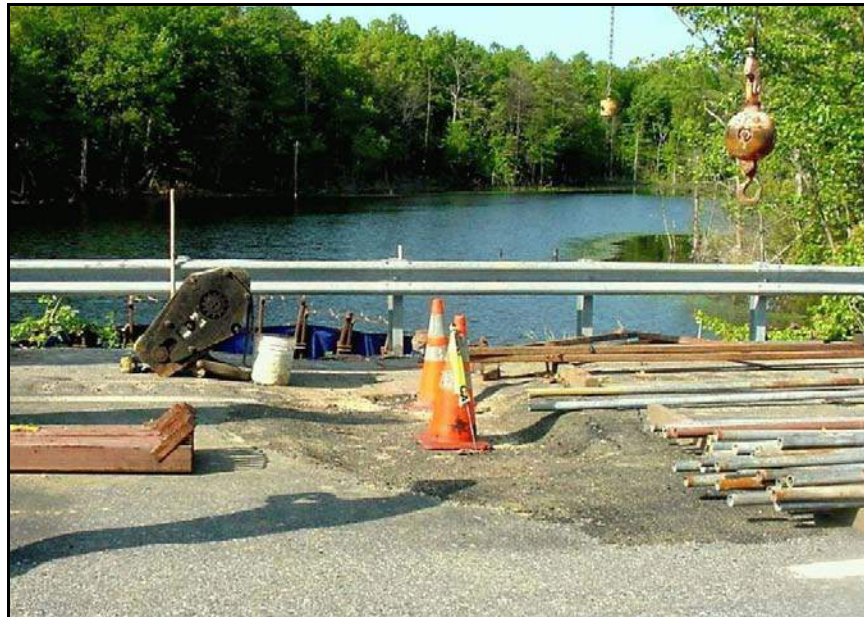
Figure B-29.—A sinkhole, which appeared in a heavily traveled roadway above a 20-year old CMP spillway, was filled with asphalt. Part of the roadway was closed when the asphalt patch subsided a few hours later.

In April 2003, a police officer traveling on State Highway 235 near Lexington Park, Maryland reported a large “pothole” in the roadway. A highway repair crew dispatched to the site promptly filled the 12-foot long, 1.5-foot deep hole with asphalt patching material, and the road remained open to traffic (figure B-29). However, one lane of the roadway was closed a few hours later when it was observed that the patched area had again subsided and a sinkhole was located directly above the spillway conduit.

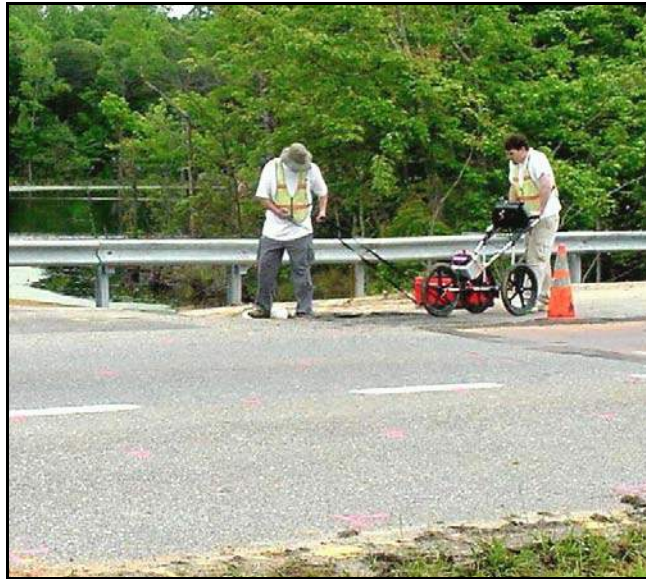
Figure B-30.—Ground penetrating radar investigations were performed from the embankment dam crest.

After the roadway collapsed in 2003, an inspection revealed extensive deterioration of the CMP and that substantial loss of embankment material had occurred. Ground penetrating radar (GPR) detected large voids in the embankment along the pipe, and a decision was made to construct a new spillway at a different location (figures B-30 and B-31). The failed CMP spillway and adjacent voids were filled with a stiff cement and flyash-based “compaction grout” (figure B-32). A specialty contractor performed the grouting and pumped the grout into the 24-inch diameter CMP using a trailer mounted, diesel powered, piston type concrete pump, specially mounted for grout injection work. The pipe fill mixture was a flowable, nonshrink, moderate strength (500-700 lb/in²) grout with the following specifications:

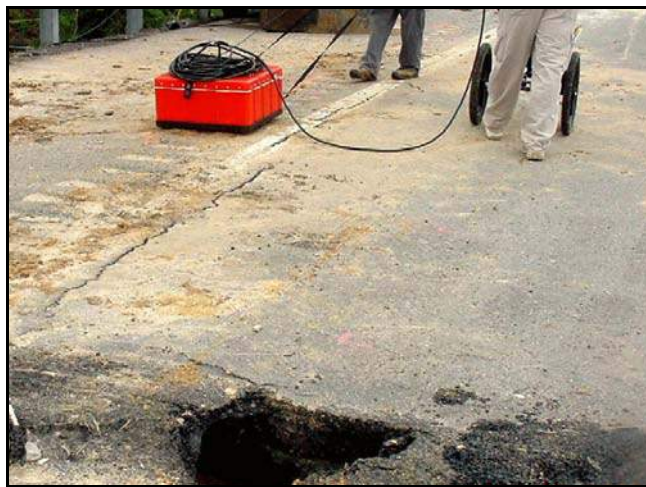
Figure B-31.—Ground penetrating radar identified the location of voids along the CMP.

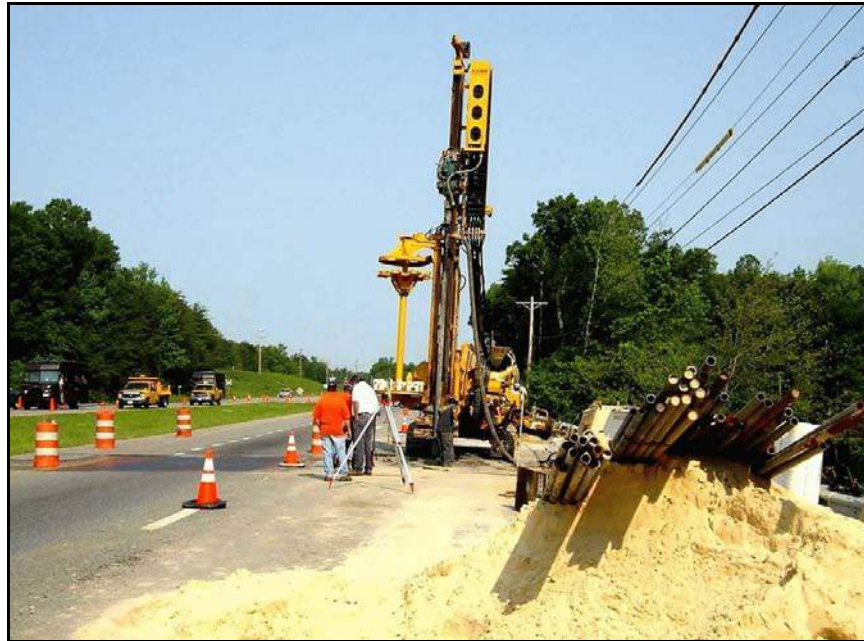
Figure B-32.—The failed CMP and voids were filled with a stiff compaction grout.

The compaction grouting to fill the voids in the embankment dam was performed from the roadway and median along the abandoned pipe alignment, with each grout pipe extending to approximately the pipe invert elevation. The grout-hole layout plan consisted of 128 compaction grout locations based on a 5-foot offset square grid throughout the anticipated treatment zone. The compaction grouting was performed utilizing a diesel powered track drill to install the grout casing through the pavement and fill soils to the invert elevation of the pipe. The grout was a blend of

concrete sand, type I Portland cement, flyash, and water proportional to provide a pumpable mix with about 500 lb/in² strength in 28 days. The compaction grout mixture specifications are as follows:
