Technical Manual: Conduits through Embankment Dams

Best Practices for Design, Construction, Problem
Identification and Evaluation, Inspection,
Maintenance, Renovation, and Repair

September 2005

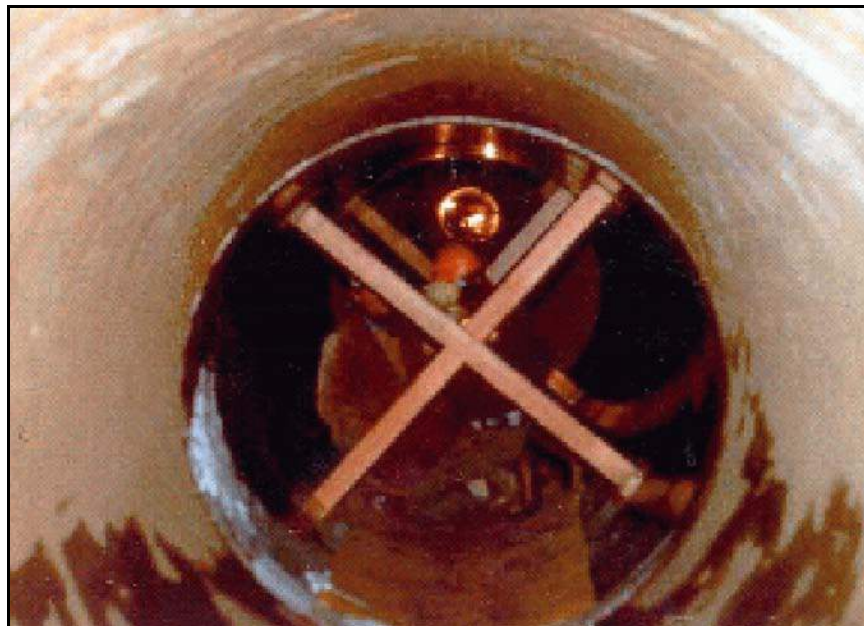
Figure B-34.—Installing the steel pipe slipliner within the existing outlet works conduit.

entire conduit with a steel pipe slipliner. This steel pipe slipliner would provide additional structural stability and a good flow surface, prevent seepage through the concrete, and could be placed in an expeditious manner to allow reservoir operation in the spring of 1993.

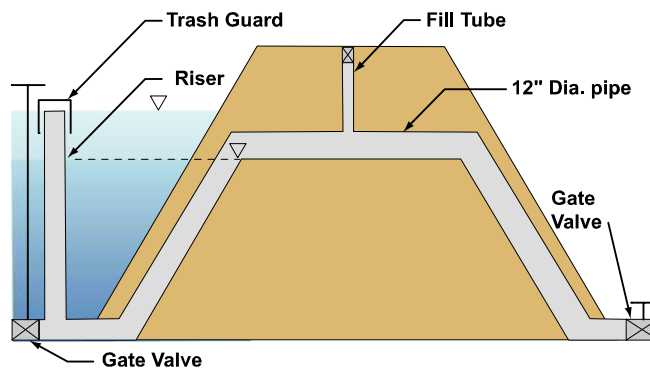
Figure B-35.—A well designed siphon was to be installed through the dam crest (from Leumas, 1998).

The design for the siphon was somewhat unique in that it served not only as a normal pool regulating device which discharged water from the surface of the reservoir, but also as a “bottom drain” structure which could drain the reservoir by discharging flow from near the bottom of the reservoir. Also, the siphon was designed to be self-priming, so that it would not need to be filled initially to start the siphon in order to drain the reservoir.

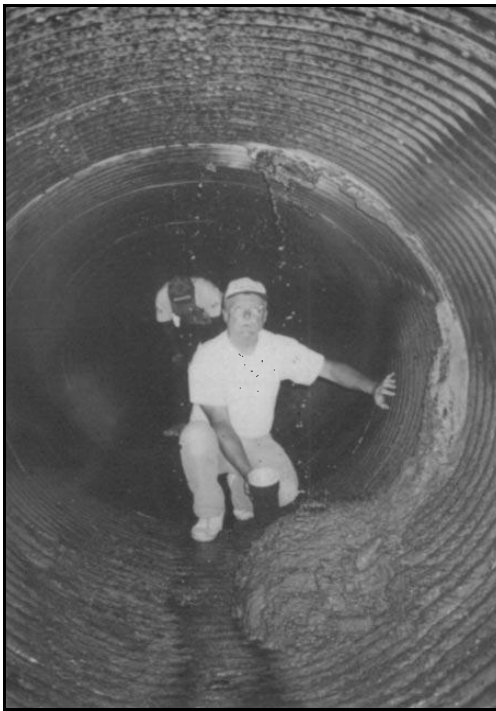
Figure B-36.—A man-entry inspection of this 60-inch CMP noted seepage and extensive loss of embankment soil at two locations.

Subsequent sloughing of the upstream slope damaged the upstream end of the CMP. An man-entry inspection of the pipe in 1993 noted that the pipe had ruptured, and seepage into the conduit was observed at two locations. At that time, the seepage flow was clear, and no soil loss was evident. However, by 1995 the seepage flow had increased, and soil deposits in the pipe indicated that internal erosion or backward erosion piping of embankment material was occurring, and failure of the embankment dam was a distinct possibility. Figure B-36 shows the man-entry inspection being performed. Due to the potential for loss of life if the embankment dam were to fail, the State dam safety agency directed the owner to hire a professional engineer to develop remedial plans to immediately repair the dam.

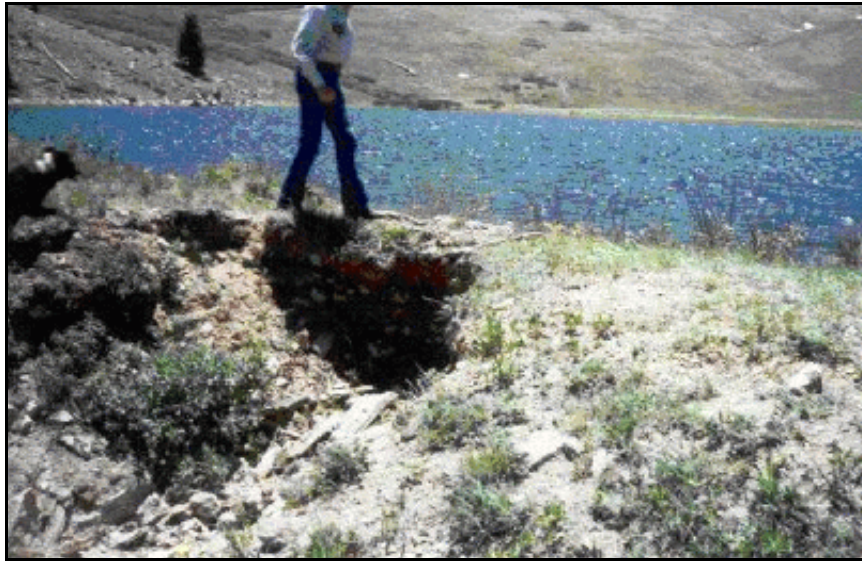
Figure B-37.—Erosion scarp on downstream slope of the embankment dam at the location of the overtopping of the dam crest.

An investigation of the damsite revealed that the embankment dam had been overtopped, but was not being overtopped at the time of the inspection. On the day of the inspection, the reservoir was at a level of approximately 2.5 feet below the dam crest. A large scarp and eroded area was noted on the downstream slope and dam crest, where the embankment dam had been overtopped (figure B-37). The scarp was eroded approximately 3 feet into the dam crest. Approximately 0.5 ft³/s of seepage was exiting from the bottom of the scarp area, and the discharge was clear. The flow into the reservoir was estimated to be approximately equal to the seepage through the erosional scarp. The embankment dam did not appear to be in imminent danger of failure, but the erosion of materials through the scarp and the reduced section of the embankment dam would eventually lead to a failure of the dam.

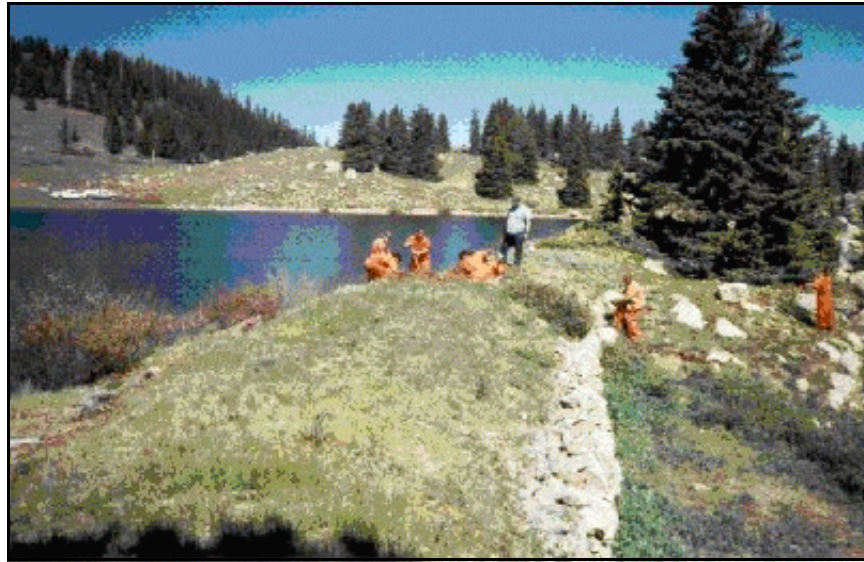
Figure B-38.—Excavation of the controlled breach in the embankment dam.

hauled in by hand. The final cut would be made through the embankment dam, allowing the reservoir to be drained in a controlled manner. The bottom and sides of the breach were excavated and lined with a graded rock riprap (figure B-38).

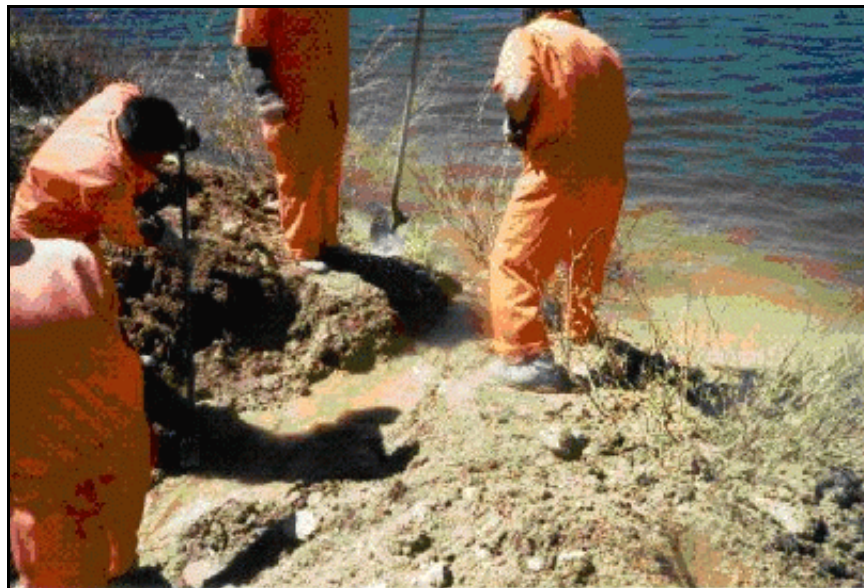
Figure B-39.—Completion of the initialization of the breach in the embankment dam.

The excavation was accomplished by a few well aimed pick swings, and the embankment dam was breached, and the water began flowing (figures B-39 and

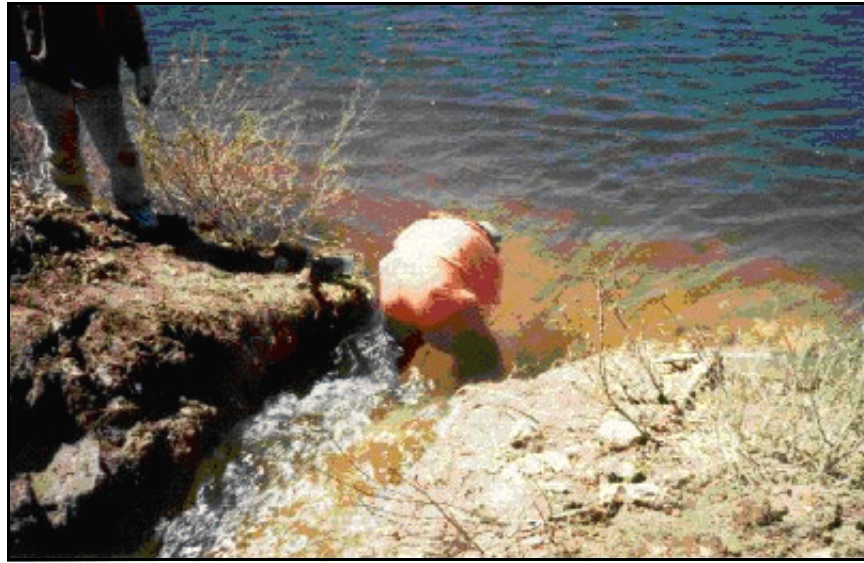
Figure B-40.—Deepening of the initial breach channel.

B-40). However, the control section, where the flow transitions from subcritical to supercritical flow, was located in the breach channel, where backcutting could occur and cause a large uncontrolled release. The reservoir basin upstream of the breach would have to be excavated in order to move the control section back into the reservoir. The inmates donned hip-waders and began the arduous task of excavating underwater, and after an hour's effort, the control section was safely located several feet back into the reservoir. Empire Dam was completely breached by July 2, and the reservoir drained in a very efficient and cost-effective manner.

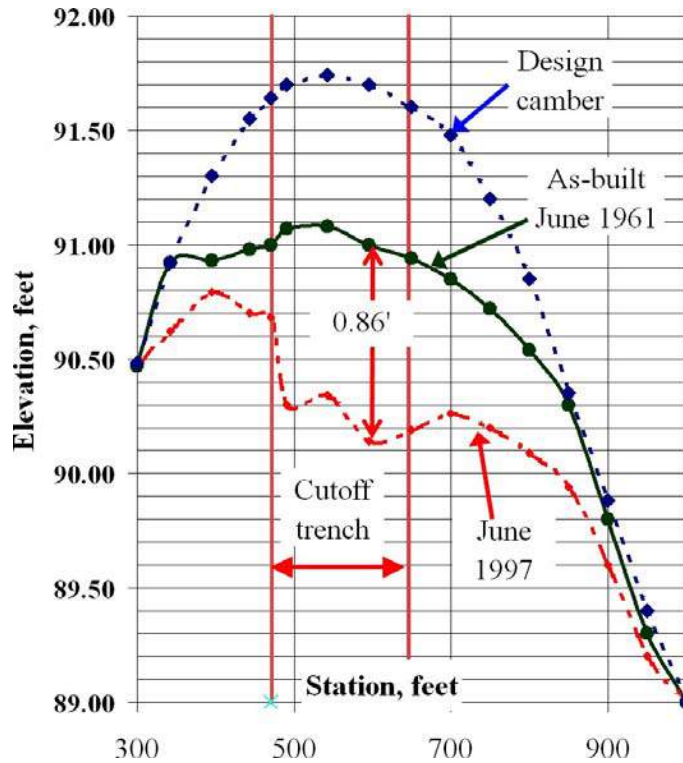
Figure B-42.—Settlement of the outlet conduit at Hernandez Dam.

This case history illustrated the need to install a outlet conduit on a uniform foundation. Sharp differences in thicknesses of compressible material beneath sections of a conduit that are near one another can lead to differential settlement that can damage rigid conduits. Cutoff trenches that are spanned by a outlet conduit should be designed to be compacted to a degree necessary to achieve similar strain characteristics in the cutoff trench backfill compared to the foundation materials on either side of the cutoff trench. Another approach to improve this situation is to flatten the side slopes of the cutoff trench to reduce differential strain. This case

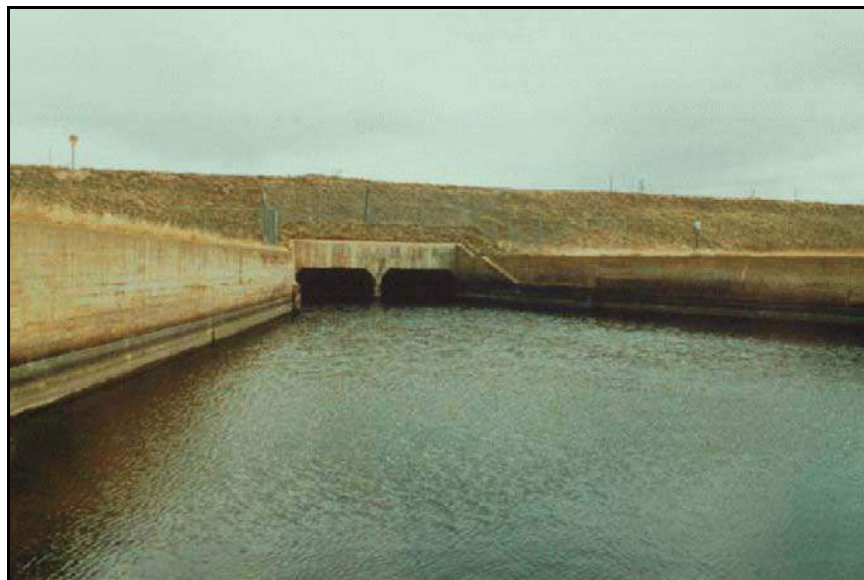
Figure B-43.— Lake Darling Dam outlet works discharge, circa 1990.

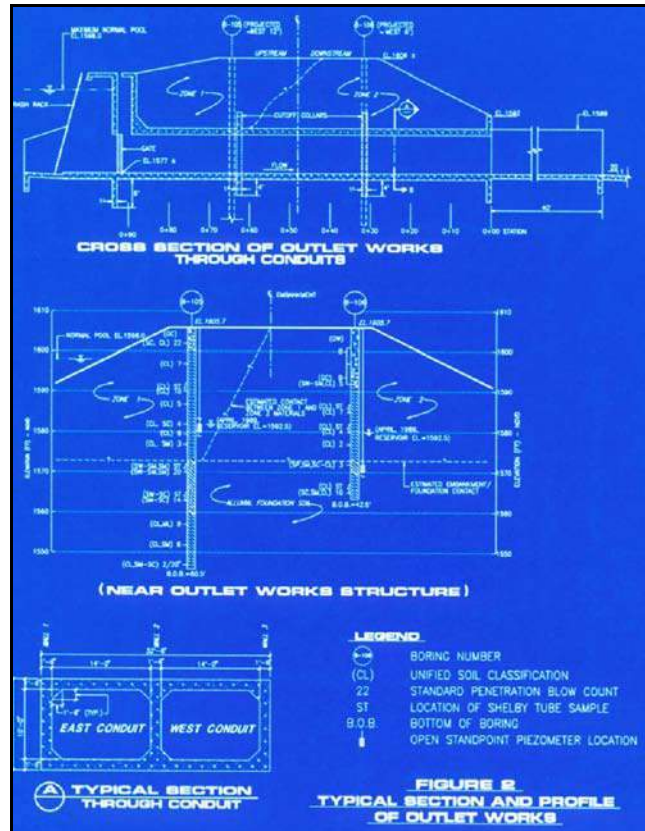
Figure B-44.—A cross section with a profile of the outlet works and design cross section of Lake Darling Dam.

embankment dam. The original design and construction did not include any control joints with waterstops in the conduits. The alluvial foundation materials beneath the conduits consist of up to 80 feet of sands, silts, and clays, some of which have moderate compressibility.

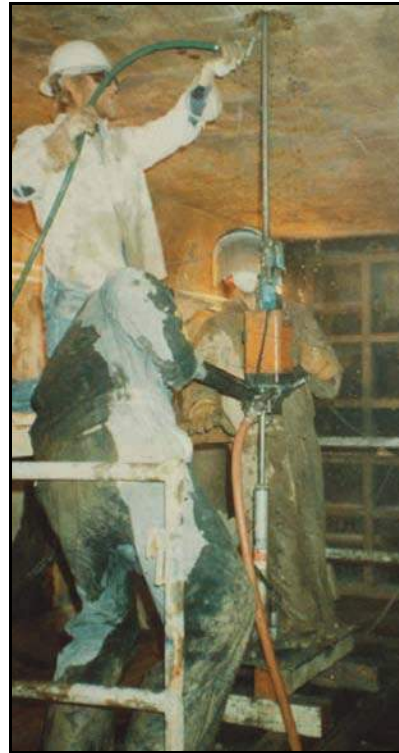
Figure B-45.—Grouting operations within the conduit.

Small voids were found beneath the conduit at a number of locations near observed cracks with seepage discharge. The lost grout was not found. Based on the additional information, final design and construction of corrective actions were initiated. The USACE was going to remove and replace the outlet works within 5 to 10 years as part of a comprehensive flood control project. The design of corrective actions took into consideration the limited planned life expectancy of the outlet. Corrective actions included in the rehabilitation design included both primary and secondary “lines of defense.” Primary lines of defense included (1) installation of six relief wells into the foundation soils to collect and safely discharge foundation seepage—these wells were installed about 15 feet downstream of the roller gates and discharged up through the floor of the conduit through a flap valve; and (2) sealing of all cracks in the conduit floors and walls with an elastic filler that would adhere to the concrete and expand and contract during seasonal changes in the width of the crack. The secondary lines of defense included (3) grouting around the base and exterior of the outlet conduits to seal existing voids and increase the effectiveness of the relief well system (see figure B-45); and (4) construction of a new floor with a filtered underdrain system.

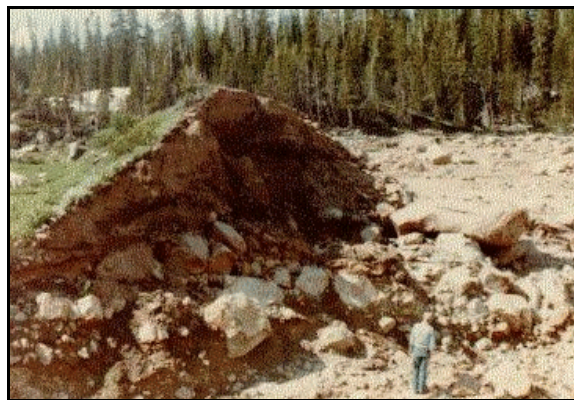
Figure B-47.—Right side of the breached Lawn Lake Dam.

At approximately 5:30 in the morning of July 15, 1982, Lawn Lake Dam failed. Estimates indicate that the breach of the embankment dam released 674 acre-feet of water, and the resulting dambreak flood had an estimated peak discharge of 18,000 ft³/s (USGS, 1982). The final breach dimensions through the embankment dam were surveyed to have a maximum depth of 28 feet, a top width of 97 feet, and a bottom width of 55 feet. The embankment dam materials exposed at the face of the breach showed the dam to have been constructed mainly of a silty and poorly graded sand with varying amounts of fine gravels and considerable amounts of organic materials. Figures B-46, B-47, and B-48 show the breached embankment dam. The embankment dam was not observed as it was failing.

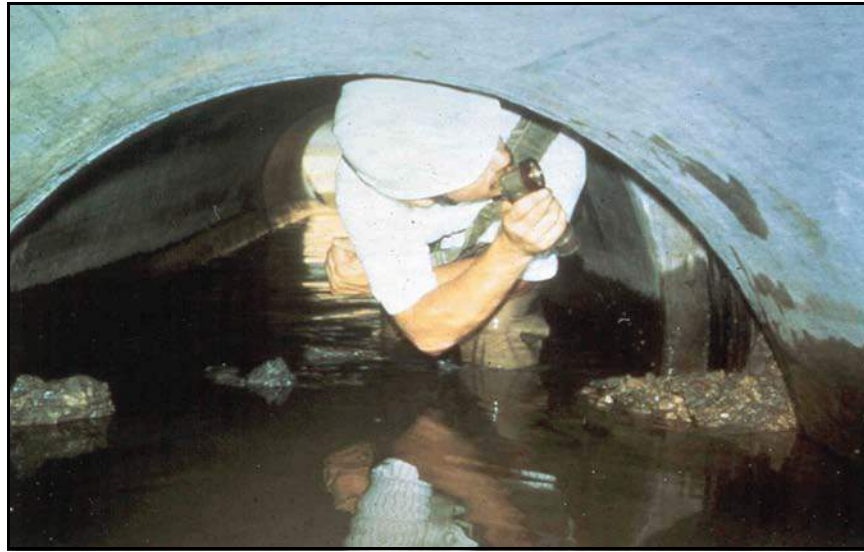
Figure B-49.—The pipe joints separated when foundation movement occurred during construction of the embankment dam.

The bottom of the pipe under the maximum earthfill height settled by about 1.5 feet, and the joints of one section of the pipe separated by more than 1 foot (figure B-49). The engineers investigating of the failure reported that the foundation soils under the

pipe, visible through the open joints, were soft, wet silts that resembled “stiff grease.” The engineer reported that no sands or gravels were encountered, and that the soil could be probed easily with a hand ruler to depths of 6 feet below the pipe. The report also indicated that the sheet metal shields on the outside of the joints appeared to support the embankment soils and minimized migration of soil into the open joints.

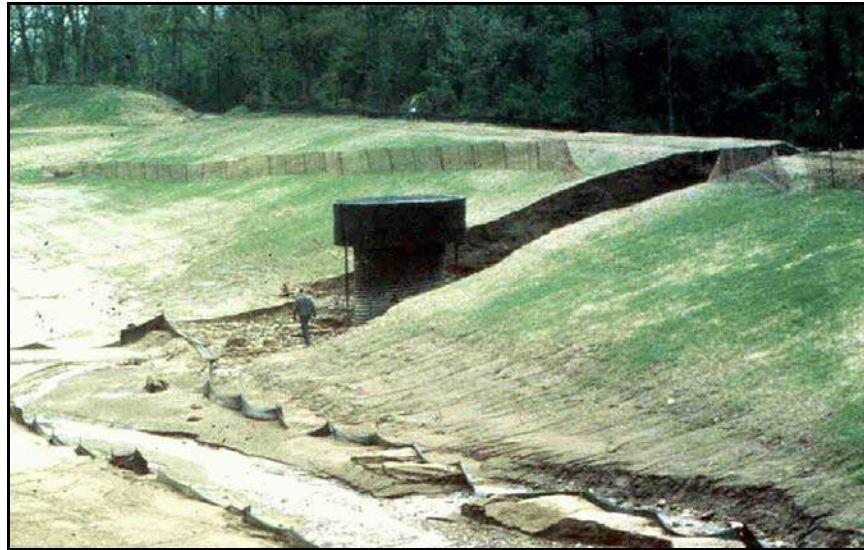
Figure B-50.—Loveton Farms Dam failure as viewed from upstream. Note that the walls of the failure area are nearly vertical. The construction records indicate that a large portion of the embankment dam was placed prior to installation of the CMP.

The embankment dam failed less than a year after it was completed, when a relatively small storm filled the pool to the top of the riser. Failure was attributed to internal erosion of embankment fill along the outside of the pipe (figures B-50 and 51). The original spillway pipe was likely placed in a vertically sided trench excavated through the nearly completed embankment dam. This construction technique is not recommended, as it makes compaction of the soil under the sides of pipe very difficult.

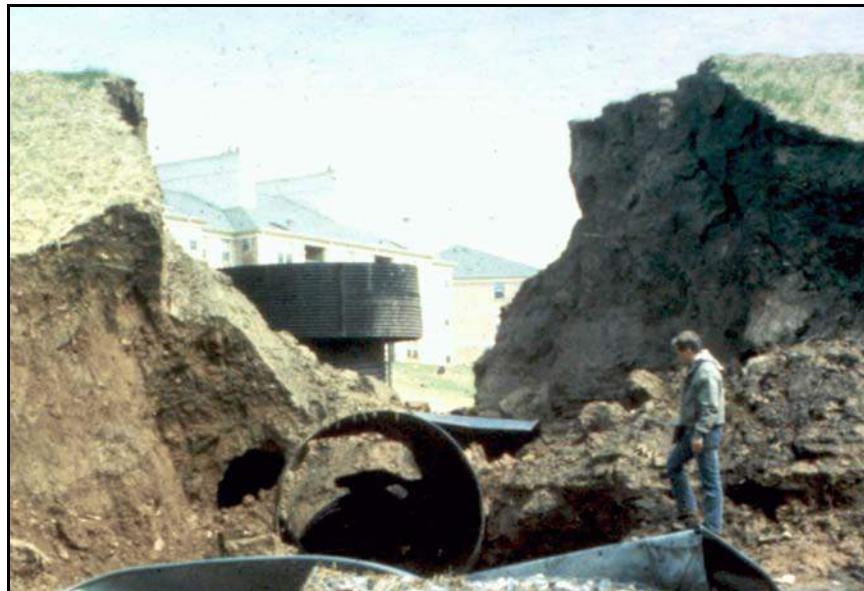
Figure B-51.—Loveton Farms Dam after failure as viewed from the downstream end of the 78-in diameter CMP spillway. Note that one of the antiseep collars, which were about 14 feet square, is visible in the breach.

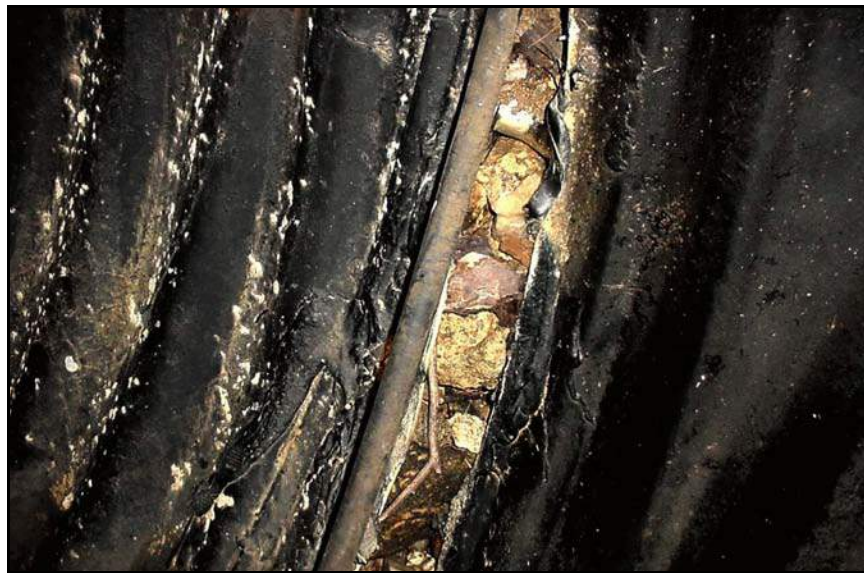
Figure B-52.—The failed embankment dam was repaired with a new 78-in diameter CMP spillway. However, soon after reconstruction, this failed joint was discovered at the upstream end of the pipe near the riser. A large void was also observed in the adjacent embankment fill. Note the o-ring gasket has been displaced from the joint.

In the years that followed the repair of the embankment dam, Maryland began to experience problems with other dams constructed with large diameter CMP spillways. In particular, it was noted that many of the joints between sections of the pipe were not watertight. This deficiency is primarily the result of deflection of the pipe, (the design standard allowed 5 percent of the pipe diameter), but poor construction techniques and manufacturing tolerances also contributed to the problem (figure B-52). Embankment dam owners were advised to carefully monitor their spillway conduits.

pipe. During an inspection in 1994, large voids (3 feet diameter and 20 feet long) were noted in the embankment around the upstream end of the pipe, and the first joint downstream of the riser had suddenly separated by about 0.1 m.

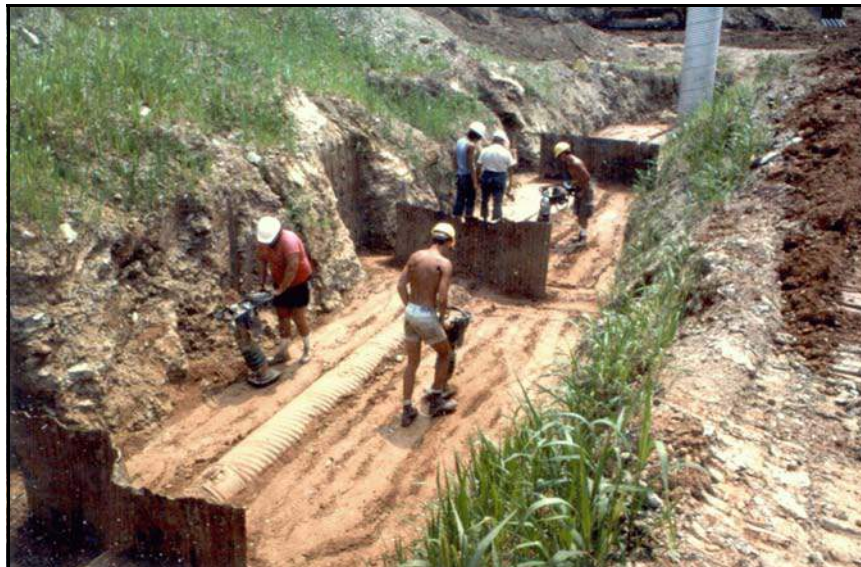
Figure B-54.—The embankment dam was constructed with antiseep collars.

The embankment dam was constructed in 1988 as a “temporary sediment basin.” Although an engineer prepared plans for the structure, no engineering supervision was provided during construction. Local materials (decomposed shale and erodible silts) were used to construct the embankment dam. A CMP spillway with conventional antiseep collars was constructed in a trench excavated into the foundation and backfilled with low plasticity silts and decomposed rock fragments from the excavation (figure B-54).

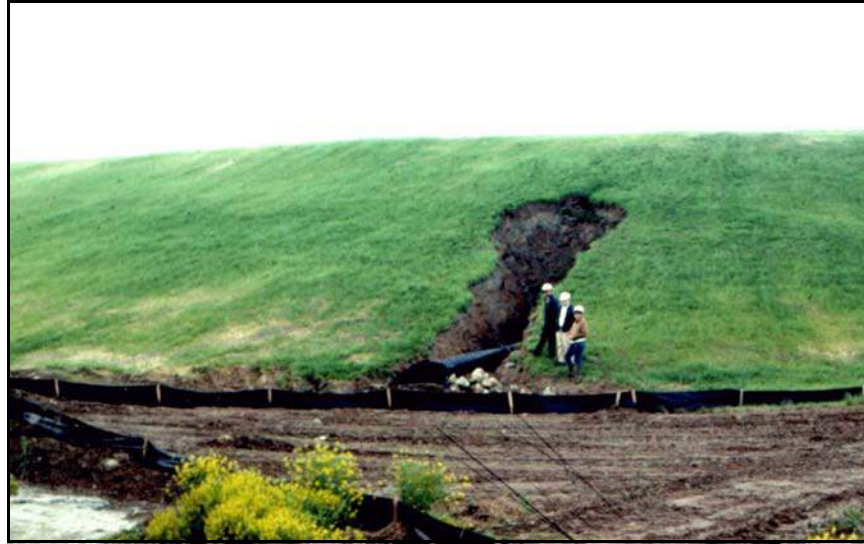
Figure B-55.—When the pool level of this embankment dam was only about 2 to 3 feet deep, flow along the outside of the CMP resulted in loss of the adjacent soils.

The structure was placed into use the following year, and it failed upon first filling. When the pool level was only about 2 to 3 feet deep, flow along the outside of the pipe resulted in loss of the adjacent soils by internal erosion (figure B-55).

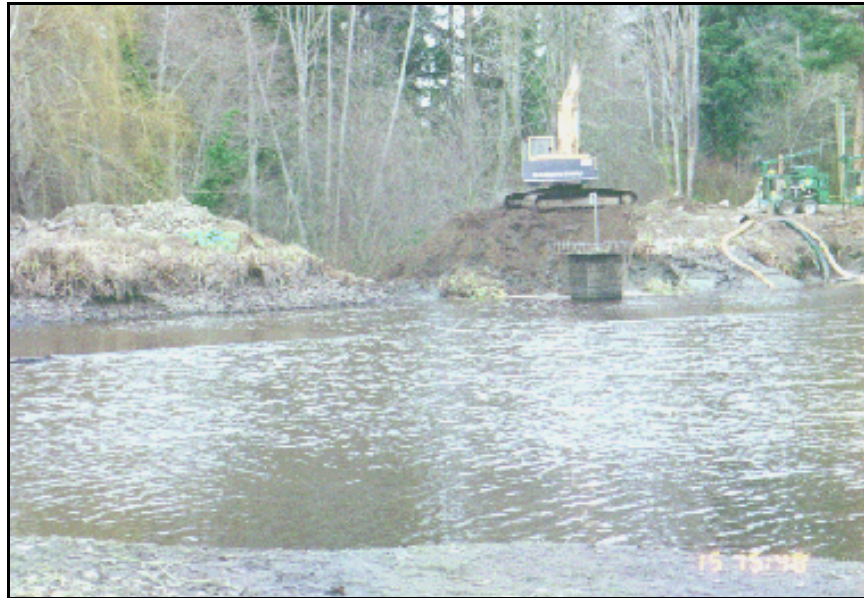
Figure B-57.—View of upstream dam crest nearing completion of breach.

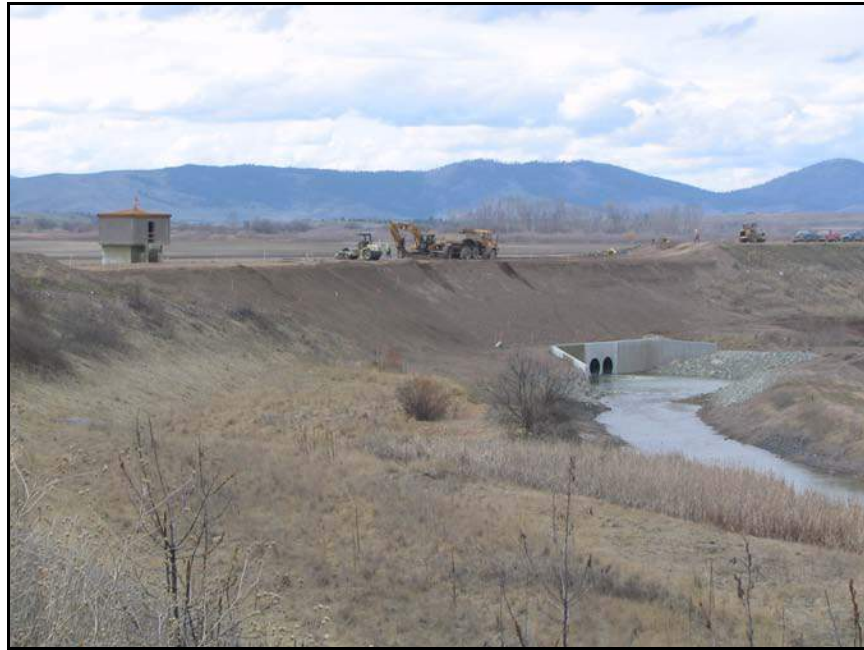
Figure B-58.—Pablo Dam nearing completion.

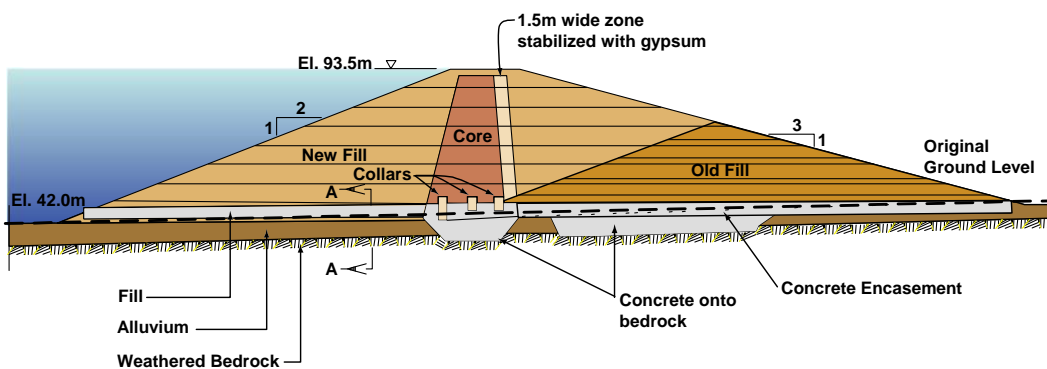
Figure B-63.—Cross section of the dam as designed.

The embankment material was broadly graded from coarse gravel sizes to clay sizes, typically with a liquid limit of 28 percent and plasticity index of 9. Both residual soil (decomposed phyllite and greywacke) and transported soil were utilized. The latter

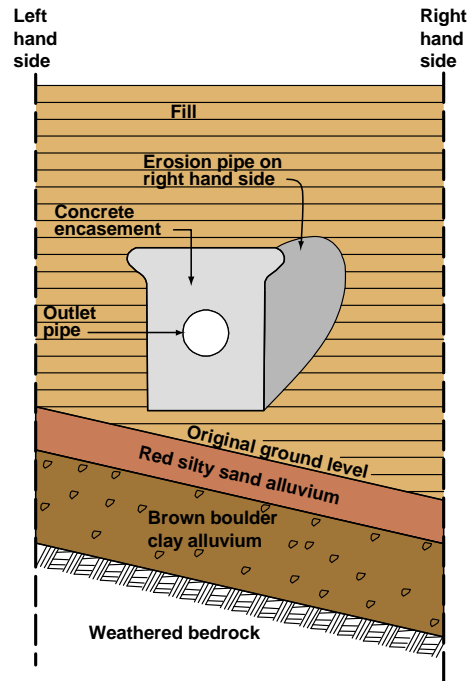
Figure B-64.—Cross section through the outlet conduit showing pipe, encasement and erosion tunnel.

Inspection after the event revealed a major tunnel through the entire width of the embankment dam along the outlet conduit. At the time of the inspection, the roof of the tunnel had collapsed over the entry and exit. The center portion of the tunnel beneath the dam crest, however, remained intact arching almost 33 feet across the tunnel. Large sinkholes were present in the upstream slope of the dam.

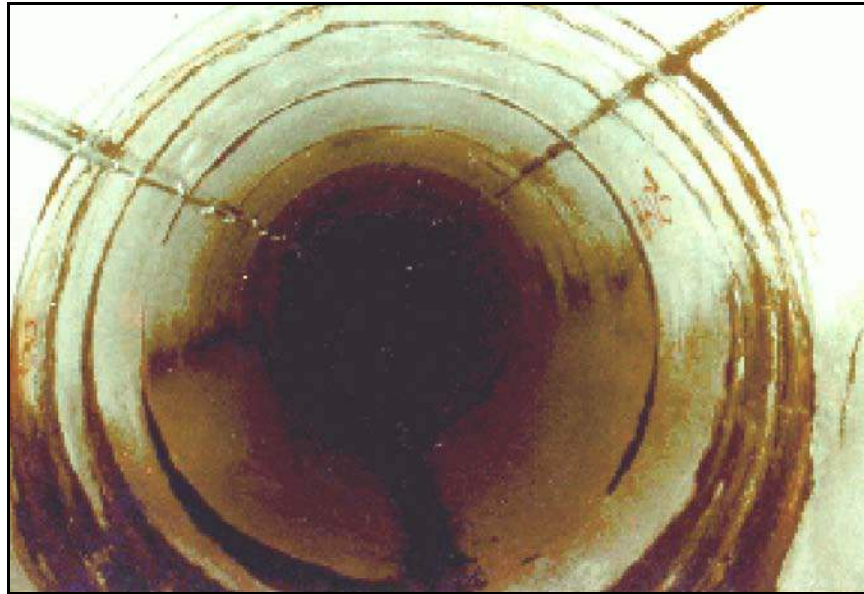
Figure B-66.—View of the interior of the outlet works after grouting.

Settlement and crack surveys were taken, in the upstream and downstream conduits, in January of 1986 and October of 1986. The maximum settlement recorded in January of 1986 was about 0.74 feet at station 11+24 in the downstream conduit. For reference, the station at the centerline of the gate chamber is located just downstream of the centerline of the embankment dam, station 7+50. In October of 1986, an additional settlement of about 0.22 feet was recorded at station 11+24. Settlements of other points in the conduit varied, seemingly based on the stiffness of the foundation. Maximum transverse cracking occurred in the upstream conduit at station 7+80 and station 8+80. The downstream conduit had very little transverse cracking, but a maximum joint opening of about $\frac{1}{2}$ inch occurred at station 10+73. Longitudinal cracking occurred in the crown and invert between stations 6+50 and 7+65 and between stations 11+74 and 14+35 in the upstream and downstream conduits, respectively. The settlement and cracking occurred during or after constructing the dam embankment to elevation 6830 in the 1985 construction season and topping out of the dam in 1986 at elevation 6886.

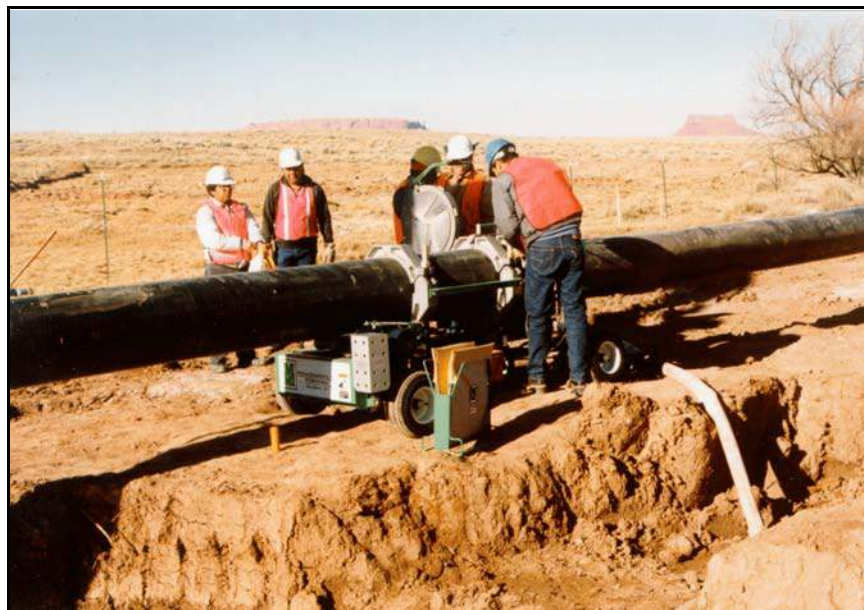
Figure B-68.—Heat fusion of an HDPE pipe joint.

Reclamation designed a modification, to address this dam safety deficiency, which consisted of an 18-inch O.D. HDPE pipe that was sliplined (figures B-68 and B-69) and then grouted into both the upstream and downstream CMP conduits. The HDPE pipe was designed to withstand external loads, disregarding any additional

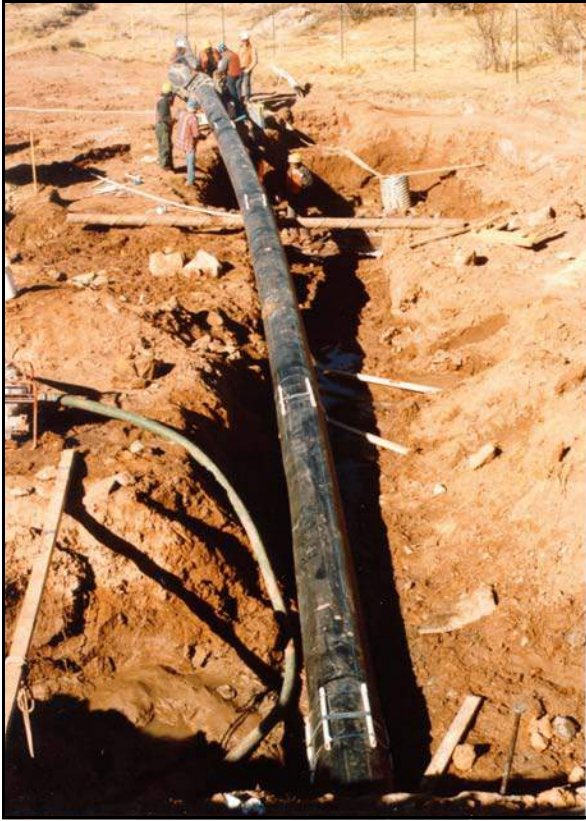
Figure B-69.—Inserting the HDPE slipliner into the existing CMP conduit.

support from the existing CMP. The design called for the HDPE pipe to withstand embankment fill loads of 38.2 feet, hydrostatic loads to 37 feet and a construction surcharge H-20 live load with a minimum of 5 feet cover. The HDPE pipe was also designed to withstand the loads associated with grouting. Installation of the liner was completed in the summer of 1994. The outlet works has operated without any liner-related incidents since that time. CCTV inspection of the slipliner was performed in May 2001, and the liner was found to be in good condition.

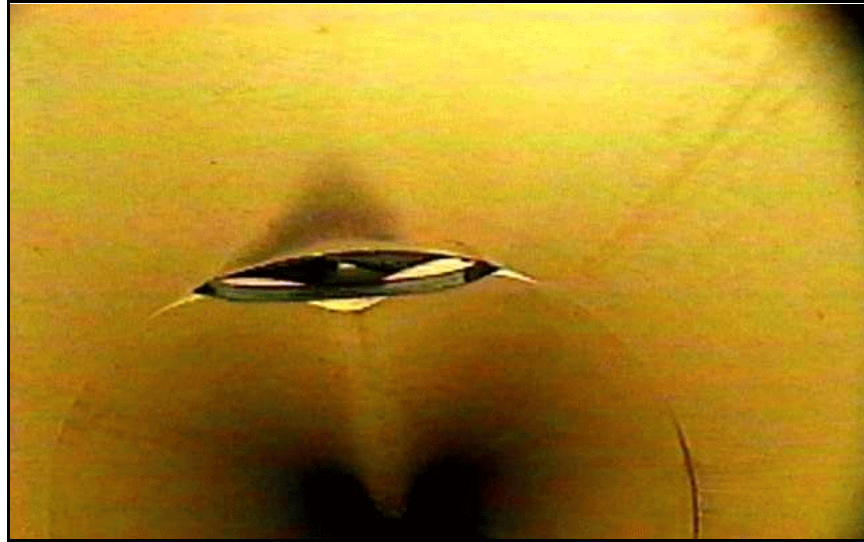
Figure B-70.—An open joint was discovered in a 16-inch PVC temporary diversion pipe under the 118-foot high embankment dam.

With the owner and his engineer present, a video camera was inserted into the downstream end of the pipe. At approximately 450 feet upstream of the pipe outlet, a separated joint was observed (figure B-70). Just upstream of that joint, the pipe had collapsed, leaving a space only a few inches high at the bottom (figure B-71) The pipe was immediately abandoned by completely filling it with grout.

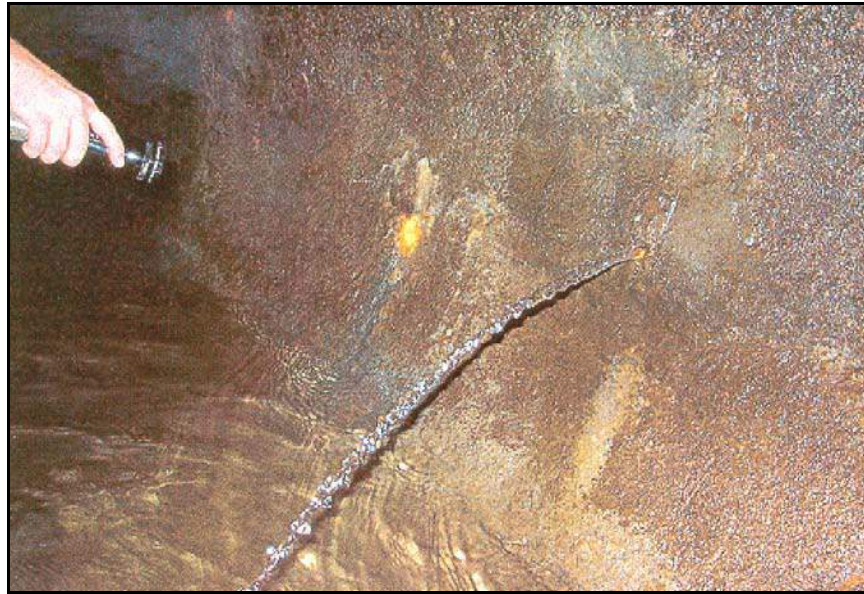
Figure B-72.—Seepage entering the downstream conduit.

A decision was made to perform concrete repairs on the poorest areas the downstream conduit. In preparation of the repair work in March 2001, a tap was inserted into a crack in the conduit approximately 190 feet upstream of the outlet portal in order to control seepage that was entering the conduit. Figure B-72 shows

the seepage into the conduit prior to installation of the tap. At this location, it was discovered that a void approximately 12 inches in depth existed behind the conduit wall. The concrete in this section of the conduit, which had previously been described as good, was determined to have 3 to 4 inches of somewhat sound concrete, backed by approximately 6 inches of loosely bonded aggregate or rubble. In subsequent explorations, it was determined that the void extended a minimum of 3 feet upstream and 4 feet downstream from the tap and was approximately 3 feet high.

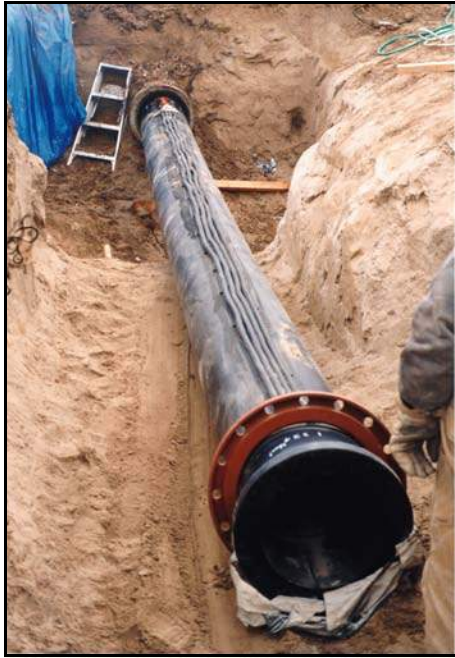
Figure B-75.—HDPE slipliner being installed at Turtle (Twin) Lake Dam. Note the HDPE grout lines welded onto top of new liner. The end flange was used to attach the two different sized liners together.

The HDPE-lined outlet works at Turtle Lake Dam has been in operation since modification without further incident. A CCTV inspection was conducted in April 2001. The inspection indicated that the HDPE slipliner was performing well.

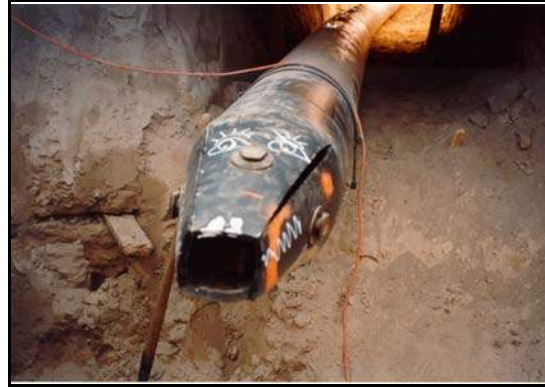
Figure B-76.—Upstream end of the HDPE slipliner modified to act as a pulling head.

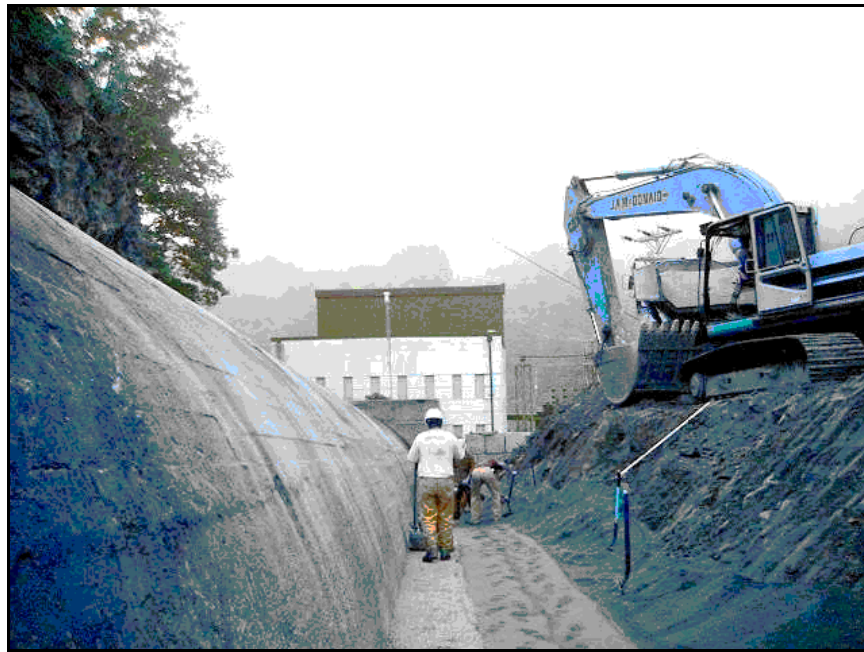
Figure B-79.—Filter material being placed in thin lifts and compacted with hand-operated vibratory compaction equipment.

Because of the confined spaces and irregular bedrock surfaces, the drainage and filter zones were placed in thin lifts and compacted with hand-operated vibratory compaction equipment (figure B-79). Although the work was time consuming, the uniformly graded materials were very easy to place and compact. To accommodate

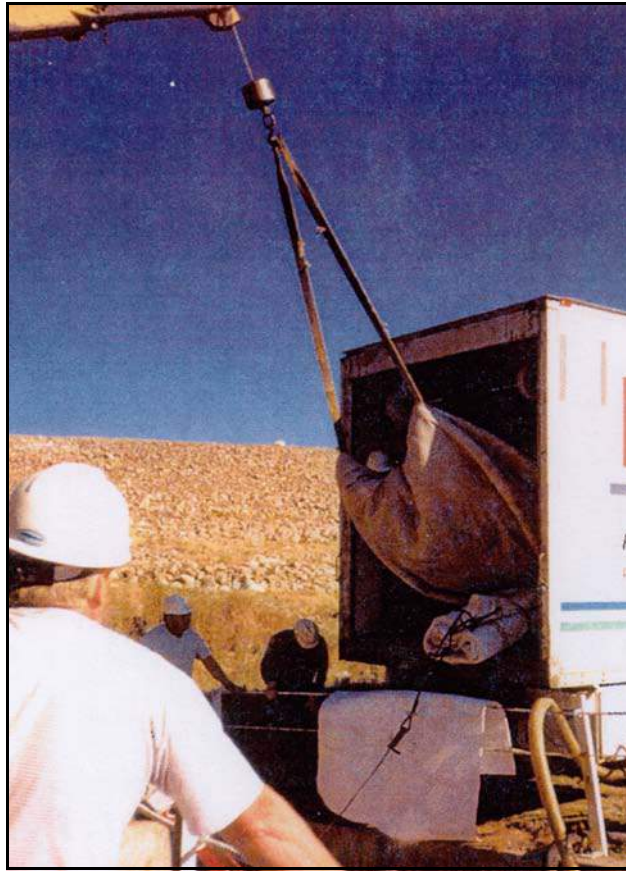
Figure B-80.—Lowering of the CIPP liner into the stilling basin, so it can be winched up the tunnel.

Both ends of the liner were trimmed using chain saws and circular saws, and a 0.5-inch deep groove was provided around the periphery to accommodate installation of end seals. Amex 10/WEKO seals were used, each consisting of a 14.5-inch wide rubber seal with three stainless steel bands spread by a hydraulic expanding device to ensure a tight fit. The work was completed on August 15, one week after site mobilization, for a total cost of about \$145,000. Subsequent laboratory tests on field samples confirmed the design parameters for tensile and flexural properties.

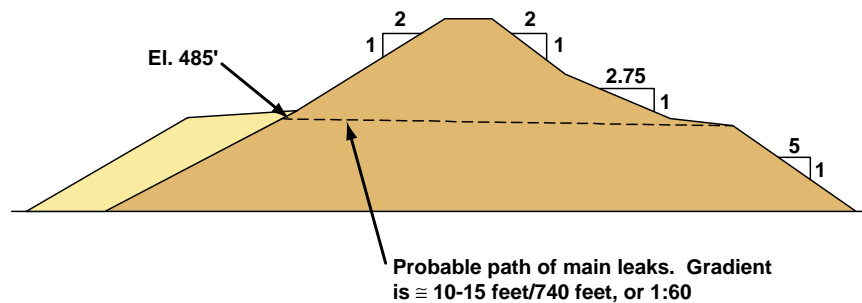
Figure B-81.—Cross section of Wister Dam showing probable path for internal erosion through embankment. The length of the flow path was about 740 feet, and the head on the entrance tunnels was less than 15 feet.

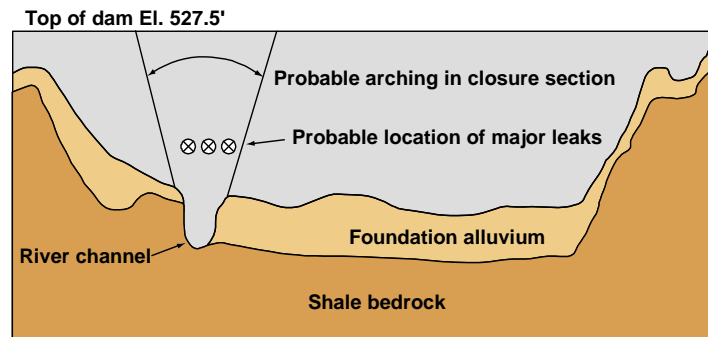
Figure B-83.—Cross section A-A from figure B-82. Profile along centerline of embankment viewed upstream.
